GROUP	MODEL
	Safety Recall Campaign	2023MY Sorento (MQ4a)
	NUMBER	DATE
	SC277	October 2023
SAFETY RECALL CAMPAIGN		
SUBJECT: <b>SUN VISOR AIRBAG WARNING LABEL (SC277)</b>

This bulletin provides the procedure to inspect both left (driver) and right (passenger) sun visors and, if necessary, replace one or both with new one(s) on certain 2023MY Sorento (MQ4a) vehicles produced from October 6, 2022 through August 5, 2023. The airbag warning labels on the driver and passenger sun visors in the affected vehicles may peel off. As a result, the affected vehicles may not comply with Federal Motor Vehicle Safety Standard (FMVSS) 208 (“Occupant Crash Protection”) which requires that each vehicle have a label permanently affixed to each of the sun visors. If the sun visor airbag warning label peels off, the driver and/or passenger may not be warned of the risks of airbag deployment, increasing the risk of injury in the event of a crash. Follow the procedure outlined in this publication to inspect, and if necessary, replace the driver and/or passenger sun visor with a new one. Before conducting the procedure, verify that the vehicle is included in the list of affected VINs.

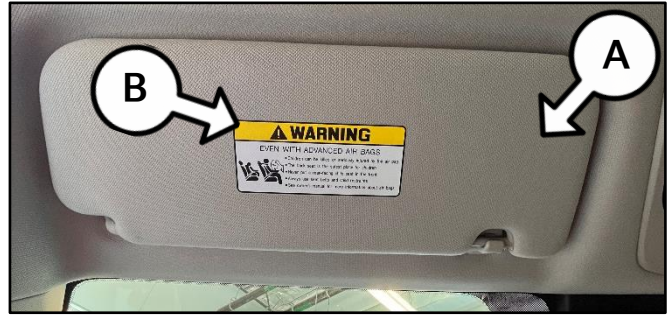
1. Identify the driver sun visor (A).
2. Inspect the Airbag Warning Label (B) for any peeling.

- If peeling is **not present (OK)**, proceed to step 3.
- If peeling is present (**NG**), proceed to 'Replacement Procedure' on page 3.

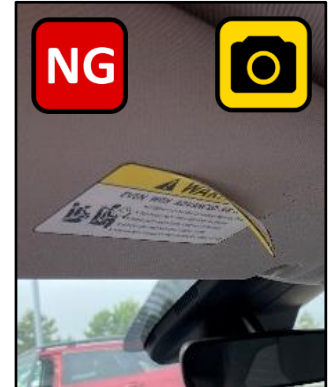
Take a photo using the KDS (KVID APP) of the peeling label. **NG** photos **ARE REQUIRED** to be attached to ALL claims.

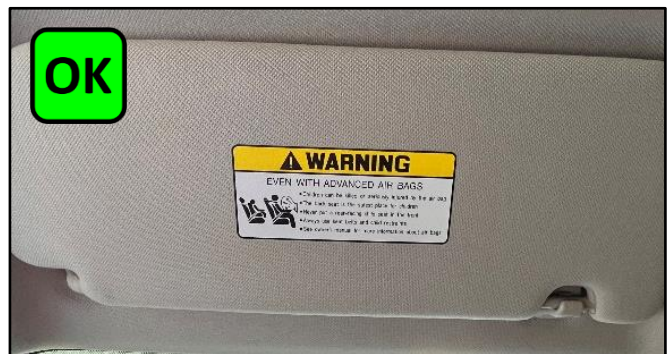
3. Using light pressure, drag finger down and over the label starting from the top and moving towards the bottom. Repeat in the three (3) sections shown:

- If peeling is **not present (OK)**, no further action needed.
- If peeling is present (**NG**), proceed to 'Replacement Procedure'.

**DO NOT** use a tool or fingernail to scrape the label's edge.

Take a photo using the KDS (KVID APP) of the peeling label. **NG** photos **ARE REQUIRED** to be attached to ALL claims.
