Safety Recall

Code: 13i6

Subject Engine Connecting Rod

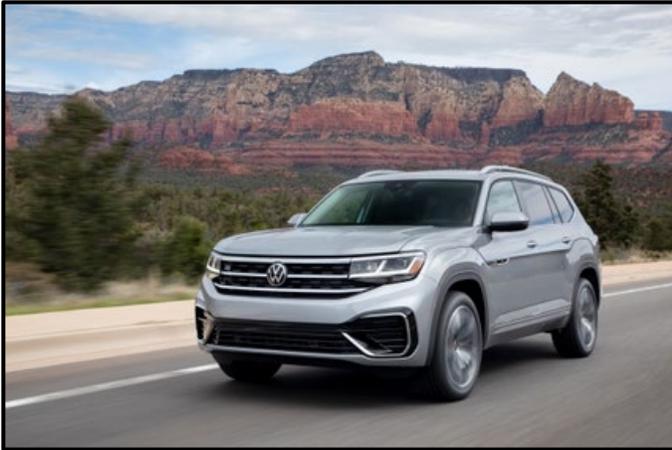
Section B – Test Procedure: Oil Filter Replacement + Road Test (connecting rod stress test) + Oil Filter Inspection

- Remove oil filter.
- **Install a new oil filter and seal.**
- Run engine at idle until it reaches operating temperature of 90°C.
- Turn on air-conditioning and all other engine loads.

- Activate Sport mode.
- Following all traffic laws, perform a road test, quickly accelerating from 1st to 2nd gear, bringing engine RPM up to 4500 RPM each time.

- Perform this road test **10 times** and listen for excessive engine knocking.
- Bring vehicle back to the shop.
- Let engine idle for at least 30 seconds.

- Turn engine off.
- Remove oil filter.
- See examples of OK and NOT OK oil filter and housing on the following pages.
- If no excessive metal particles are found:

- Engine does not require replacement.
 - **Replace oil filter and seal again.**
 - Torque housing to 25 Nm.
 - Proceed to Section D.
- If excessive metal particles are found:

- The engine requires replacement.
 - Take clear photos of oil filter and housing.
 - Proceed to Section C
