# SAFETY RECALL

| Date | Number | Release | Page |
|---|---|---|---|
| 09.2024 | SC0448 | 01 | 1(19) |

## **Mack GR, GU Turn Signal Visibility GR, GU**

Mack Trucks has determined that on certain 2015 to 2023 model year GR and GU trucks, the turn signal visibility may not alert other drivers to a turning vehicle, increasing the risk of a crash.

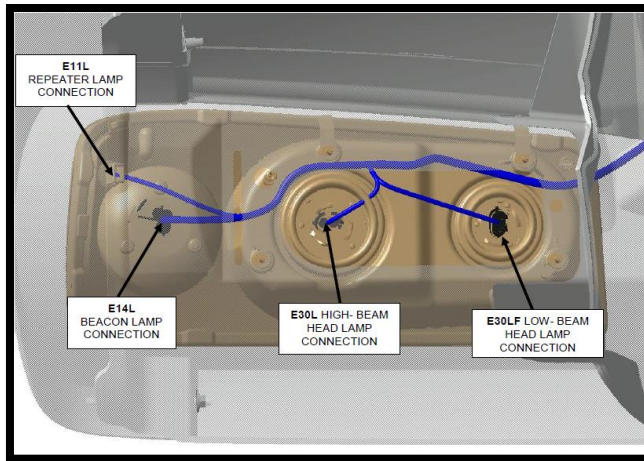
-Axle Forward 4 connections

9. Disconnect all connectors to bulbs. Axle Forward trucks will have 4 connections and Axle Back trucks will have 3 connections.

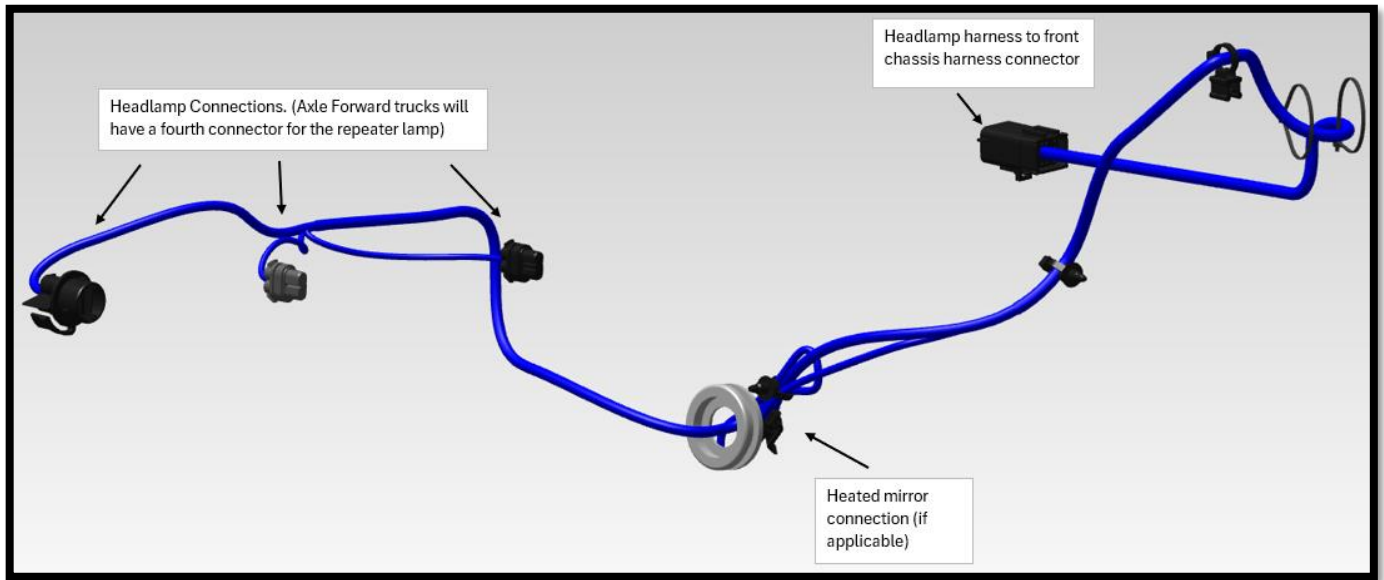
10. Disconnect connections between the front harness and the headlamp harness on both sides including the heated mirror connection.

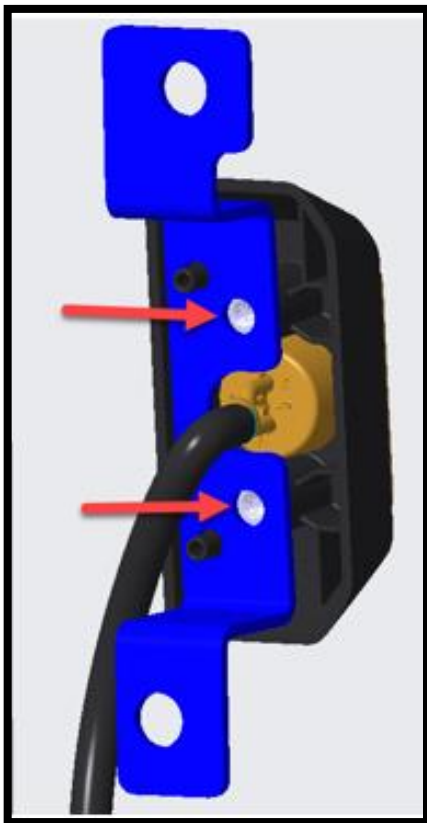
11. Remove both headlamp harnesses by removing the grommets and feeding the connections through the open hole. You will have to snip all zip ties holding the harnesses in place.
12. Once the harness is removed, install the new supplied harness and grommet. The new harness will connect and route in the exact locations as the original harness but will have an extra connection for the new turn signal indicator.
13. Pre-assemble the two supplemental turn signal indicators with their brackets.

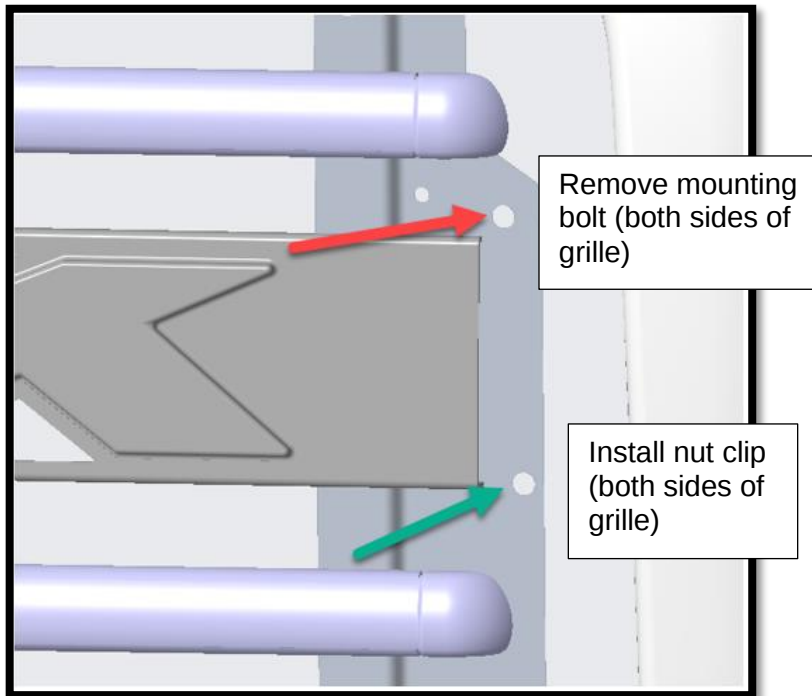
14. Remove the top mounting bolt in the grille on both the left- and right-hand side. Add a nut clip on the hole below on both left- and right-hand side.

15. Mount supplemental turn signal indicator using supplied bolts. Torque to  $3.5 \pm 0.5$  Nm.

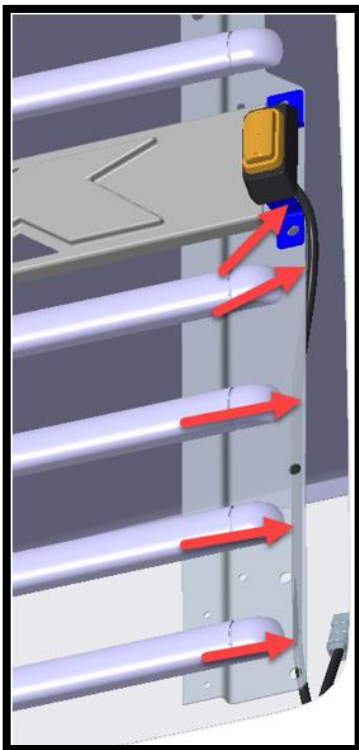
16. Add 5 edge clipping ties included with the install kit on both sides of the grille to route the harness of the turn signal.

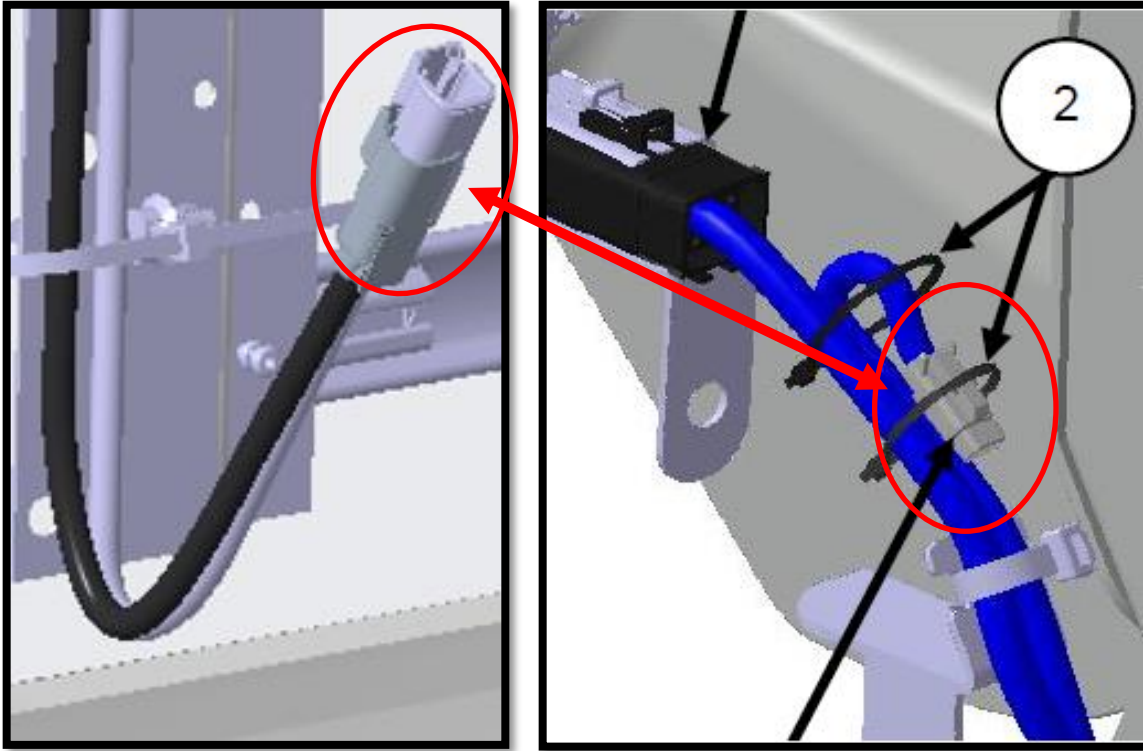
17. Connect turn signal indicator harness to the new connector on the headlamp harness on both the left-hand and right-hand side.

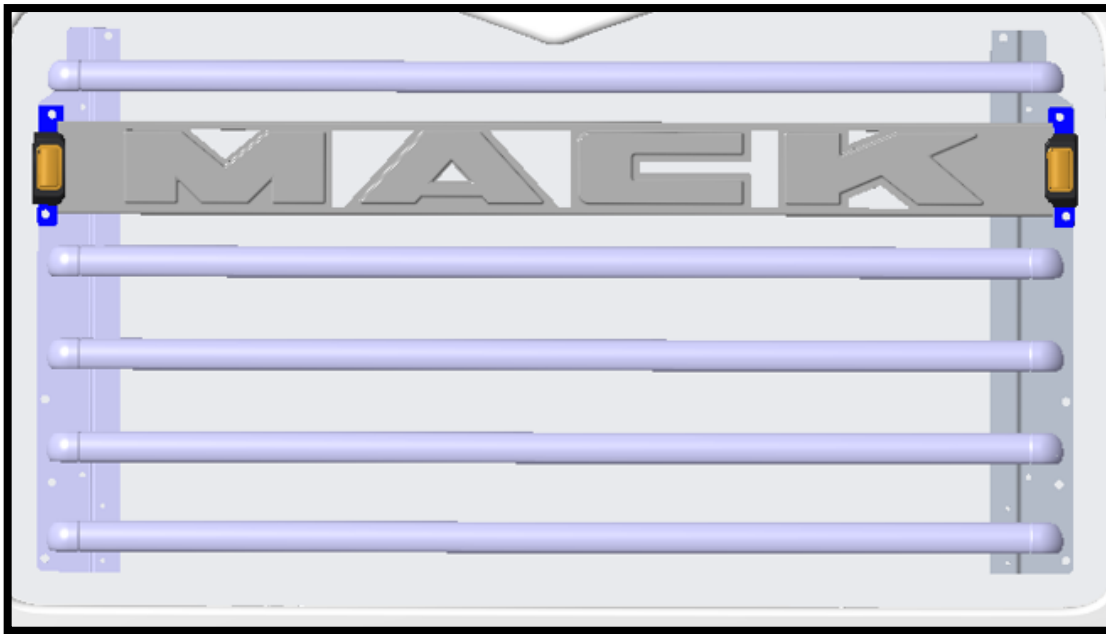
22. Check for proper function of all lights and turn signals. New indicators should operate in sync with headlamp turn signals. Install is complete.

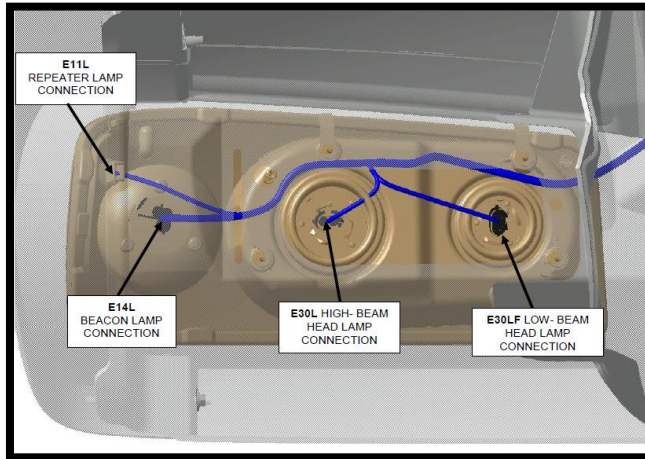
-Axle Forward 4 connections

9. Disconnect all connectors to bulbs. Axle Forward trucks will have 4 connections and Axle Back trucks will have 3 connections.

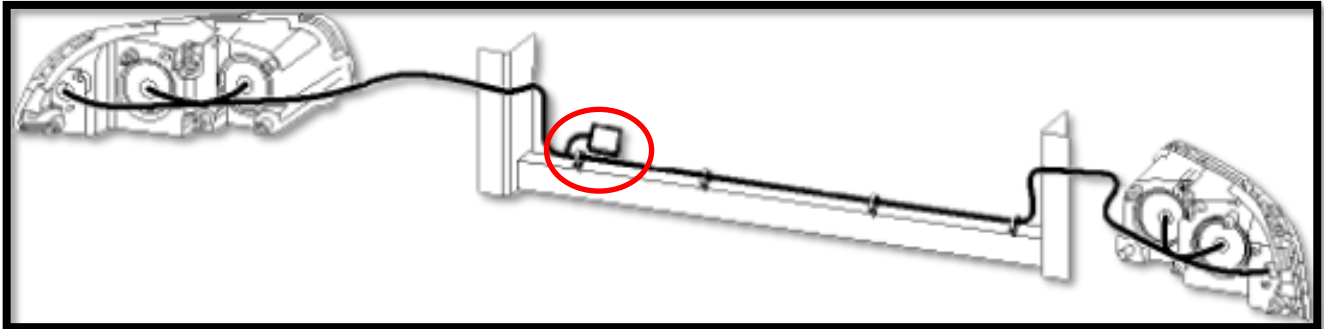
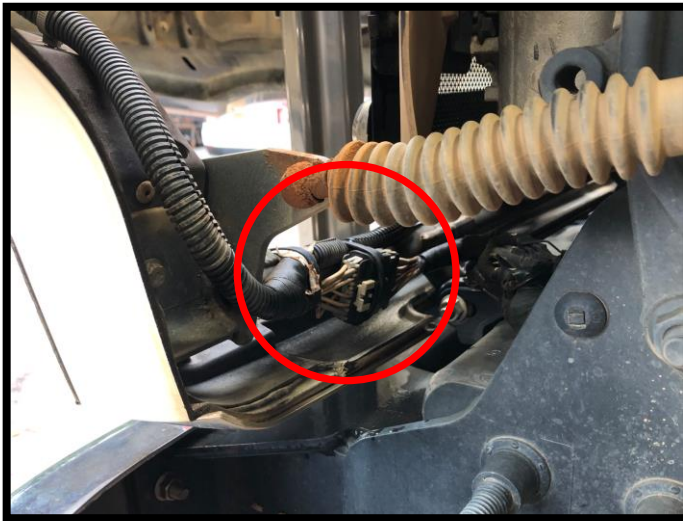
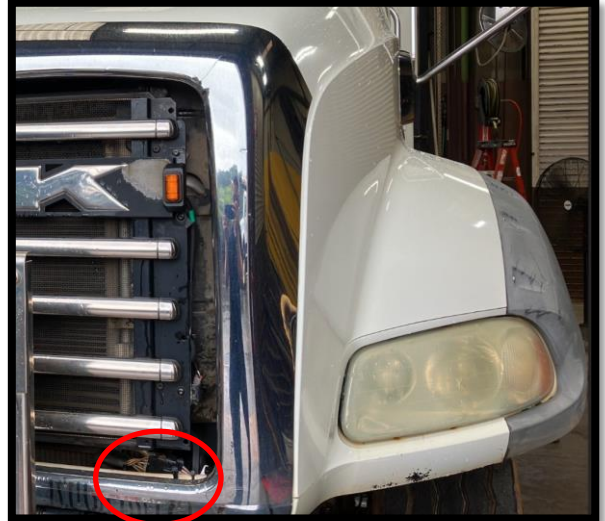
10. Disconnect connection between the front harness and the headlamp harness located along the bottom of the grille on the driver side.

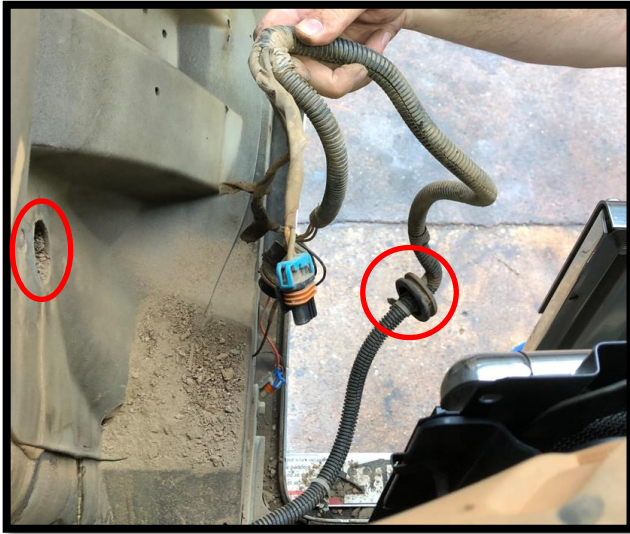
11. Remove both driver side and passenger side sections of the headlamp harness by removing the grommet and feeding the connections through the open hole.

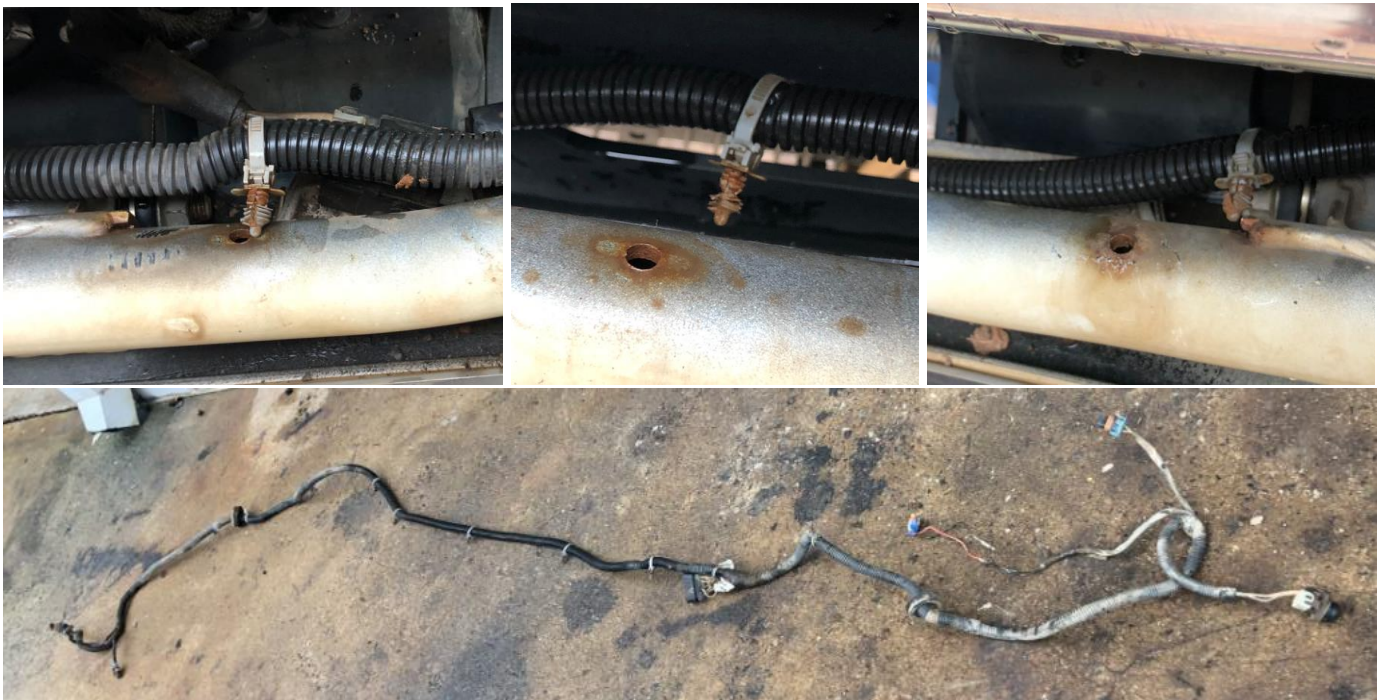
12. Pull all plastic tabs out holding the harness in place along the bottom of the grille and remove the harness.

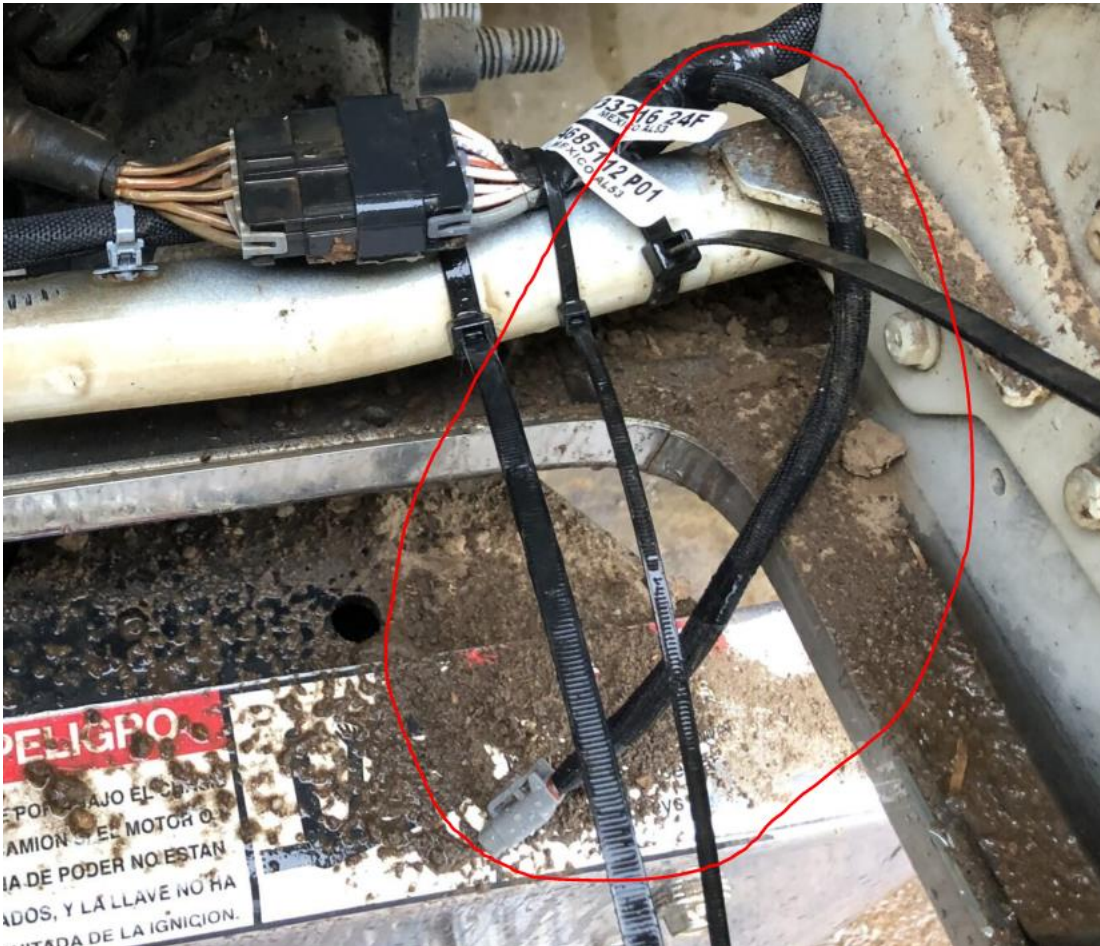
13. Once the harness is removed, install the new supplied harness and grommets. The new harness will connect and route in the exact locations as the original harness but will have an extra connection (see image) on either side for the new turn signal indicator.

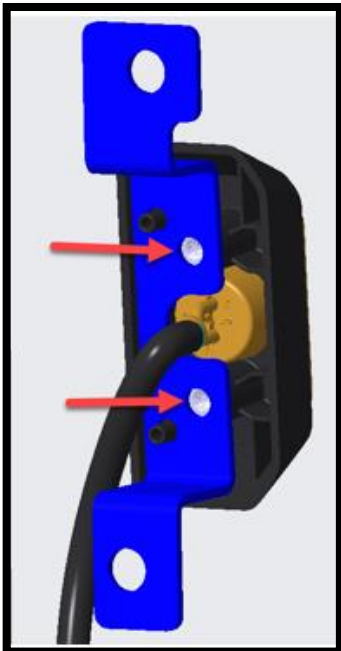
14. Pre-assemble the two supplemental turn signal indicators with their brackets.

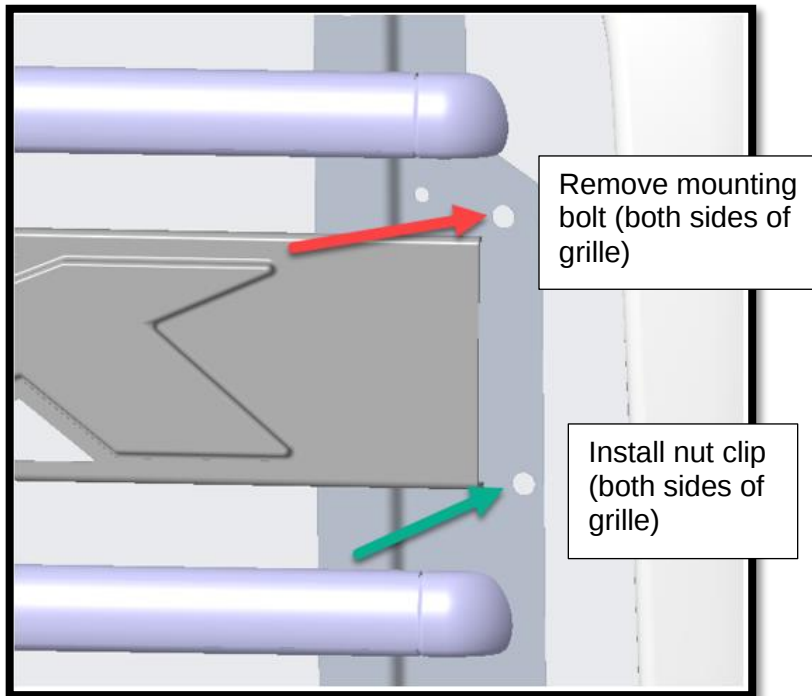
15. Remove the top mounting bolt in the grille on both the left- and right-hand side. Add a nut clip on the hole below on both left- and right-hand side.

16. Mount turn signal indicator using supplied bolts. Torque to  $3.5 \pm 0.5$  Nm.

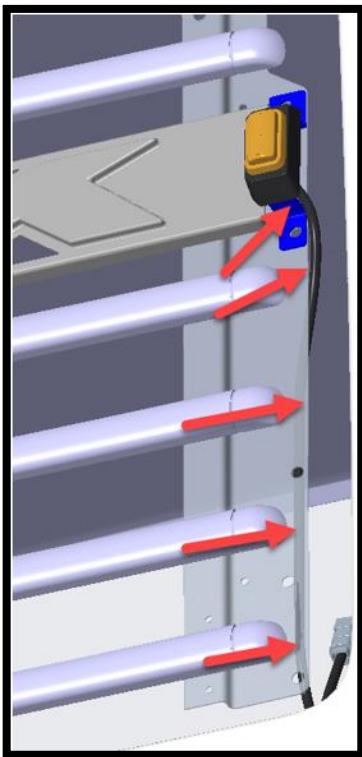
17. Add 5 edge clipping ties included with the install kit on both sides of the grille to route the harness of the turn signal.

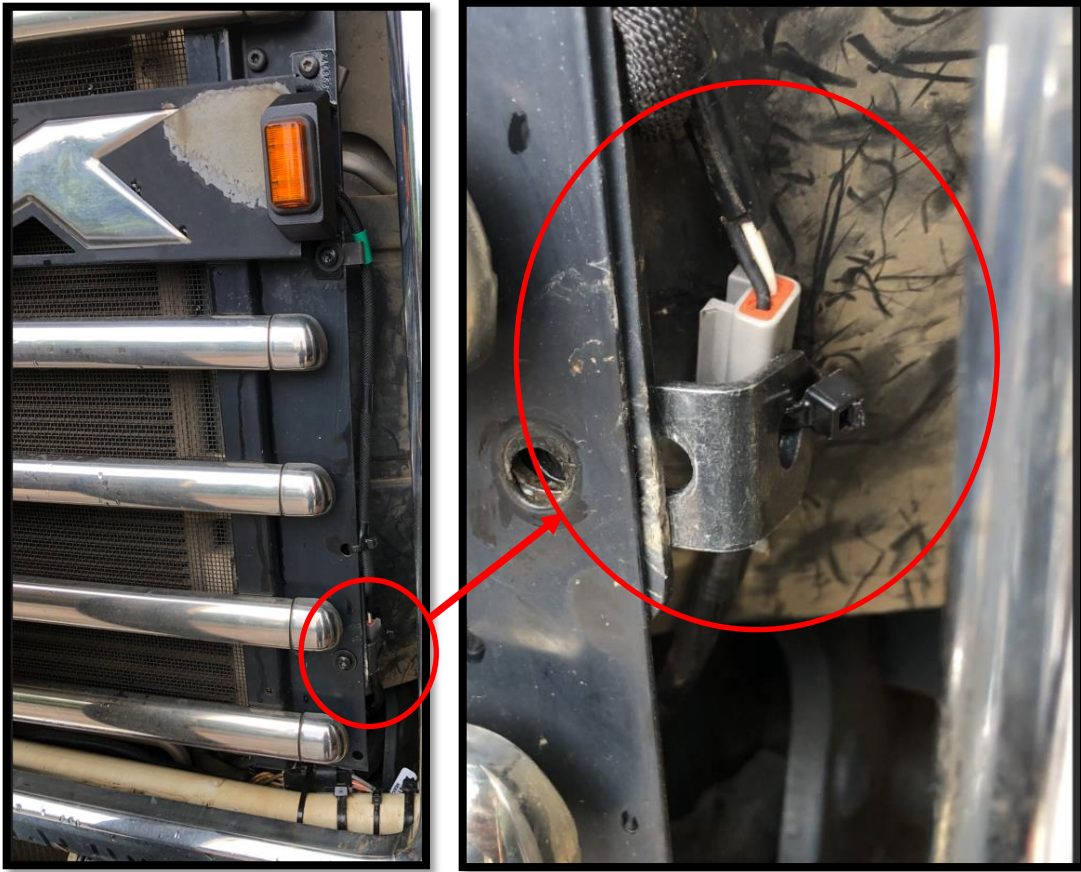
18. Connect turn signal indicator harness to the new connector on the headlamp harness on both the left-hand and right-hand side and zip tie out of the way using supplied bracket.

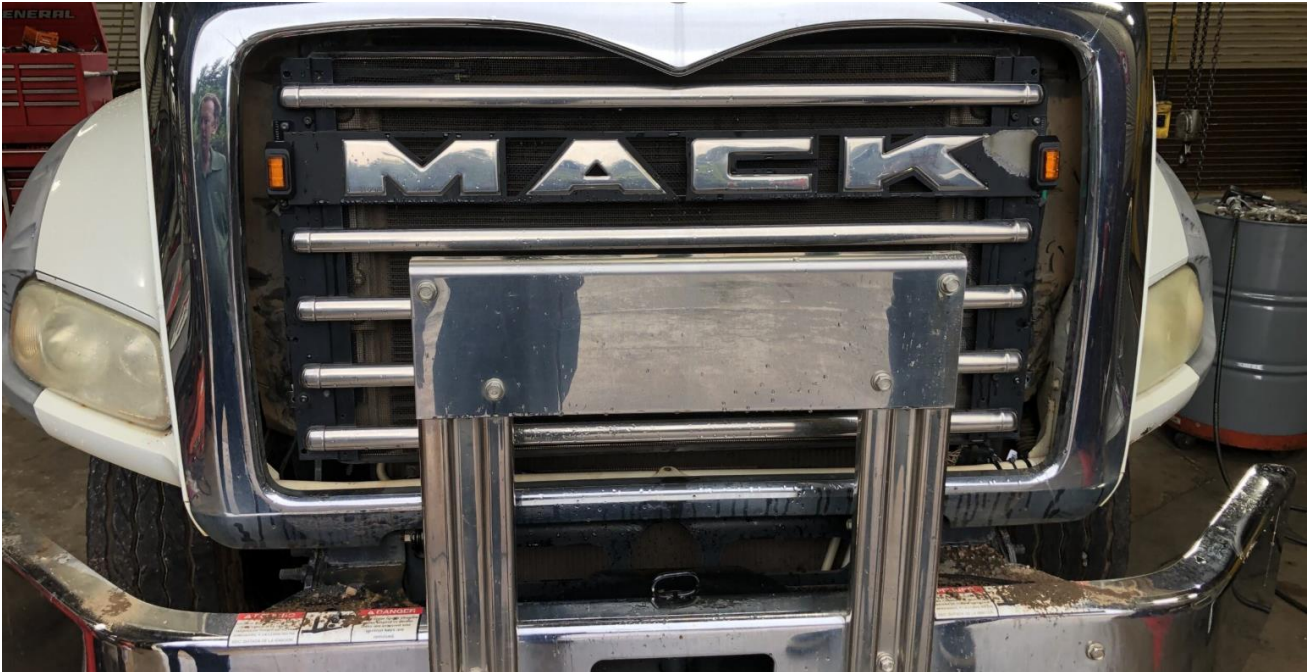
23. Check for proper function of all lights and turn signals. New indicators should operate in sync with headlamp turn signals. Install is complete.
