Compliance Recall

Code: 47T9

Subject	Brake Fluid Reservoir Cap																																								
Document History	<table border="1"> <thead> <tr> <th style="background-color: #c00000; color: white;">Date</th> <th style="background-color: #c00000; color: white;">Summary</th> </tr> </thead> <tbody> <tr> <td>09/14/2023</td> <td>Original publication</td> </tr> </tbody> </table>	Date	Summary	09/14/2023	Original publication																																				
Date	Summary																																								
09/14/2023	Original publication																																								
Affected Vehicles	<table border="1"> <thead> <tr> <th style="background-color: #c00000; color: white;">Country</th> <th style="background-color: #c00000; color: white;">Beginning Model Year</th> <th style="background-color: #c00000; color: white;">Ending Model Year</th> <th style="background-color: #c00000; color: white;">Vehicle</th> <th style="background-color: #c00000; color: white;">Vehicle Count</th> </tr> </thead> <tbody> <tr> <td>USA</td> <td>2021</td> <td>2021</td> <td>A6 ALLROAD</td> <td>267</td> </tr> <tr> <td>USA</td> <td>2019</td> <td>2021</td> <td>A6 SEDAN</td> <td>4,681</td> </tr> <tr> <t

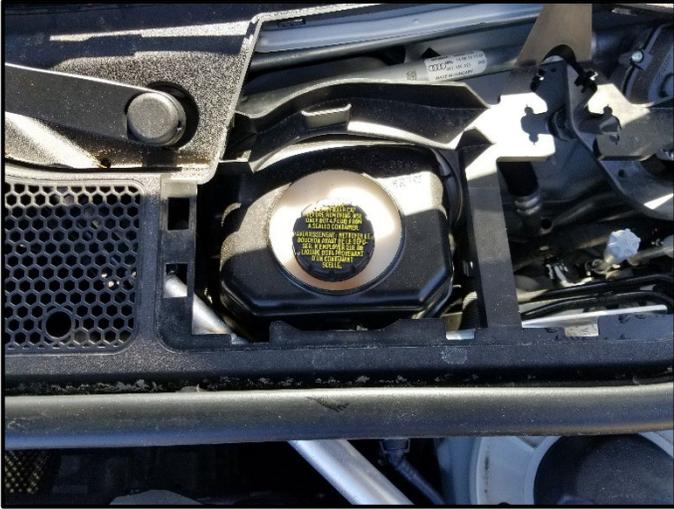
Repair Overview

- Inspect brake fluid reservoir cap and replace if necessary.

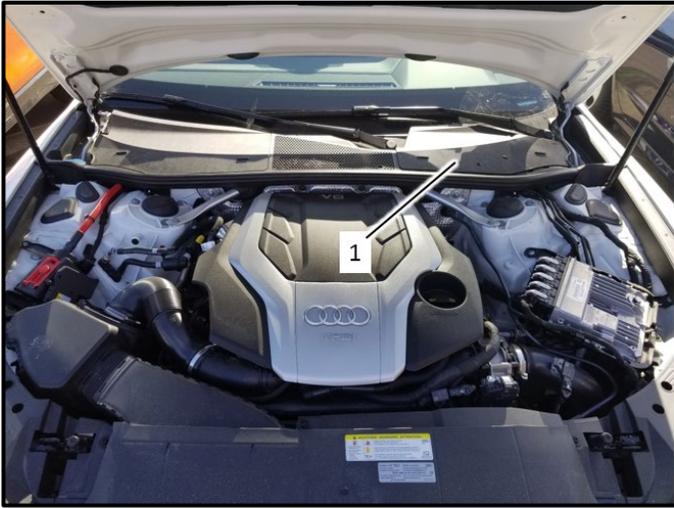
Section B – Brake Fluid Reservoir Cap Inspection

Remove left plenum cover:

- Carefully remove left plenum cover <1> toward the rear of the vehicle.

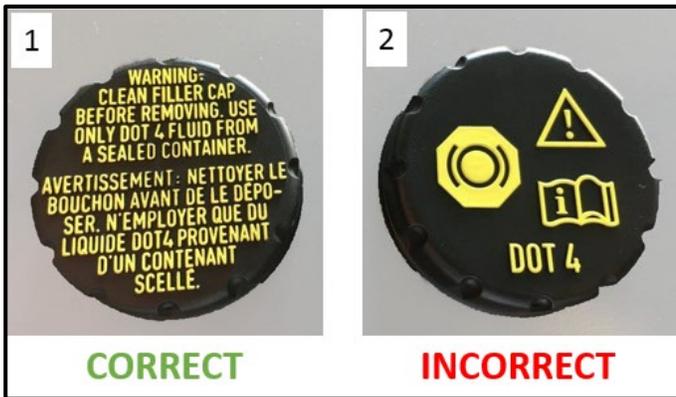
Inspect brake fluid reservoir cap:

- If the North American version <1> is present:
 - No replacement is necessary.
 - Install left plenum cover in opposite direction of removal.
 - **Proceed to Section D.**
- If the European version <2> is present:
 - Replacement is necessary.
 - **Proceed to Section C.**

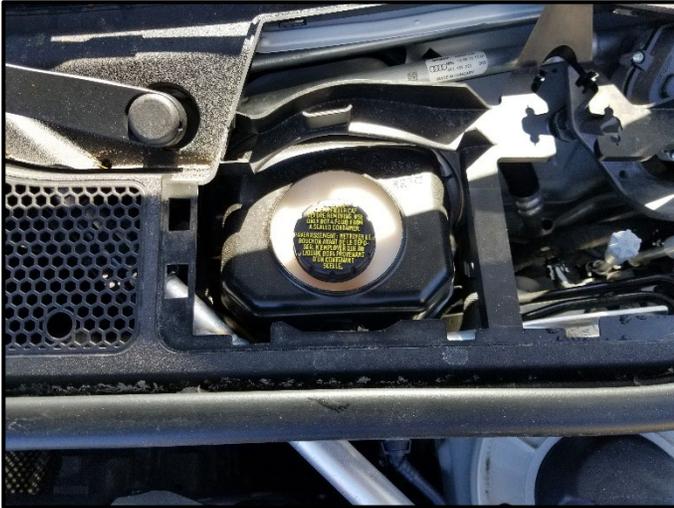
Section C – Brake Fluid Reservoir Cap Replacement

Replace brake fluid reservoir cap:

- To protect against escaping brake fluid, place a cloth around the reservoir cap.
- Clean cap before removing.
- Unscrew cap.
- Install new cap.

- Install left plenum cover in opposite direction of removal.
