# Safety Recall

## Code: 93T7

<b>Subject</b>	<b>High Voltage Battery</b>				
<b>Document History</b>	<b>Date</b>		<b>Summary</b>		
	04/09/2024		Updated claiming information		
	03/21/2024		Updated claiming information		
	12/19/2023		Updated claiming and work instructions		
	10/31/2023		Original publication		
<b>Affected Vehicles</b>	<b>Country</b>	<b>Beginning Model Year</b>	<b>Ending Model Year</b>	<b>Vehicle</b>	<b>Vehicle Count</b>
	USA	2023	2023	E-TRON GT	1,438
	USA	2023	2023	RS E-TRON GT	461
	CAN	2023	2023	E-TRON GT	192
	CAN	2023	2023	RS E-TRON GT	42
	<p><i>Check Campaigns/Actions screen in Elsa on the day of repair to verify that a VIN qualifies for repair under this action. Elsa is the <u>only</u> valid campaign inquiry &amp; verification source.</i></p> <ul style="list-style-type: none"> <li>✓ Campaign status must show "open."</li> <li>✓ If Elsa shows other open action(s), inform your customer so that the work can also be completed at the same time the vehicle is in the workshop for this campaign.</li> </ul>

**Subject: Safety Recall 93T7 - High Voltage Battery**

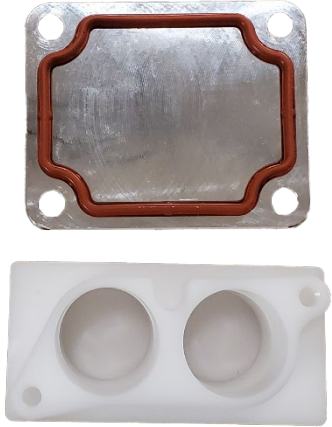
<p>Test Adapter Set -4J3-998-099-</p>
<p>One Test Adapter Set was allocated to specific Audi dealers. DO NOT contact Special Tools and Equipment if additional quantities are needed. If an adapter set is needed, orders can be placed through Parts on Command.</p>

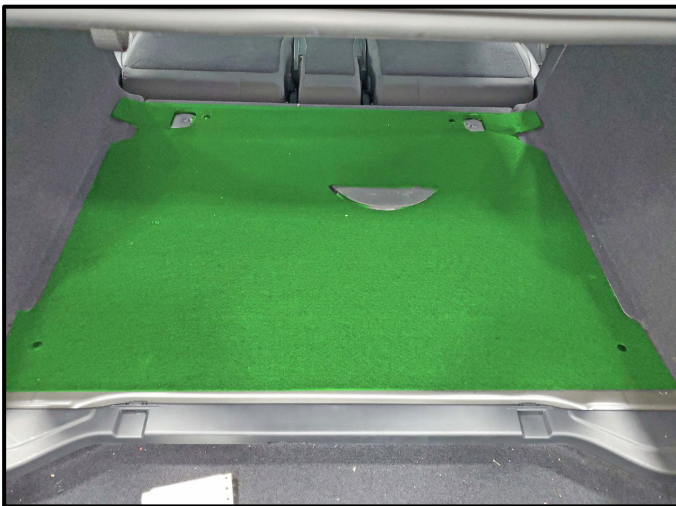
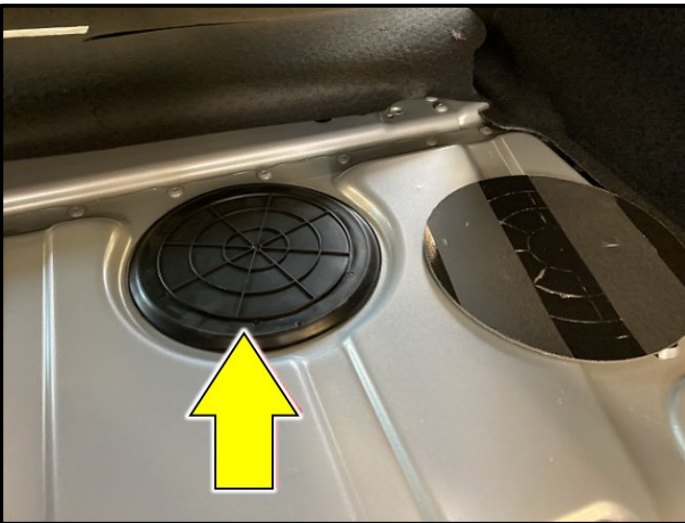
#### Remove cover:

- Remove cover <arrow> using a trim removal tool.

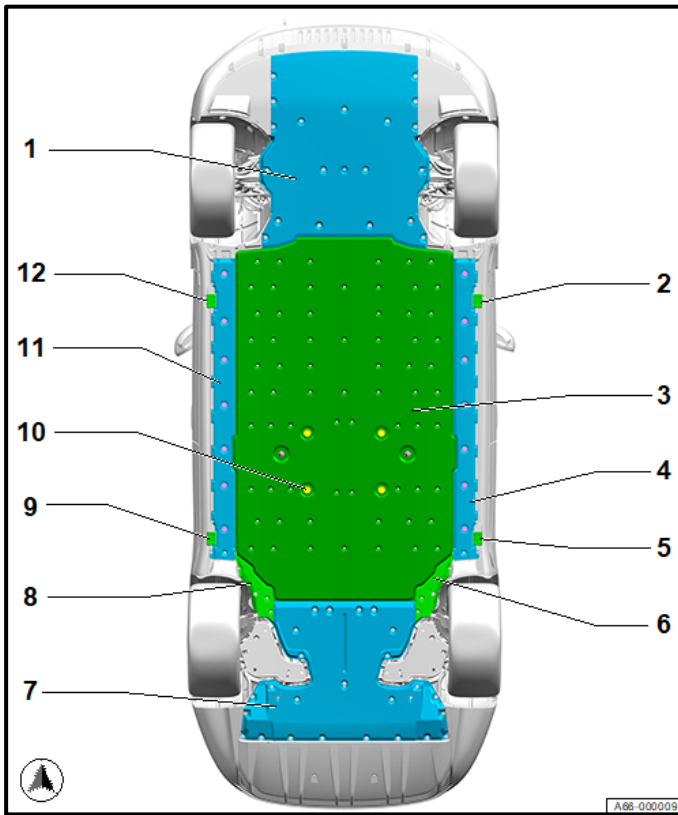
**Remove front underbody cover:**

- Remove front underbody cover <1> according to the ELSA Repair Manual: *Repair manual > Body > 66 Exterior Equipment > Underbody Trim Panel Overview - Underbody Trim Panels*

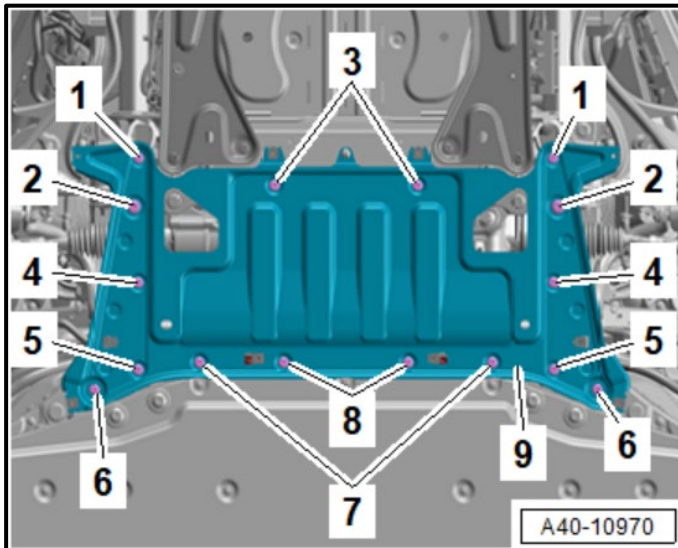
**Remove reinforcement:**

- Remove reinforcement <9> according to the ELSA Repair Manual: *Repair manual > Chassis > 40 Front Suspension > Subframe > Rear Reinforcement, Removing and Installing*

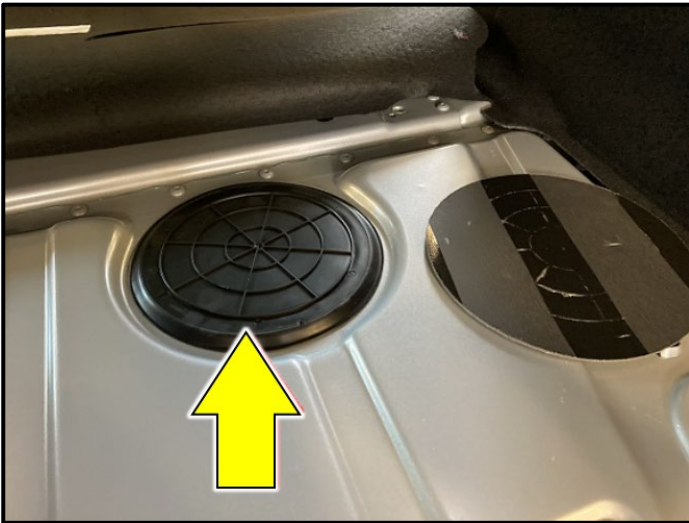
- Reinstall cover <arrow>.
