# Safety Recall

## Code: 93T7

<b>Subject</b>	<b>High Voltage Battery</b>																													
<b>Document History</b>	<table border="1"> <thead> <tr> <th>Date</th> <th colspan="4">Summary</th> </tr> </thead> <tbody> <tr> <td>03/21/2024</td> <td colspan="4">Updated claiming information</td> </tr> <tr> <td>12/19/2023</td> <td colspan="4">Updated claiming and work instructions</td> </tr> <tr> <td>10/31/2023</td> <td colspan="4">Original publication</td> </tr> </tbody> </table>					Date	Summary				03/21/2024	Updated claiming information				12/19/2023	Updated claiming and work instructions				10/31/2023	Original publication								
Date	Summary																													
03/21/2024	Updated claiming information																													
12/19/2023	Updated claiming and work instructions																													
10/31/2023	Original publication																													
<b>Affected Vehicles</b>	<table border="1"> <thead> <tr> <th>Country</th> <th>Beginning Model Year</th> <th>Ending Model Year</th> <th>Vehicle</th> <th>Vehicle Count</th> </tr> </thead> <tbody> <tr> <td>USA</td> <td>2023</td> <td>2023</td> <td>E-TRON GT</td> <td>1,438</td> </tr> <tr> <td>USA</td> <td>20

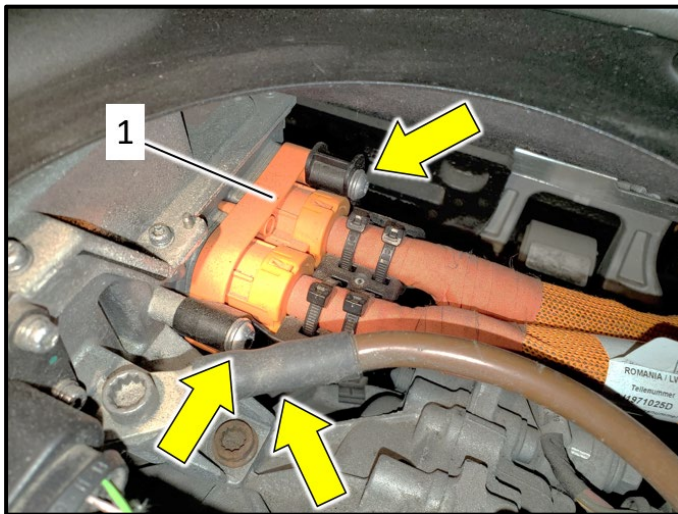
#### Loosen high voltage connection:

- Loosen the three screws <arrows> and disconnect the high voltage connection <1>.

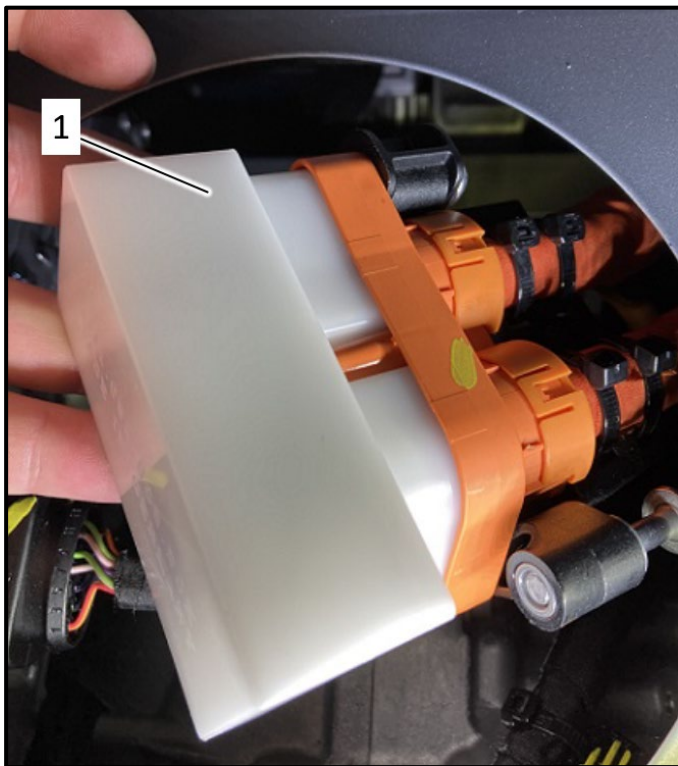
#### Attach adapter block to cable:

- Attach the adapter block <1> from Test Adapter Set -4J3-998-099-.
- Tighten the two screws on the cable connection hand tight.
- **DO NOT OVERTIGHTEN SCREWS!**
- Move the cable with adapter block to the side. Do not kink the cable.

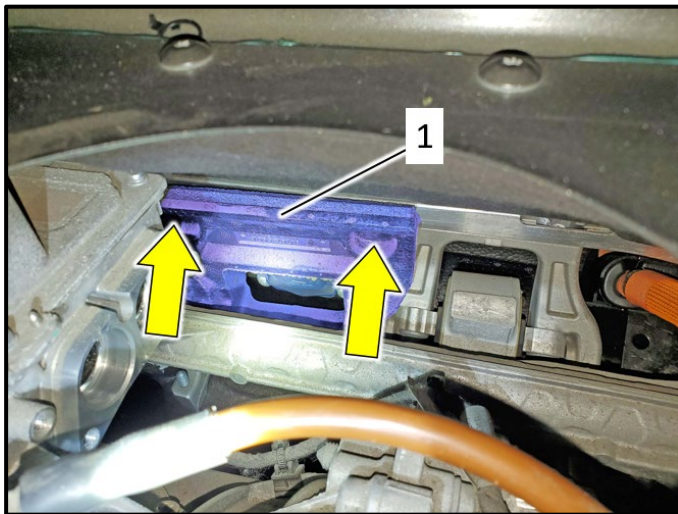
#### Remove foam insert:

- Carefully unclip the foam insert at the securing pins <arrows> and remove the insert upward.

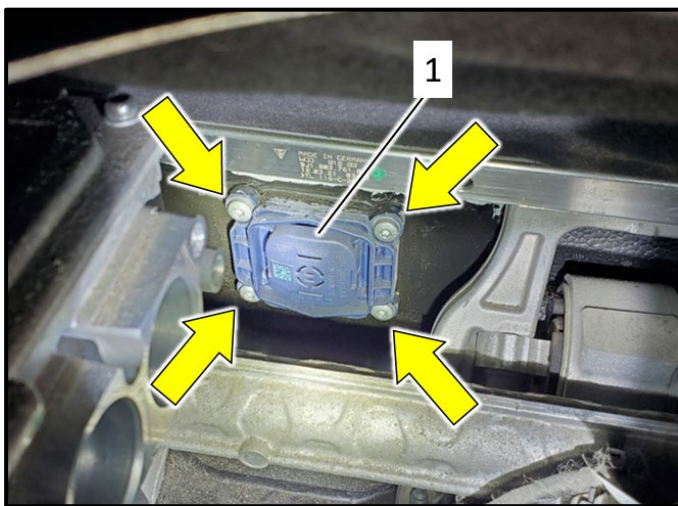
#### Remove pressure valve:

- Remove bolts <arrows> and remove pressure valve <1>.

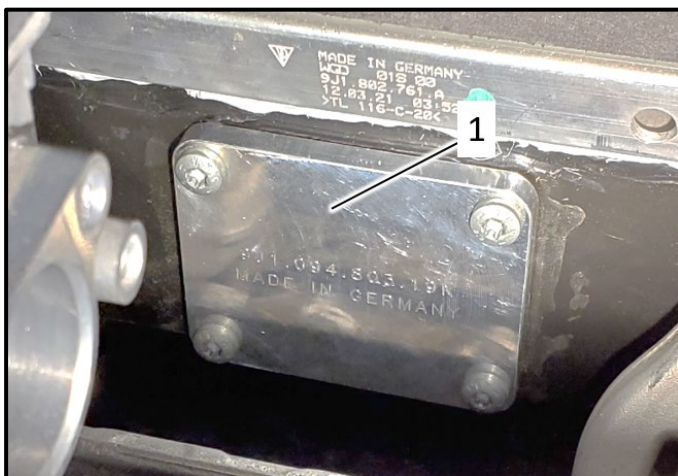
#### Install adapter plate:

- Ensure the sealing surface on the battery is clean.
- Install adapter plate <1> from Test Adapter Set -4J3-998-099- using the original bolts and torque bolts to 8 Nm.

To aid in lining up the plate and installing the bolts, a M6x1.0mm stud or modified bolt can be screwed into one of the bolt holes on the high voltage battery.

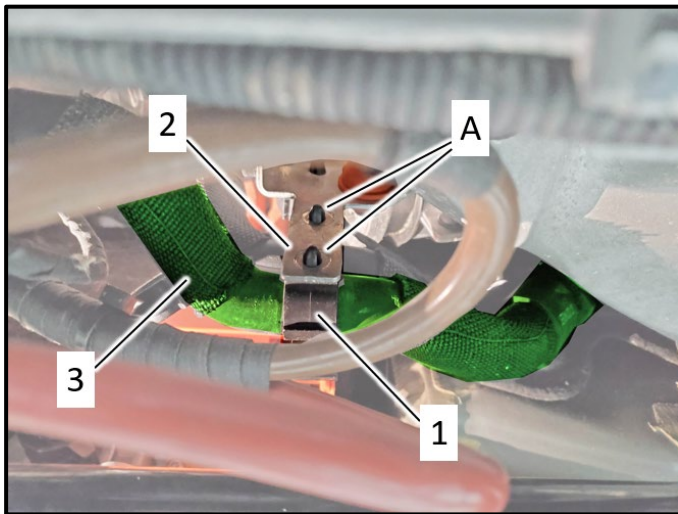
#### Free up coolant hoses:

- Release locking pins <A> with a pick tool, for example.
- Remove coolant hose holder <1> from bracket <2>.
- Remove the hose holder <1> from coolant hoses <3>.

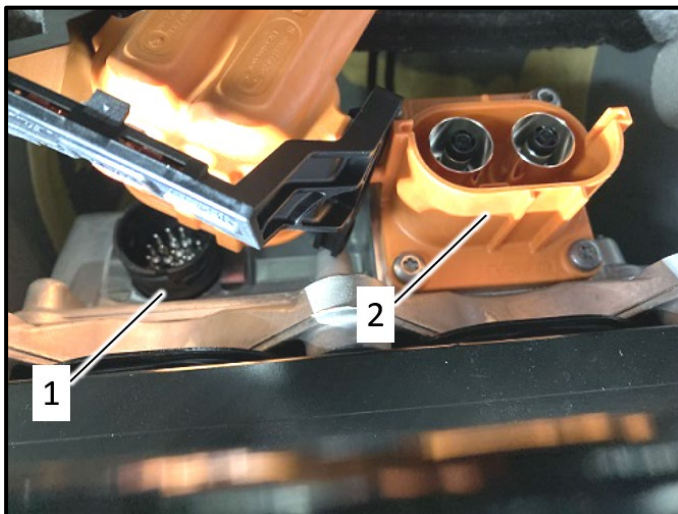
#### Disconnect high voltage battery connectors:

- Disconnect the HV Battery Switch Box -SX6- connections <1> and <2>.

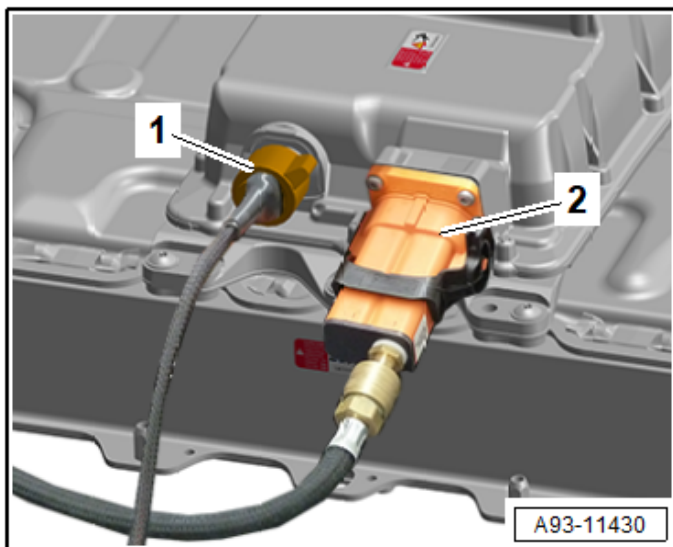
Install pressure test adapters:

- Install Leak Tester -VAS6911/3B- <2> to HV Battery Switch Box -SX6-.
- Install Adapter Cable -VAS5581A/12- <1> to HV Battery Switch Box -SX6-.

Diagnosis Lead -VAS5581A/12- will be used to connect the high voltage battery to the High Voltage Diagnostics Box -VAS5581-. This is required to initiate the Guided Functions test plan for the high voltage battery leak test.

The -VAS5581A/12- is not sealed. Therefore, it will have to be replaced with -VAS5581/6- in a later step. Otherwise, the high voltage battery cannot be properly pressurized.

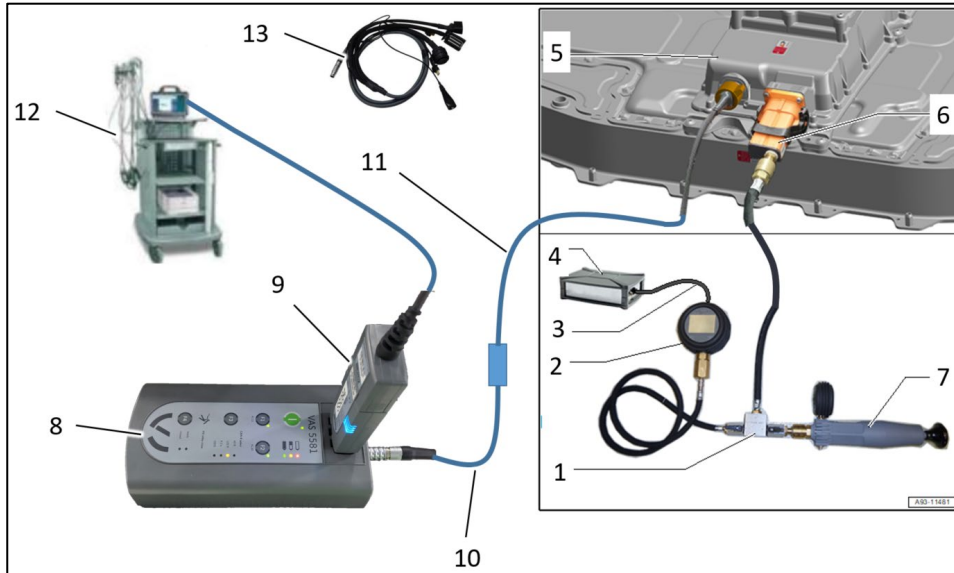
### Prepare for the high voltage battery leak test:

- Arrange the tools as shown below to perform the high voltage battery leak test.
- The CAN bus terminating resistor on the High Voltage Diagnostics Box -VAS5581A- <8> is preset to 120 Ω and must not be changed.
- Connect the black ground clamps of the Diagnosis Lead -VAS5581A/12- <11> and Adapter Cable -VAS5581/1A-2- <10> to the ground on the battery housing.

- 1) -VAS691005/1-
- 2) -VAS611013-
- 3) -VAS5051/66-
- 4) -VAS6356-
- 5) HV Battery Switch Box -SX6-
- 6) -VAS6911/3B-
- 7) -VAG1274B-
- 8) -VAS5581- or -VAS5581A-
- 9) Diagnostic Interface
- 10) -VAS5581/1A-2-
- 11) -VAS5581A/12-
- 12) -VAS6150F/TSP-
- 13) -VAS5581/6-

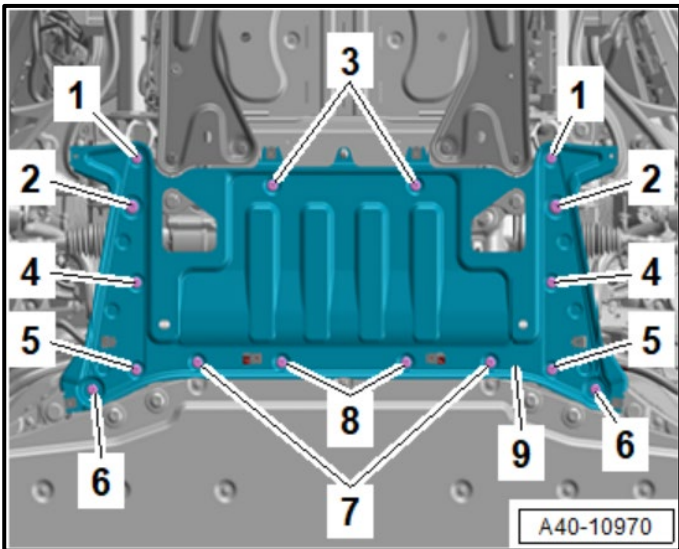
- Reinstall reinforcement and torque fasteners as follows:

Step	Sequence	Specification
1	<1> through <8>	Install all the way by hand
2	<1>	30 Nm
3	<2>	55 Nm
4	<3> to <8>	30 Nm

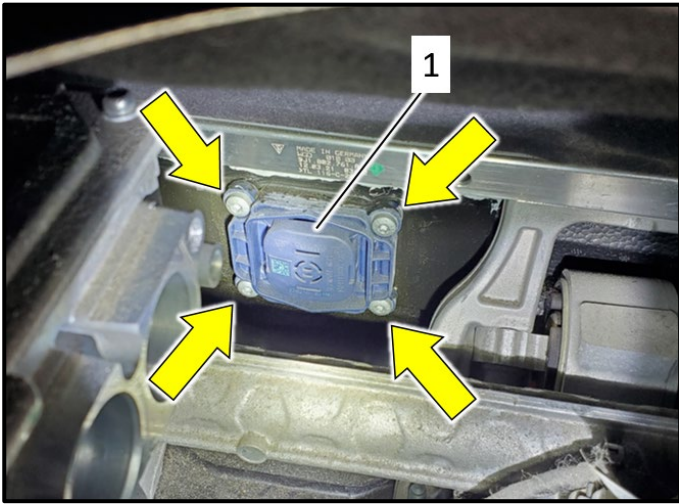
- Remove adapter plate.
- Install new pressure valve <1> with new bolts <arrows>.
- Torque new bolts <arrows> to 8 Nm.

Part Number	Part Description
9J1-915-754	Pressure Valve
N -107-002-01	Bolt (x4)

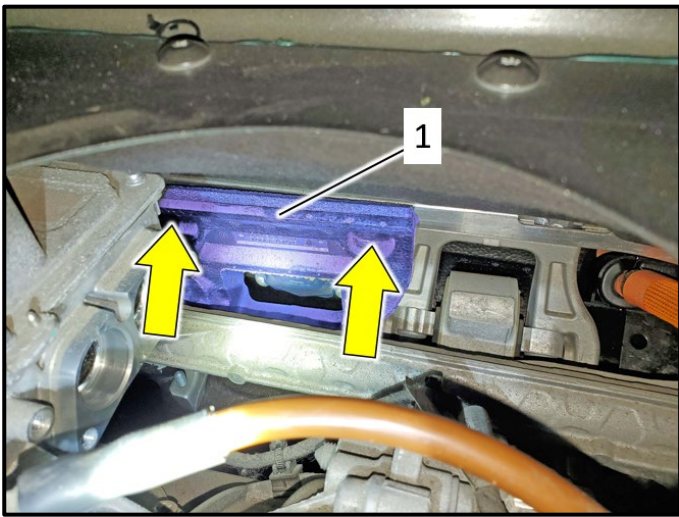
- Reinstall foam insert <1> and ensure securing pins <arrows> are fully engaged.

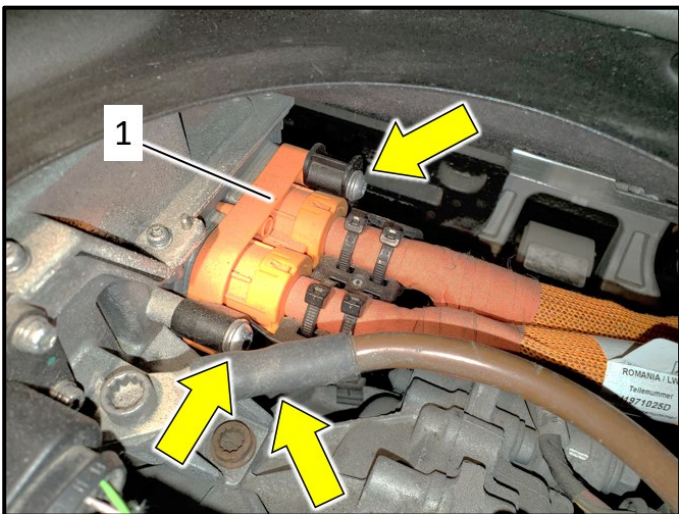
- Remove adapter block from high voltage cable.
- Connect high voltage cable <1> and torque screws <arrows> to 8 Nm.

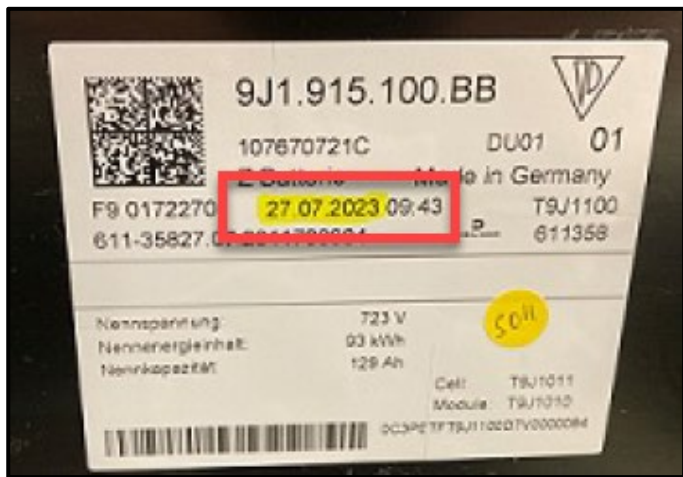
The production date on the label is in the DD/MM/YYYY format.

- High voltage batteries with an earlier production date must be pressure tested **once** before installation.
- If the pressure test of the new high voltage battery fails, contact TAC.
