# 2021 or Older Ram Promaster Chassis Travato G/GL Awning Rework:

**Read the entire instructions carefully before starting the procedure. If you have any questions, please contact Winnebago Industries Technical Service Department by calling 1-866-653-4329 or by email: [techservice@wgo.net](mailto:techservice@wgo.net). This document is confidential and is intended for dealer use only.**

2021 and older chassis are identified by having an 'M' or preceding letter as the 10th digit of the VIN, or by having a manual parking brake lever.

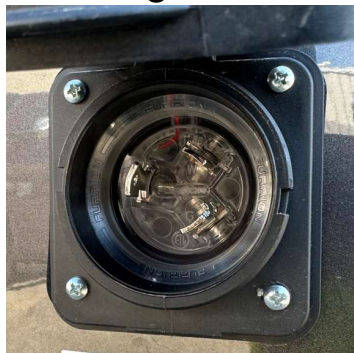
Image 1

1. Disconnect the shore power cord from the coach – See Image 1.
2. Turn off the house disconnect switch – See Image 2.
3. Disconnect the 12v chassis battery ground. Refer to the Promaster user manual to disconnect the ground cable from the battery.
4. NOTE: If the chassis battery ground is not disconnected before performing the rework, chassis faults may occur that will require a Promaster service center. This cost is not covered under this recall.

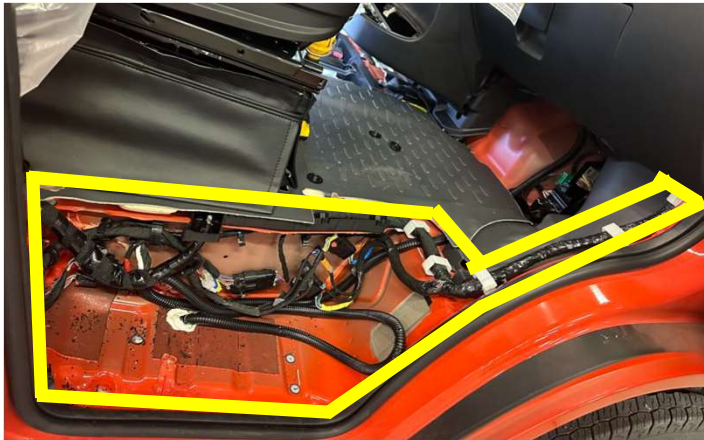
Image 1

1. Locate and remove the passenger side stepwell covers using a screw gun with Philips bit, see Image 1.
2. Using the Unibit, drill a 1.25" hole going through the chassis as shown, see Image 2 red arrow. The hole should be at most 1" away from the vertical walls. Prime the bare metal around the cut hole to prevent rust.
3. Put a split into a 1.25" grommet, install it on the harness, and then into the floor from above.

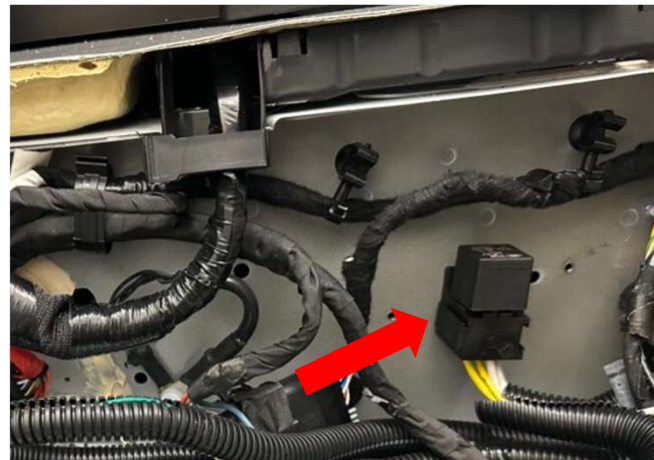
Image 1

1. If your coach is Gen 1 (Winnebago model years 2016-2019), follow the instructions below. Otherwise continue to next page (5).
2. Mount the relay of the new harness using self-tapping screws on the vertical wall of the stepwell closest to the seat, See Image 1.
3. Follow Step 2A – Installing Harness Driver Side
4. Any excess wiring on the new harness can be pulled through the 1.25" hole.
5. Reinstall the Passenger side stepwell covers.
6. Follow Step 2C – Harness Install Under Coach
7. Follow Step 2H – Route to Roof (awning connection circuits FFT and NM)
8. Continue to Step 3.

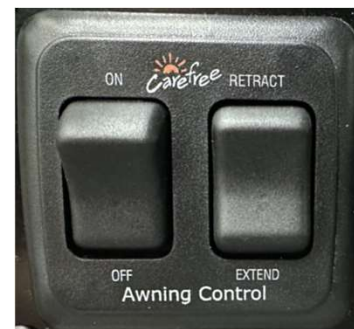
Image 2

6. Follow Step 2B – Harness Install Passenger B Pillar.
7. Follow Step 2C – Harness Install Under Coach.
8. Follow Step 2D – Switch Connection W/ Carefree Switch IF the awning switch looks like Image 2.

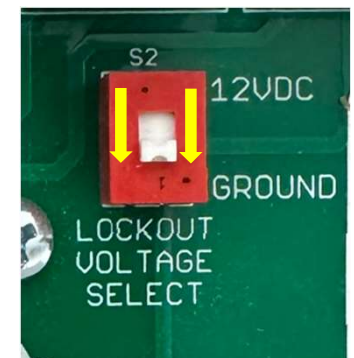
Image 4

3. Connect the 12-pin plug on the new harness to the Awning Control Module.
4. IMPORTANT: The switch on the Awning Control Module controls needs to be set to GROUND– See Image 4.

- o Setting the switch to GROUND will auto retract the awning when the engine is started.
  - o 12VDC would disable the auto retract function.
5. Follow Step 2A – Installing Harness Driver Side.

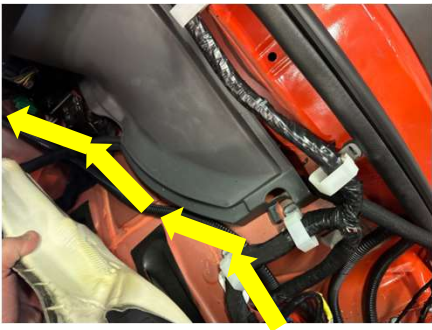
1. Route the three manual park brake DY circuits from the new harness up under the passenger side wheel well plastic trim and flooring, and behind the passenger kick cover. See Image 1 and 2, yellow arrows.

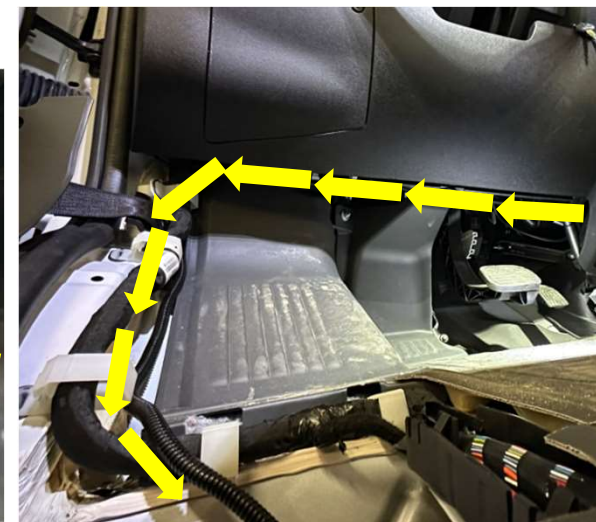
Image 4

5. Locate and remove the driver side stepwell covers using a screw gun with Philips bit.
6. Route the harness below the steering column, following the existing harnesses. Then route the harness beneath the driver side stepwell covers. See Image 4, yellow arrows for wire path.

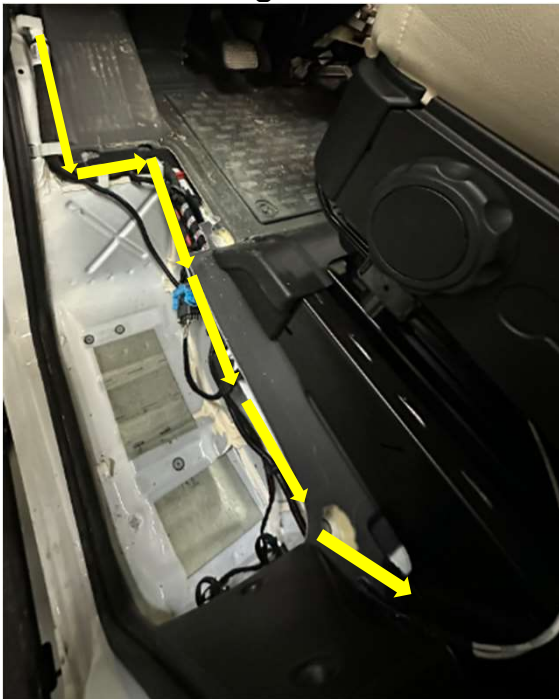
Image 1

1. Route the harness below the steering column, following the existing harnesses. Then route the harness beneath the driver side stepwell covers. See Image 1, yellow arrows for wire path.

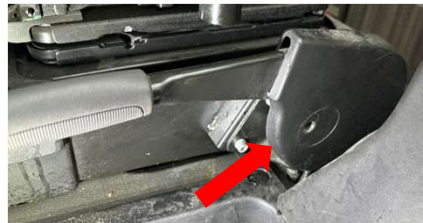
2. Remove the parking brake plastic shroud, it is held on with one screw. See Image 2 red arrow.
3. Remove the parking brake switch from the parking brake bracket, See Image 3 and 4. It is secured with one screw.

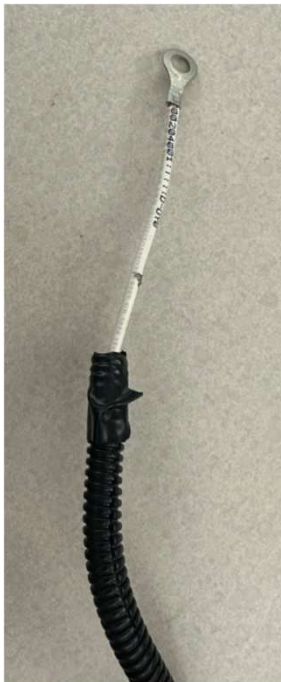
Image 1

1. Some coaches will already have a Winnebago harness going to the chassis park brake, if this is the case follow the steps below.
2. Locate DY on the existing harness that passes through the driver side stepwell.
3. Cut the existing harness to separate the diodes and park brake connections from the rest of the harness.
4. Terminate the DY that runs up into the dash with the supplied ring terminal, See Image 1.
5. Connect the ring terminal to the chassis ground stud and torque to 8NM(5.9 Ft Lbs.), See Image 2.
6. Connect the butt splice DY on the new harness to the chassis park brake harness in place of the existing harness's DY. See Image 3, Red arrow.
7. Return to the previous page and ensure step 2A is complete before moving forward.

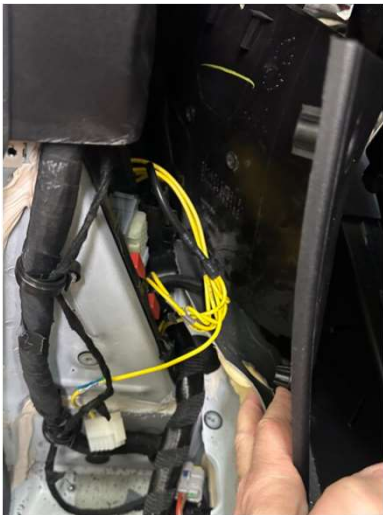
Image 1

1. Unscrew the forward 2 screws on the passenger side B pillar cover and partially pull away for access. See Image 1.
2. Route the 15 pin plugs on the new harness from the Passenger stepwell into the B pillar.
3. Replace the male 15 pin housing already connected to the bodybuilder plug with the new harness' 15-pin male connector. See Image 2.
4. Connect the original harness' Male connector the new harness' 15-pin female connector. See Image 3.
5. Tuck the harness below the floor as it travels from the stepwell to the B pillar. See Image 4 yellow line for path.
6. **Note:** Your coach may not have the adjoining ZZJ circuit to match the new harness. Additionally, the color of the wires in mating circuits at these connectors may not match. This is expected and will not affect the functionality of the coach.

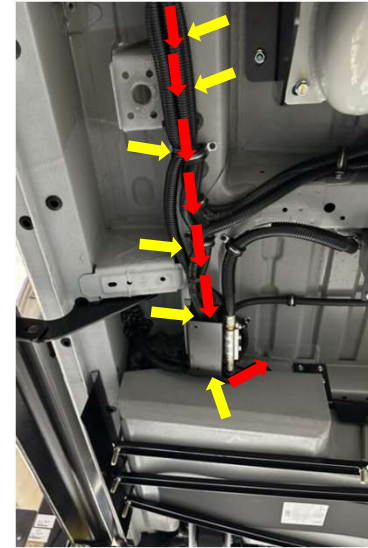
Image 5

4. Route the new harness from the passenger stepwell back through the LP manifold mounting bracket. See Image 5, red arrows.
5. Route the new harness through the grey tank mounting brackets, over the rearward battery, and into the new bed cabinet 1.25" hole. See Image 4 and 6, red arrows. Cut a split into a 1.25" grommet, install it on the harness, and then into the floor from above.

6. Secure the new harness up to the existing Winnebago harnesses or chassis mounting holes using zip ties and to the chassis rib using P clamps. See Images 4, 5 and 6, yellow arrows. The new harness should not be allowed to sag below the existing harnesses. The 1.25" holes in the chassis can be filled with Manus to prevent water intrusion.

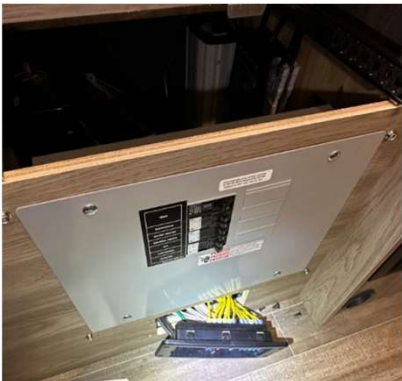
Image 1

1. Follow these instructions for Gen 1 2017-2019 coaches, otherwise continue to next page.
2. Gain access to the area behind the fuse panel in the bed cabinet. This can be done by removing the drawer above the fuse panel and unmounting the fuse panel itself. See Image 1.

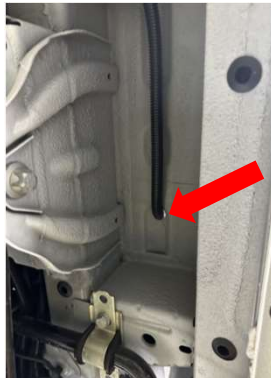
3. Below the coach, drill a 1.25" hole up through the chassis into the bed cabinet, See Image 3 red arrow for a typical location. The best location for this hole may vary by build, locate an open area behind the breaker and fuse panels in the bed cabinet to drill through. When identifying a location drill a pilot hole from inside the cabinet down and then cut the 1.25" hole up to confirm there is no obstacles or damage to existing parts. Prime the bare metal around the cut hole to prevent rust.

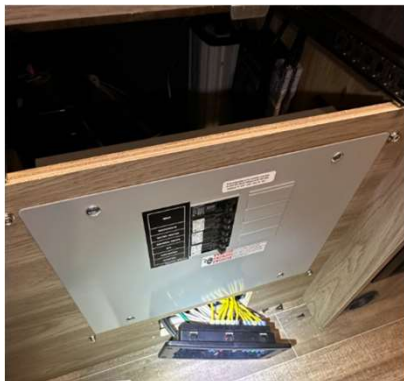
Image 1

3. Gain access to the area behind the fuse panel in the bed cabinet. This can be done by removing the drawer above the fuse panel and unmounting the fuse panel itself. See Image 1.

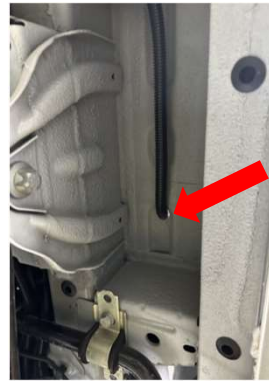
5. Below the coach, drill a 1.25" hole up through the chassis into the bed cabinet, See Image 3 red arrow for a typical location. The best location for this hole may vary by build, locate an open area behind the breaker and fuse panels in the bed cabinet to drill through. When identifying a location drill a pilot hole from inside the cabinet down and then cut the 1.25" hole up to confirm there is no obstacles or damage to existing parts Prime the bare metal around the cut hole to prevent rust.

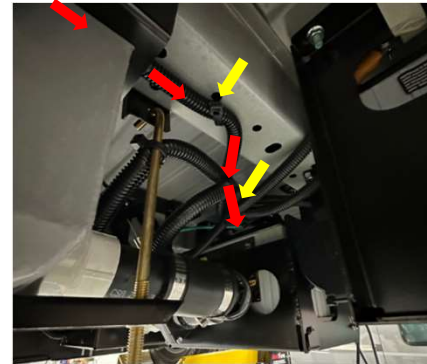
7. Route the new harness branch with NM through the grey tank mounting brackets, over the rearward battery, and into the new bed cabinet 1.25" hole. See Image 4 and 6, red arrows. Cut a split into a 1.25" grommet, install it on the harness, and then into the floor from above.

8. Secure the new harness up to the existing Winnebago harnesses or chassis mounting holes using zip ties and to the chassis rib using P clamps. See Images 4, 5 and 6, yellow arrows. The new harness should not be allowed to sag below the existing harnesses. The 1.25" holes in the chassis can be filled with Manus to prevent water intrusion.

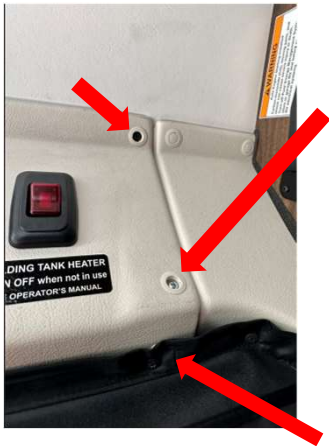
1. Partially unmount the plastic closeout panel above the sliding door. The closeout panel is secured to the roof, sidewall rib, and screen door. Only remove screws as needed to pull away panel, and gain access to the necessary connections. See Image 1 for screw locations, keep track of which type of screw goes into which hat retainer.
2. Take the awning connection circuits of the new harness and route it behind the cabinet, up through the plastic trim at the rear of the sliding door, and up to the BT-12. There is a recessed path that allows the wire to pass through without interfering with the abs panel fitment, See Image 2 and 4 yellow arrows for wire path. Use trim tools as needed to pry the panels away and fish tape to bring the circuits up, See Image 3. The sliding door seal can be removed for easier access.

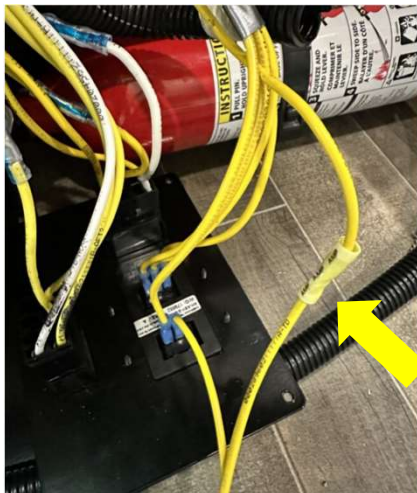
- c) Splice the new harness to one of the hot TD circuits. See Image 1 yellow arrow. The other unused TD circuit connections, if any, can be taped up.

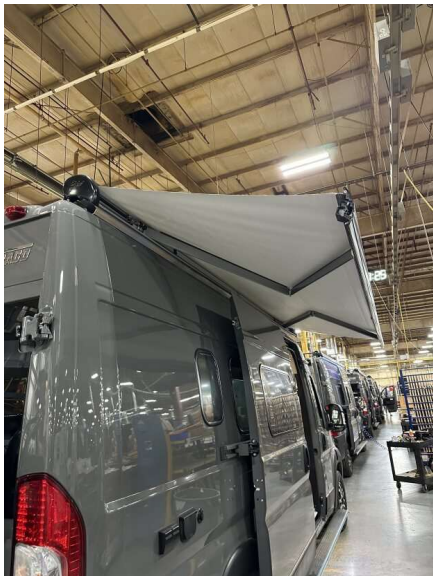
1. This page is for Gen 1 coaches only, move onto next page for Gen 2.
2. See the chart in Image 1 and confirm that all 'With' situations result in the correct actions when the extend and retract commands are operated.
  - o **Note:** awning will need to be partially extended to confirm retraction, See Image 2.
3. If all the above actions result in their defined outcomes the rework is complete.

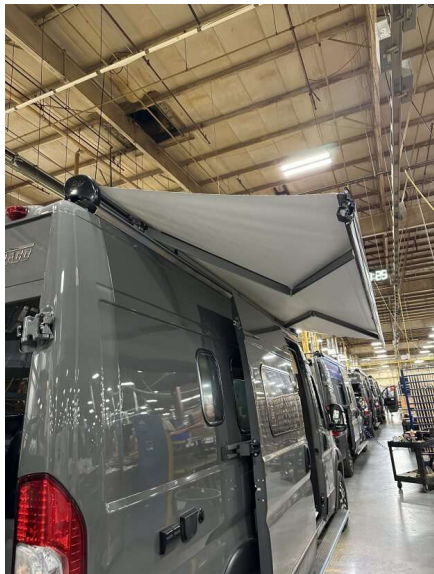
Image 2

- o **Note:** awning will need to be partially extended to confirm auto-retraction, See Image 2.
  - o **Note:** the relay module will hold the park brake signal from when the park brake is engaged until the engine is started or the module loses power. This is due to the chassis going to sleep and needing to hold the park brake signal.

3. With the engine off and the parking brake and 12v coach power on, bring the awning to a partially extended position, See Image 2. Locate the edge of the awning with the wind sensor and shake the awning to simulate high winds. The awning should automatically retract when the sensor reads the awning movement.

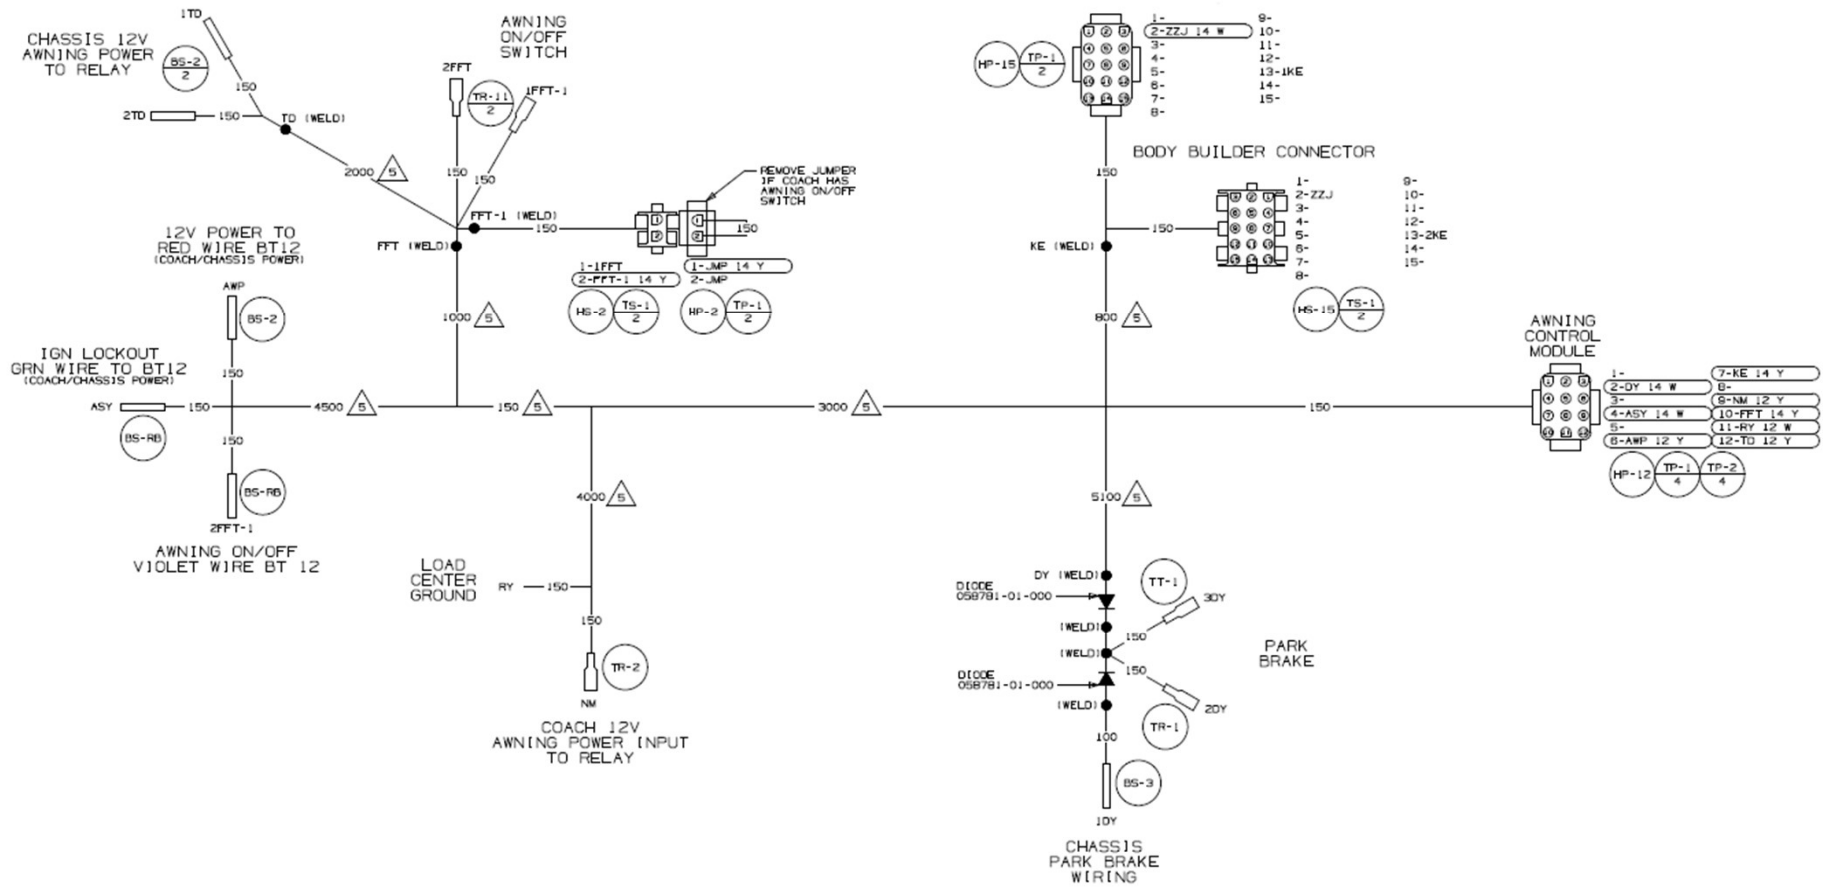
## WIRE ASM-AWNING UPDATE – Gen 2

# Wiring Diagram – Harness Gen 2
