NHTSA Safety Recall 23V-627

SUBJECT: Campaign # 176 – Travato Awning Deployment

Winnebago Motorhomes has decided that a defect related to motor vehicle safety exists on certain 2017 – 2024 Travato Motorhomes. These motor homes were manufactured, September 06, 2016 through August 31, 2023.

The retractable awnings are extending unintentionally while the motorhome is in motion. An awning that extends unintentionally while the motorhome is in motion could present a road hazard, which can increase the risk of a crash.

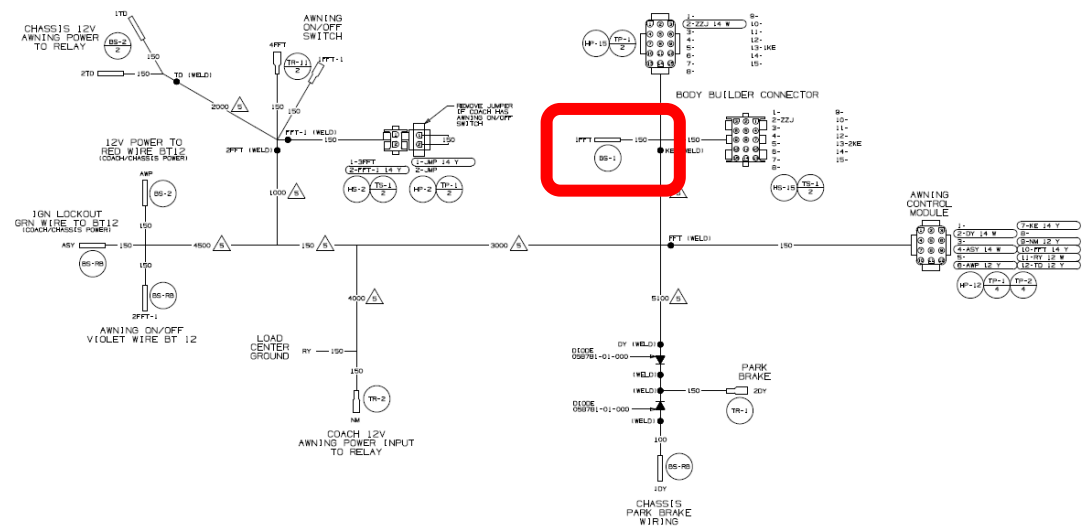
Image 3
Gen 2 Harness

- Locate the Chime Relay on the existing harness. This should be located in the passenger side B pillar and will have the connections shown in Image 1.
 - There are two JIX circuits going into this relay.
- Locate the JIX going to pin 85. Cut the wire leaving some of it on the relay side to splice to.
- Connect the butt spliced FFT from the new harness to the wire going into pin 85 of the relay.
 - FFT replaces JIX on the shade relay to allow the park brake to disable the shade chime, with the engine running.
 - Note: there are 2 butt spliced FFT connections on the new harness. Ensure the one you connect to is near the relay, not the one in a branch with NM.
- Tape up the cut JIX from the existing harness, it will not be used.

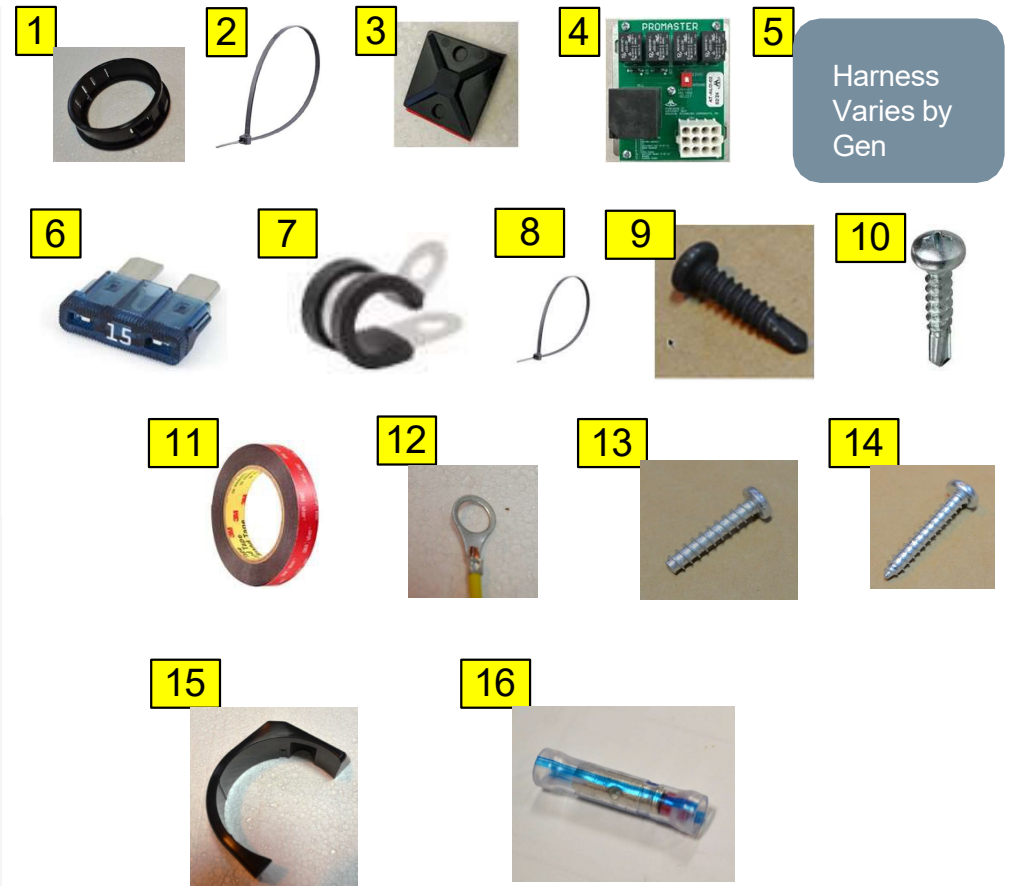
RC7919-24-776 Gen 2 G/GL

1. 1.25" Grommet – 114208-07-000 (3)
2. Large zip ties - 008343-04-000(25)
3. Adhesive zip tie mounts - 357004-01-000 (2)
4. Awning Control Module (Gen 2) - 358901-01-000 (1)
5. Wire Asm - Awning (Gen 1)–358895-01-000, (Gen 2) - 358883-01-000 (1)
6. 15A Fuse – 062901-05-000 (1)
7. P clamp - 083610-01-000 (3).
8. Small zip ties - 008343-03-000(10)
9. Black Self-tapping screw – 000G39-10-12T (3)
10. Silver Self-tapping screw – 000G39-08-12B (4)
11. Double Sided Tape – 076322-22-000 (4")
12. Ring Terminal - 326278-01-000 (1)
13. Screws M4 X 20 – 339810-01-703 (2)
14. Screws #8 x 1", T20 – 339810-01-704 (5)
15. Carefree LH Motor Wedge – 339810-01-709 (1)
16. Butt Splice (Gen 2) – 326335-01-000 (1)

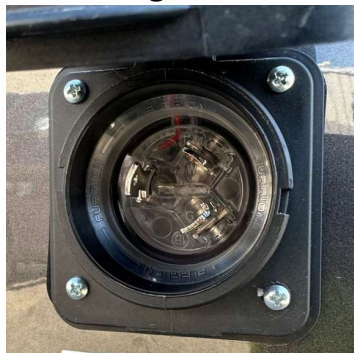
Image 1

1. Disconnect the shore power cord from the coach – See Image 1.
2. Turn off the house disconnect switch – See Image 2.
3. Disconnect the 12v chassis battery ground. Refer to the Promaster user manual to disconnect the ground cable from the battery.
4. NOTE: If the chassis battery ground is not disconnected before performing the rework, chassis faults may occur that will require a Promaster service center. This cost is not covered under this recall.

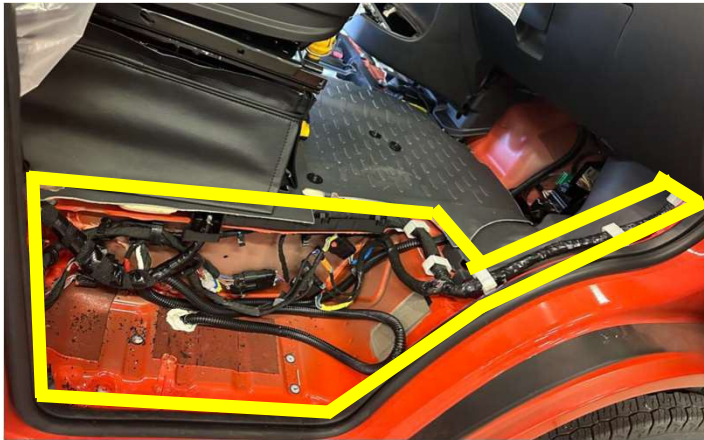
Image 1

1. Locate and remove the passenger side stepwell covers using a screw gun with Philips bit, see Image 1.
2. Using the Unibit, drill a 1.25" hole going through the chassis as shown, see Image 2 red arrow. The hole should be at most 1" away from the vertical walls. Prime the bare metal around the cut hole to prevent rust.
3. Put a split into a 1.25" grommet, install it on the harness, and then into the floor from above.

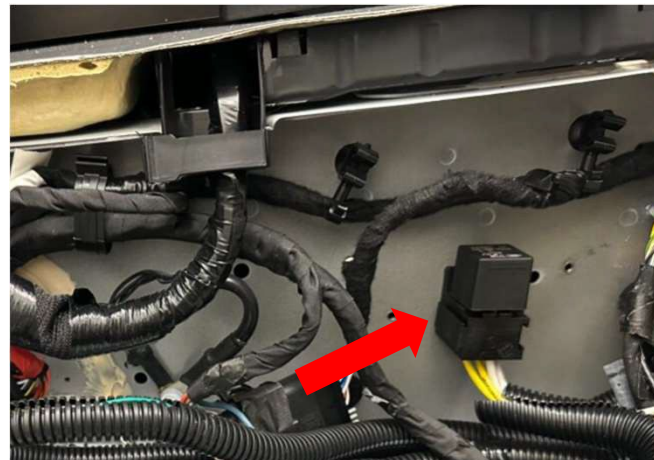
Image 1

1. If your coach is Gen 1 (Winnebago model years 2016-2019), follow the instructions below. Otherwise continue to next page (5).
2. Mount the relay of the new harness using self-tapping screws on the vertical wall of the stepwell closest to the seat, See Image 1.
3. Follow Step 2A – Installing Harness Driver Side
4. Any excess wiring on the new harness can be pulled through the 1.25" hole.
5. Reinstall the Passenger side stepwell covers.
6. Follow Step 2C – Harness Install Under Coach
7. Follow Step 2H – Route to Roof (awning connection circuits FFT and NM)
8. Continue to Step 3.

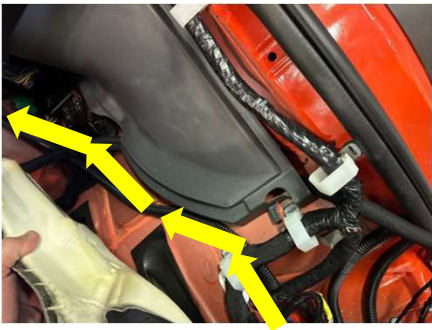
1. Route the three manual park brake DY circuits from the new harness up under the passenger side wheel well plastic trim and flooring, and behind the passenger kick cover. See Image 1 and 2, yellow arrows.

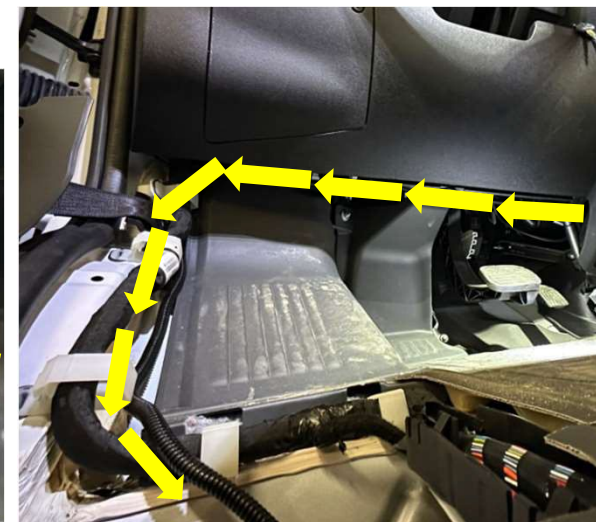
Image 4

5. Locate and remove the driver side stepwell covers using a screw gun with Philips bit.
6. Route the harness below the steering column, following the existing harnesses. Then route the harness beneath the driver side stepwell covers. See Image 4, yellow arrows for wire path.

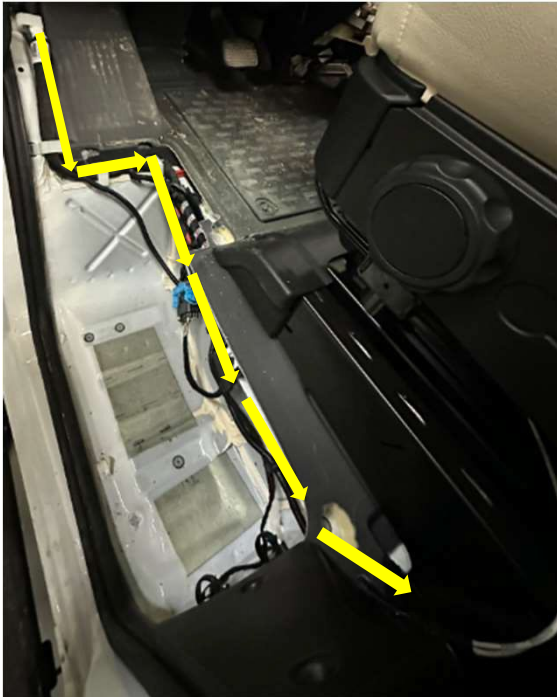
Image 1

1. Route the harness below the steering column, following the existing harnesses. Then route the harness beneath the driver side stepwell covers. See Image 1, yellow arrows for wire path.

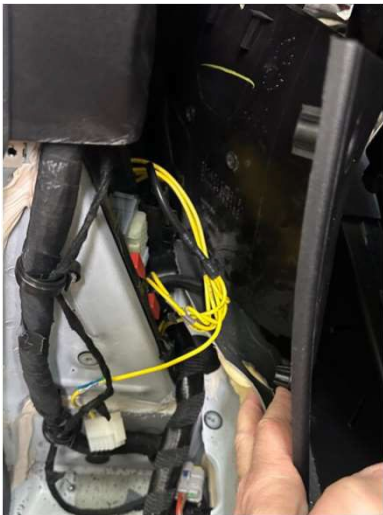
Image 1

1. Unscrew the forward 2 screws on the passenger side B pillar cover and partially pull away for access. See Image 1.
2. Route the 15 pin plugs on the new harness from the Passenger stepwell into the B pillar. See Image 2.
3. Replace the male 15 pin housing already connected to the bodybuilder plug with the new harness' 15-pin male connector. See Image 3.
4. Connect the original harness' Male connector the new harness' 15-pin female connector. See Image 3.
5. Tuck the harness below the floor as it travels from the stepwell to the B pillar. See Image 4 yellow line for path.
6. **Note:** Your coach may not have the adjoining ZZJ circuit to match the new harness. Additionally, the color of the wires in mating circuits at these connectors may not match. This is expected and will not affect the functionality of the coach.

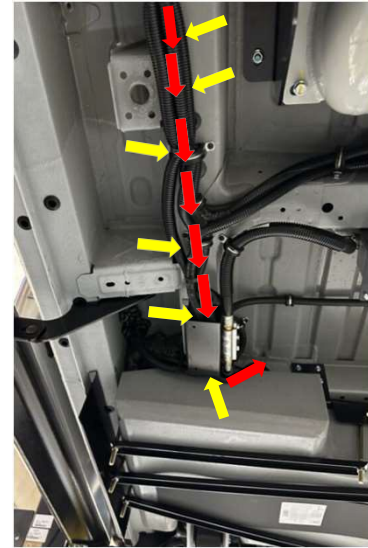
Image 5

6. Secure the new harness up to the existing Winnebago harnesses or chassis mounting holes using zip ties and to the chassis rib using P clamps. See Images 4, 5 and 6, yellow arrows. The new harness should not be allowed to sag below the existing harnesses. The 1.25" holes in the chassis can be filled with Manus to prevent water intrusion.

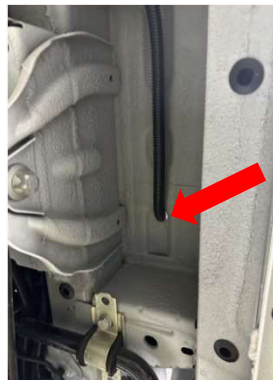
3. Below the coach, drill a 1.25" hole up through the chassis into the bed cabinet, See Image 3 red arrow for a typical location. The best location for this hole may vary by build, locate an open area behind the breaker and fuse panels in the bed cabinet to drill through. When identifying a location drill a pilot hole from inside the cabinet down and then cut the 1.25" hole up to confirm there is no obstacles or damage to existing parts. Prime the bare metal around the cut hole to prevent rust.

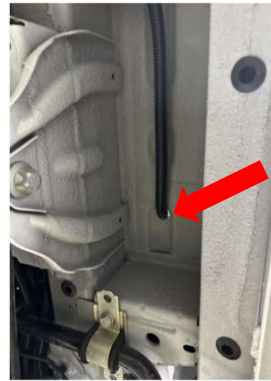
5. Below the coach, drill a 1.25" hole up through the chassis into the bed cabinet, See Image 3 red arrow for a typical location. The best location for this hole may vary by build, locate an open area behind the breaker and fuse panels in the bed cabinet to drill through. When identifying a location drill a pilot hole from inside the cabinet down and then cut the 1.25" hole up to confirm there is no obstacles or damage to existing parts Prime the bare metal around the cut hole to prevent rust.

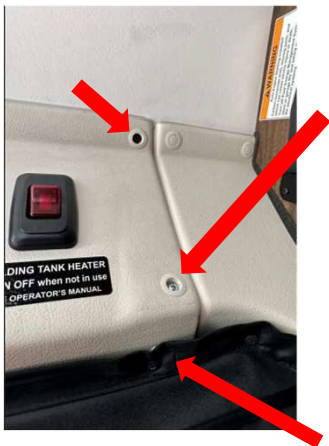
1. Partially unmount the plastic closeout panel above the sliding door. The closeout panel is secured to the roof, sidewall rib, and screen door. Only remove screws as needed to pull away panel, and gain access to the necessary connections. See Image 1 for screw locations, keep track of which type of screw goes into which hat retainer.
2. Take the awning connection circuits of the new harness and route it behind the cabinet, up through the plastic trim at the rear of the sliding door, and up to the BT-12. There is a recessed path that allows the wire to pass through without interfering with the abs panel fitment, See Image 2 and 4 yellow arrows for wire path. Use trim tools as needed to pry the panels away and fish tape to bring the circuits up, See Image 3. The sliding door seal can be removed for easier access.

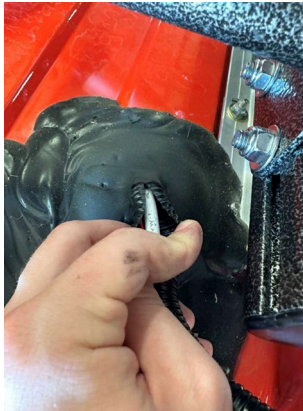
Image 1

1. Go to the coach roof and locate the wiring on the awnings left hand side.
2. Remove electrical tape wrap without damaging wires to gain access to the interior of the convolute tubing, See Image 1.
3. Insert nozzle of cartridge gun into convolute tubing as far into the coach as you can, seal the inside tubing back to 2 inches up from the roof, See Image 2. Ensure sealant oozes out to confirm the convolute is fully filled. Wipe off excess, prep, and retape convolute starting from the roof and wrapping up to the awning creating a shingled effect. See Image 3
4. Using Manus, reseal on top of the existing self-leveling around the base of the convolute and tool to ensure no gaps are present, See Image 4.

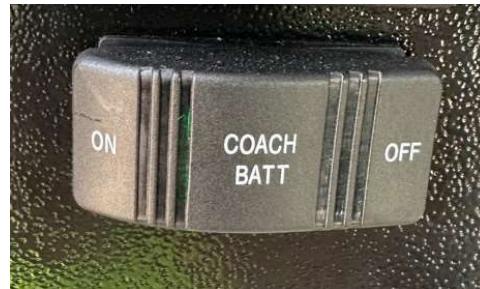
Image 1

1. Turn on the 12v house disconnect switch – See Image 1.
2. Reconnect the 12v chassis battery ground. Refer to the Promaster user manual to disconnect the ground cable from the battery.

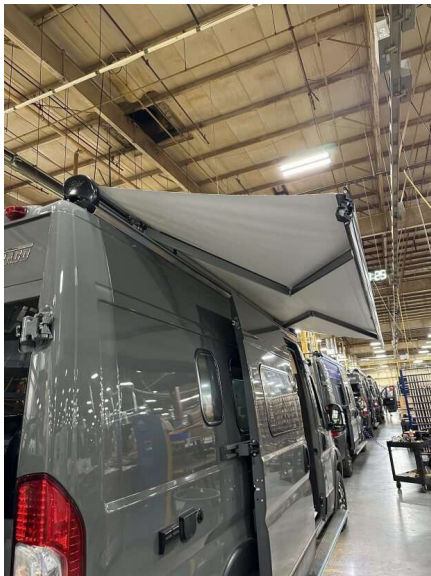
1. This page is for Gen 1 coaches only, move onto next page for Gen 2.
2. See the chart in Image 1 and confirm that all 'With' situations result in the correct actions when the extend and retract commands are operated.
 - o **Note:** awning will need to be partially extended to confirm retraction, See Image 2.
3. If all the above actions result in their defined outcomes the rework is complete.

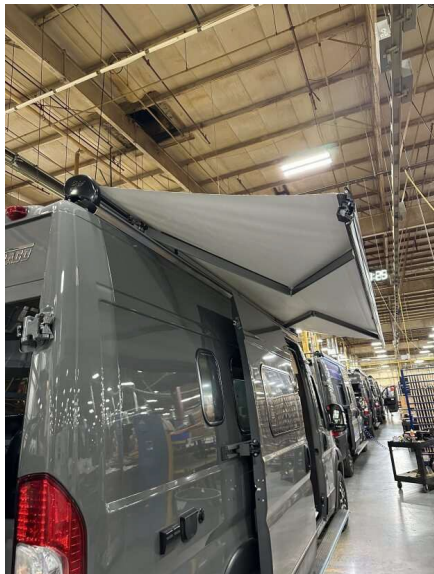
Image 2

4. If all the above actions result in their defined outcomes the rework is complete.

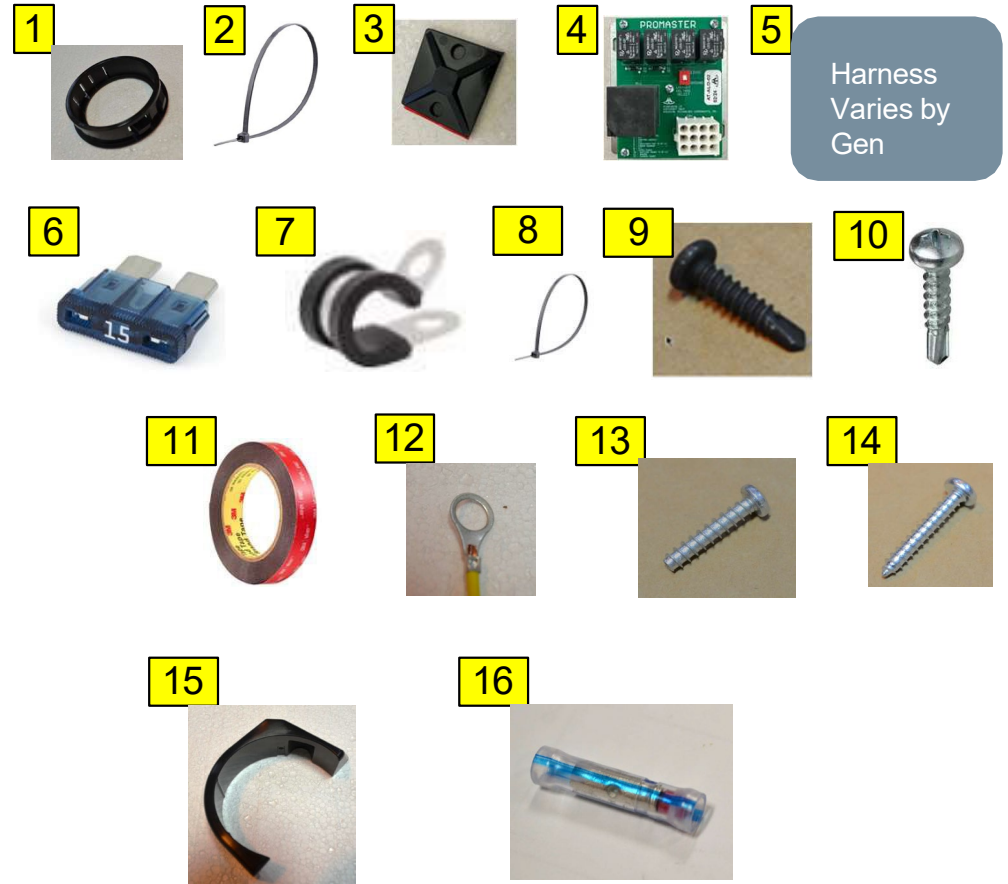
RC7922-24-776 Gen 2 K/KL

1. 1.25" Grommet – 114208-07-000 (3)
2. Large zip ties - 008343-04-000(25)
3. Adhesive zip tie mounts - 357004-01-000 (2)
4. Awning Control Module (Gen 2) - 358901-01-000 (1)
5. Wire Asm - Awning (Gen 1)–358895-01-000, (Gen 2) - 358883-01-000 (1)
6. 15A Fuse – 062901-05-000 (1)
7. P clamp - 083610-01-000 (3).
8. Small zip ties - 008343-03-000(10)
9. Black Self-tapping screw – 000G39-10-12T (3)
10. Silver Self-tapping screw – 000G39-08-12B (4)
11. Double Sided Tape – 076322-22-000 (4")
12. Ring Terminal - 326278-01-000 (1)
13. Screws M4 X 20 – 339810-01-703 (2)
14. Screws #8 x 1", T20 – 339810-01-704 (5)
15. Carefree LH Motor Wedge – 339810-01-709 (1)
16. Butt Splice (Gen 2) – 326335-01-000 (1)

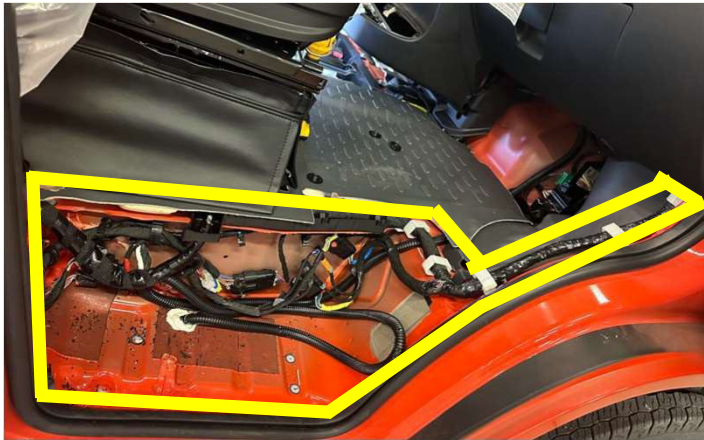
Image 1

1. Locate and remove the passenger side stepwell covers using a screw gun with Philips bit, see Image 1.
2. Using the Unibit, drill a 1.25" hole going through the chassis as shown, see Image 2 red arrow. The hole should be at most 1" away from the vertical walls. Prime the bare metal around the cut hole to prevent rust.
3. Put a split into a 1.25" grommet, install it on the harness, and then into the floor from above.

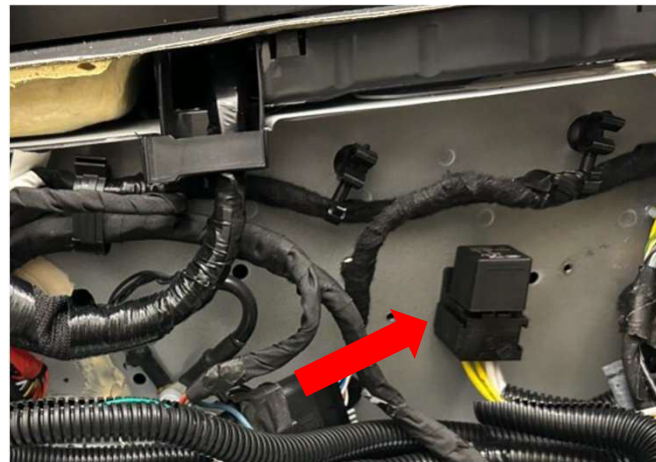
Image 1

1. If your coach is Gen 1 (Winnebago model years 2016-2019), follow the instructions below. Otherwise continue to next slide.
2. Mount the relay of the new harness using self-tapping screws on the vertical wall of the stepwell closest to the seat, see Image 1.
3. Follow Step 2A – Installing Harness Driver Side
4. Any excess wiring on the new harness can be pulled through the 1.25" hole.
5. Reinstall the Passenger side stepwell covers.
6. Follow Step 2C – Harness Install Under Coach
7. Follow Step 2H – Route to Roof (awning connection circuits FFT and NM)
8. Continue to Step 3.

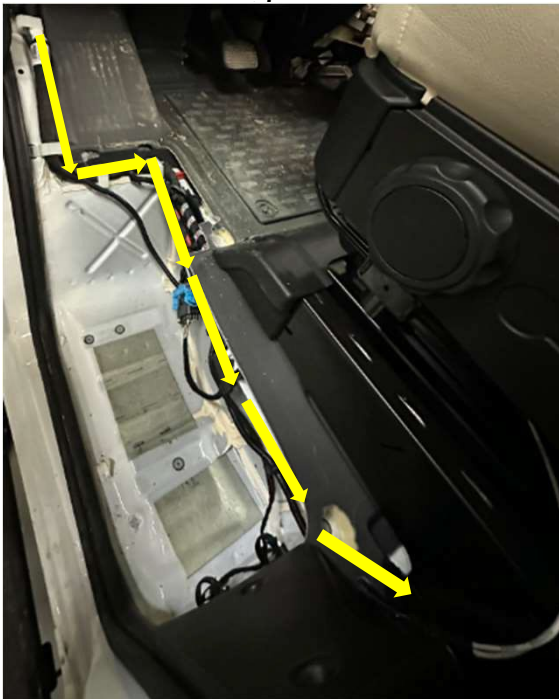
Image 1

1. Route the harness below the steering collum, following the existing harnesses. Then route the harness beneath the driver side stepwell covers. See Image 1, yellow arrows for wire path.

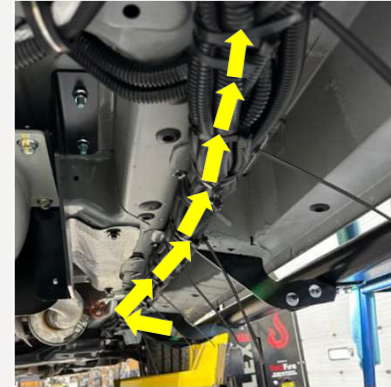
Image 5

4. Secure the new harness up to the existing Winnebago harnesses using zip ties and to the chassis rib using P clamps. See Images 5 and 6, yellow arrows for the wire path. The new harness should not be allowed to sag below the existing harnesses. The 1.25" holes in the chassis can be filled with Manus to prevent water intrusion.

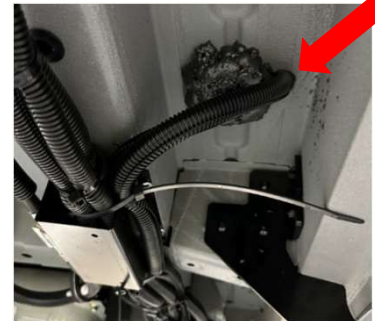
Image 4

- c) Remove the panel assembly from the coach and set aside for reinstallation.
2. With the panel now removed, go below the coach and drill a 1.25" hole up into the bed cabinet, a typical location is shown in Image 4. The best location for this hole may vary by build, locate an open area within the footprint of the Galley cabinet to drill through. When identifying a location drill a pilot hole from inside the cabinet down and then cut the 1.25" hole up to confirm there is no obstacles or damage to existing parts.

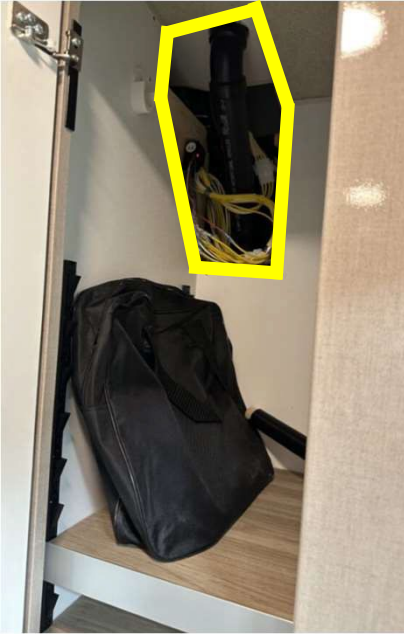
Image 1

1. Remove the abs closeout in the upper corner of the shirt cabinet, See Image 1.
2. Remove the access panel and drawer from the shirt cabinet.
3. Using fish tape, route the awning connection circuits up to the closeout area having it pass behind the drawer and behind the shirt closet paneling. See Image 2 and 3 yellow arrows for wire path.

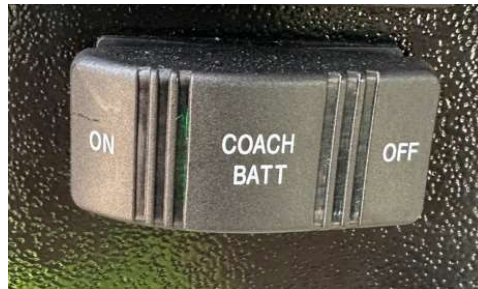
Image 1

1. Turn on the 12v house disconnect switch – See Image 1.
2. Reconnect the 12v chassis battery ground. Refer to the Promaster user manual to disconnect the ground cable from the battery.

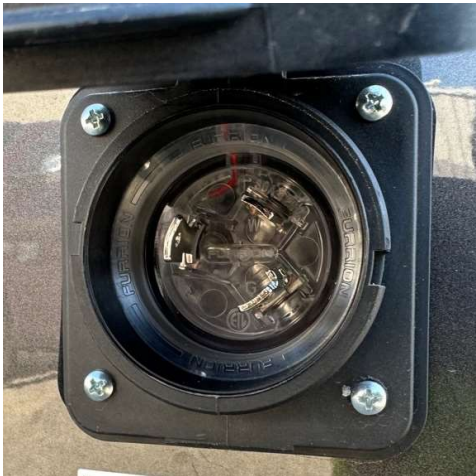
Image 1

1. Disconnect the shore power cord from the coach – See Image 1.
2. Turn off the house disconnect switch – See Image 2.
3. Disconnect the 12v chassis battery ground. Refer to the Promaster user manual to disconnect the ground cable from the battery.
4. NOTE: If the chassis battery ground is not disconnected before performing the rework, chassis faults may occur that will require a Promaster service center. This cost is not covered under this recall.

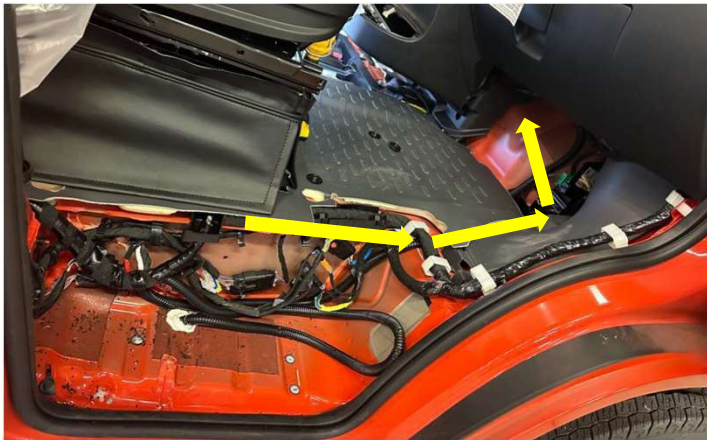
Image 1

1. Locate and remove the passenger side stepwell covers using a screw gun with Philips bit, see Image 1.
2. Using the Unibit, drill a 1.25" hole going through the chassis as shown, see Image 2 red arrow. The hole should be at most 1" away from the vertical walls. Prime the bare metal around the cut hole to prevent rust.
3. Mount the new Awning Control Module using self-tapping screws on the vertical wall of the stepwell closest to the seat, see Image 3. Creating a pilot hole may assist with the installation and avoid damage to the relay board.
4. Connect the 12-pin plug on the new harness to the Awning Control Module.
5. IMPORTANT: The switch on the Awning Control Module controls needs to be set to GROUND– See Image 4.
 - o Setting the switch to GROUND will auto retract the awning when the engine is started.
 - o 12VDC would disable the auto retract function.

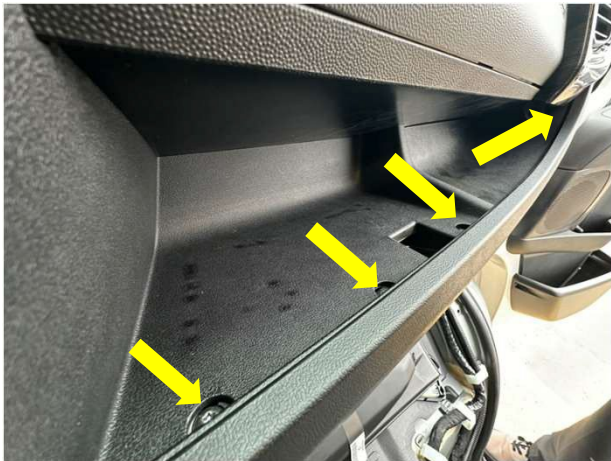
Image 1

1. Locate and remove the four T20 screws holding in the top of the glove box assembly. The fourth screw is below the right passenger air vent. See image 1 yellow arrows.

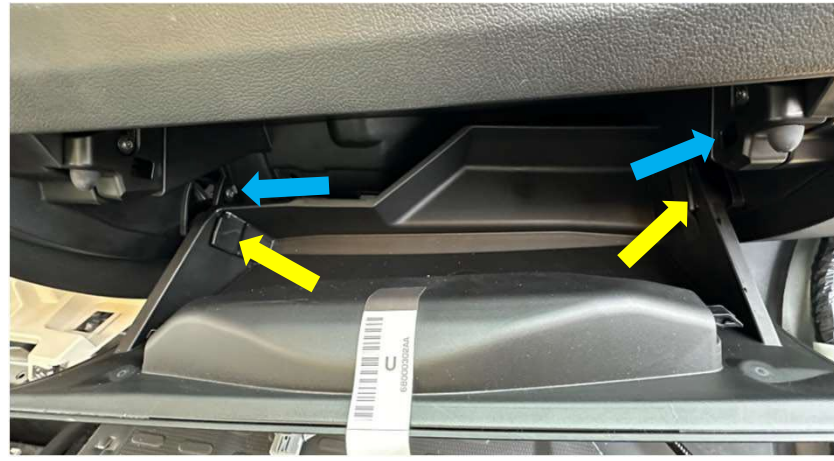
Image 2

2. Pop the two release tabs, one on either side of the glove box and allow it to drop down. See image 2 yellow arrows.
3. Loosen or remove the two T20 screws behind the glove box tray securing the assembly, see image 2 blue arrows.

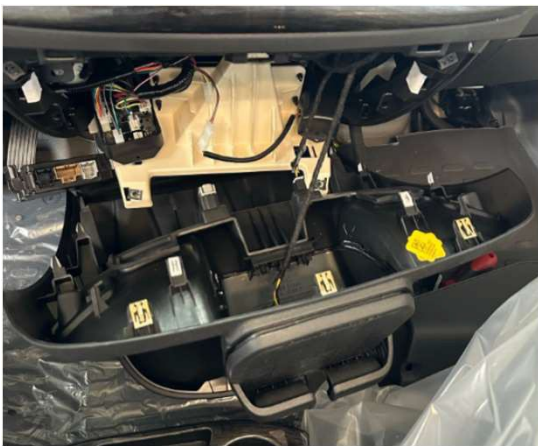
Image 1

1. Pop out the center cup holder and screw covers from the center console plastic enclosure. It is held in with clips.
2. Using a screw gun with a T20 Torx bit and trim tools, remove the 4 mounting screws and pop the clips to detach the center console plastic enclosure from the chassis, see Image 1.

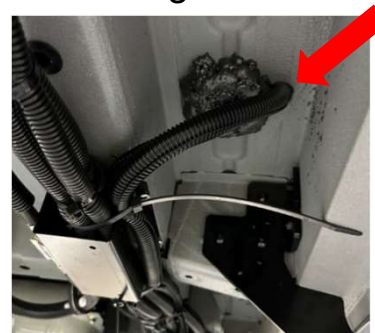
- c) Remove the panel assembly from the coach and set aside for reinstallation.
2. With the panel now removed, go below the coach and drill a 1.25" hole up into the bed cabinet, see Image 4 red arrow. The new hole should be about 3" towards the coach exterior compared to the original and should stay out of the existing Manus. Ensure when drilling that no wiring inside the bed cabinet will be damaged. Prime the bare metal around the cut hole to prevent rust.

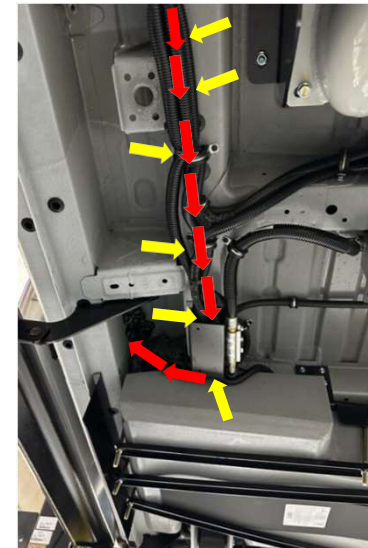
Image 5

7. Secure the new harness up to the existing Winnebago harnesses or chassis mounting holes using zip ties or to the chassis rib using P clamps. See Images 4, 5 and 6, yellow arrows. The new harness should not be allowed to sag below the existing harnesses. The 1.25" holes in the chassis can be filled with Manus to prevent water intrusion.

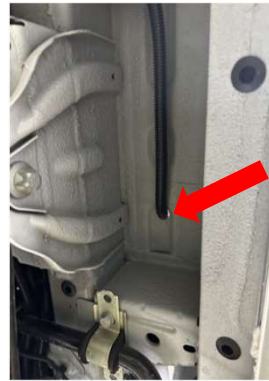
4. Below the coach, drill a 1.25" hole up into the bed cabinet, see Image 3 red arrow. The new hole should be in the edge of the last section of rib right next to the driver side leaf spring's forward pivot. Ensure when drilling that no wiring inside the bed cabinet will be damaged. Prime the bare metal around the cut hole to prevent rust.

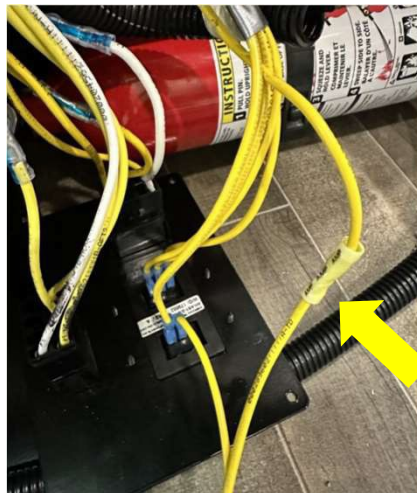
Image 1

1. In the galley cabinet near the awning switch, locate the circuits labeled TD on the existing harnesses.
2. Using a multimeter, test these circuits to find one that shows 12v power now that chassis power is restored.
3. Note: Some of the existing TD circuits, either on the original harness or rework harnesses, may have been fully disconnected during the recall and will no longer carry chassis power. These circuits can be taped off or removed as they are no longer a useable connection.
4. Splice the new harness to one of the hot TD circuits. See image 1 yellow arrow.

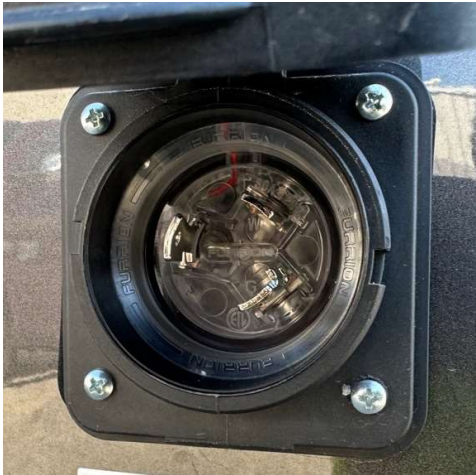
Image 1

1. Disconnect the shore power cord from the coach – See Image 1.
2. Turn off the house disconnect switch – See Image 2.
3. Disconnect the 12v chassis battery ground. Refer to the Promaster user manual to disconnect the ground cable from the battery.
4. NOTE: If the chassis battery ground is not disconnected before performing the rework, chassis faults may occur that will require a Promaster service center. This cost is not covered under this recall.

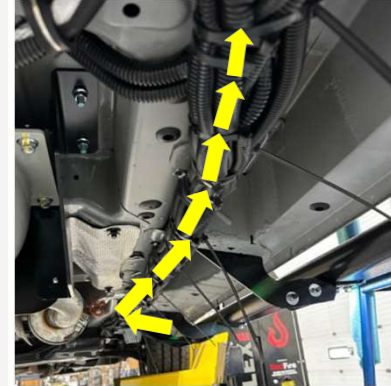
Image 5

4. Secure the new harness up to the existing Winnebago harnesses using zip ties or to the chassis rib using P clamps. See Images 5 and 6, yellow arrows for the wire path. The new harness should not be allowed to sag below the existing harnesses. The 1.25" holes in the chassis can be filled with Manus to prevent water intrusion.

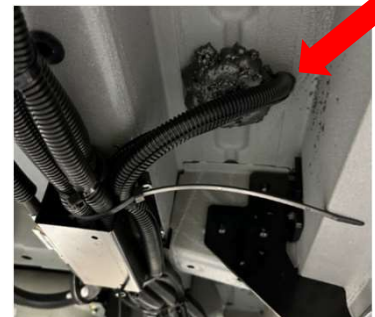
- c) Remove the panel assembly from the coach and set aside for reinstallation.
2. With the panel now removed, go below the coach and drill a 1.25" hole up into the bed cabinet, see Image 4 red arrow. The new hole should be about 3" towards the coach exterior compared to the original and should stay out of the existing Manus. Ensure when drilling that no wiring inside the bed cabinet will be damaged. Prime the bare metal around the cut hole to prevent rust.

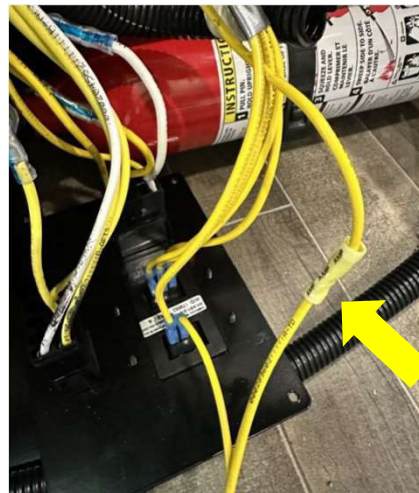
Image 1

1. In the bed cabinet near the awning switch, locate the circuits labeled TD on the existing harnesses.
2. Using a multimeter, test these circuits to find one that shows 12v power now that chassis power is restored.
3. Note: Some of the existing TD circuits, either on the original harness or rework harnesses, may have been fully disconnected during the recall and will no longer carry chassis power. These circuits can be taped off or removed as they are no longer a useable connection.
4. Splice the new harness to one of the hot TD circuits. See image 1 yellow arrow.
