2022 Ram Promaster Chassis Travato G/GL Awning Rework: Gen 3

RC7923-24-776 Gen 3 G/GL

2022 Ram Promaster Chassis Travato G/GL Awning Rework:

2022 can be identified by having either a 'N' as the 10th digit of the VIN, or by not having a VSIM module and having an electronic parking brake.

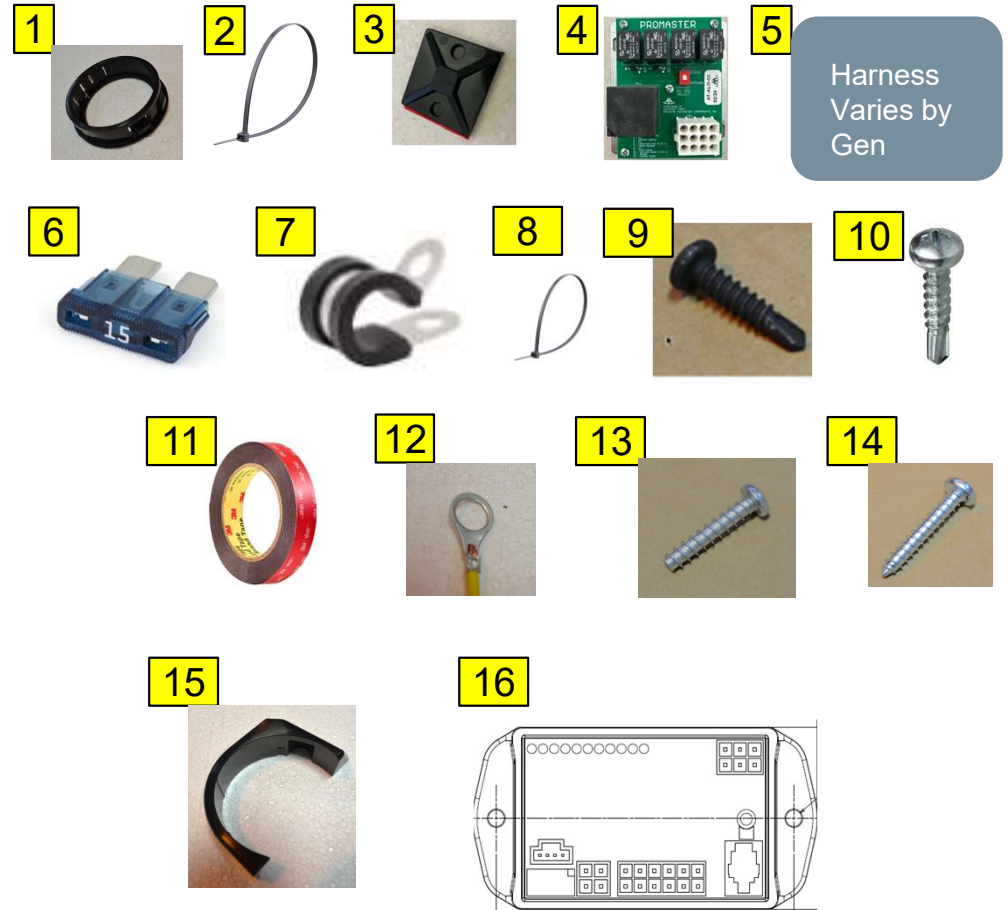
1. 1.25" Grommet – 114208-07-000 (3)
2. Large zip ties - 008343-04-000(25)
3. Adhesive zip tie mounts - 357004-01-000 (2)
4. Awning Control Module (Gen 2) - 358901-01-000 (1)
5. Wire Asm - Awning – 358863-01-000 (1)
6. 15A Fuse – 062901-05-000 (1)
7. P clamp - 083610-01-000 (3).
8. Small zip ties - 008343-03-000(10)
9. Black Self-tapping screw – 000G39-10-12T (3)
10. Silver Self-tapping screw – 000G39-08-12B (4)
11. Double Sided Tape – 076322-22-000 (4")
12. Ring Terminal - 326278-01-000 (1)
13. Screws M4 X 20 – 339810-01-703 (2)
14. Screws #8 x 1", T20 – 339810-01-704 (5)
15. Carefree LH Motor Wedge – 339810-01-709 (1)
16. Interface Module - 358822-01-000 (1)

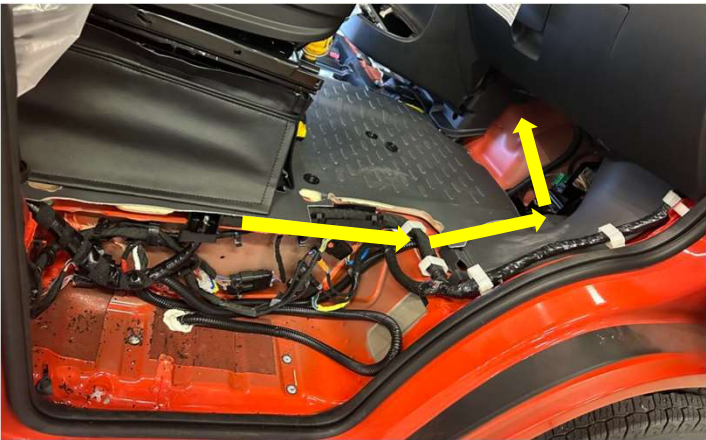
Image 1

1. Locate and remove the passenger side stepwell covers using a screw gun with Philips bit, see Image 1.
2. Using the Unibit, drill a 1.25" hole going through the chassis as shown, see Image 2 red arrow. The hole should be at most 1" away from the vertical walls. Prime the bare metal around the cut hole to prevent rust.
3. Mount the new Awning Control Module using self-tapping screws on the vertical wall of the stepwell closest to the seat, see Image 3. Creating a pilot hole may assist with the installation and avoid damage to the relay board.
4. Connect the 12-pin plug on the new harness to the Awning Control Module.
5. IMPORTANT: The switch on the Awning Control Module controls needs to be set to GROUND– See Image 4.
 - o Setting the switch to GROUND will auto retract the awning when the engine is started.
 - o 12VDC would disable the auto retract function.

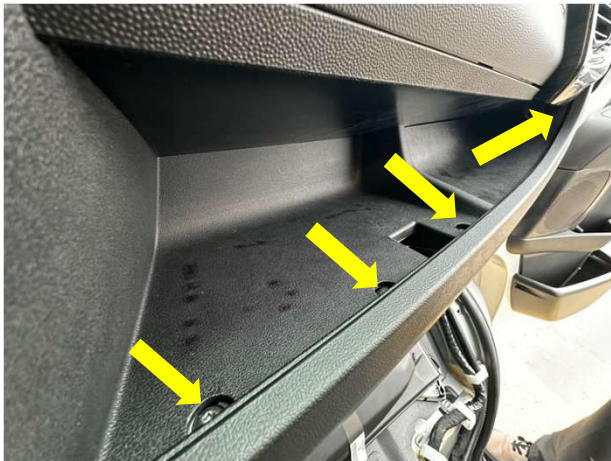
Image 1

1. Locate and remove the four T20 screws holding in the top of the glove box assembly. The fourth screw is below the right passenger air vent. See image 1 yellow arrows.

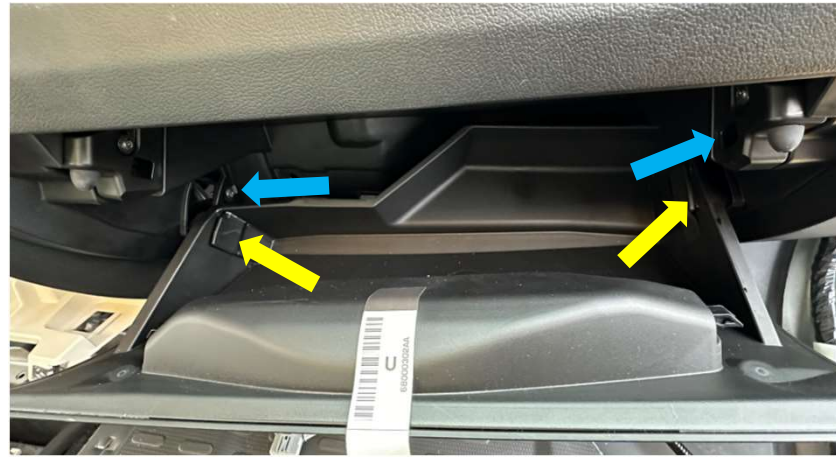
Image 2

2. Pop the two release tabs, one on either side of the glove box and allow it to drop down. See image 2 yellow arrows.
3. Loosen or remove the two T20 screws behind the glove box tray securing the assembly, see image 2 blue arrows.

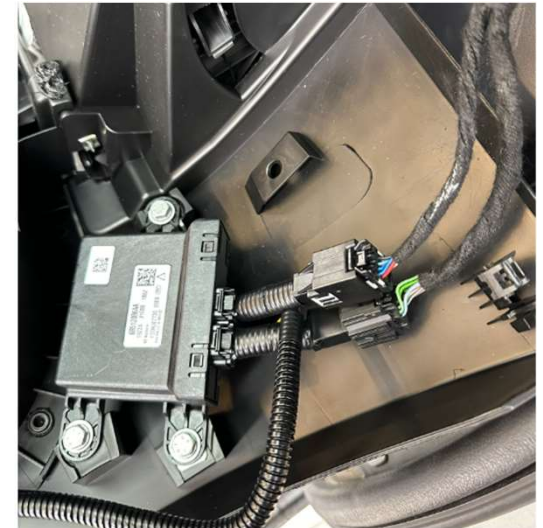
Image 4

4. At this point, only clips retain the glove box assembly. Use your hands or plastic trim tools to detach it from the chassis.
5. Locate the Ram Gateway module mounted on the back of the glove box assembly. See image 4.

6. Remove the 12-pin and 8-pin connectors from the Gateway module and plug in the 12-pin and 8-pin connectors from the Intermotive Interface Module harness. Plug the RAM 12-pin and 8-pin connectors into the mating connectors on the Interface Module harness. See image 4.

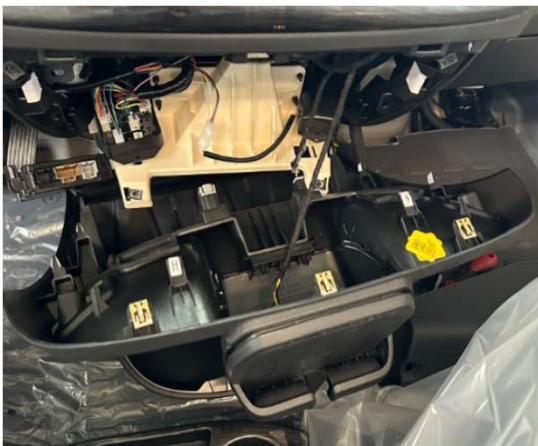
Image 1

1. Pop out the center cup holder and screw covers from the center console plastic enclosure. It is held in with clips.
2. Using a screw gun with a T20 Torx bit and trim tools, remove the 4 mounting screws and pop the clips to detach the center console plastic enclosure from the chassis, see Image 1.

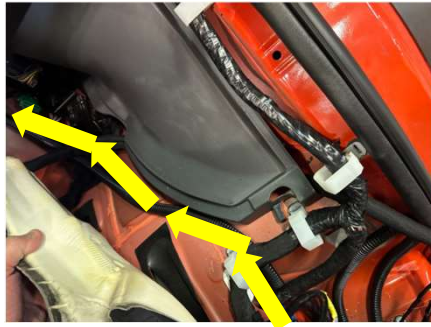
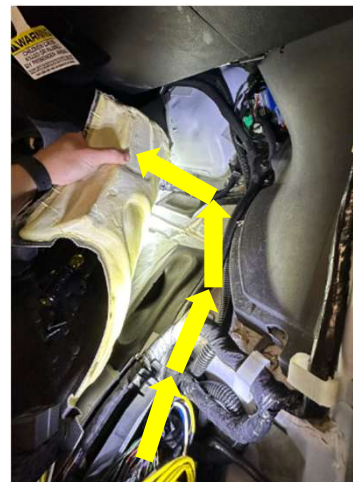
3. Route the section of the new Winnebago harness with the 2X6 CAN plug up under the wheel well plastic trim and flooring, beneath the glovebox, behind the passenger kick cover, and back behind the center console area. See Image 2 and 3, yellow arrows.

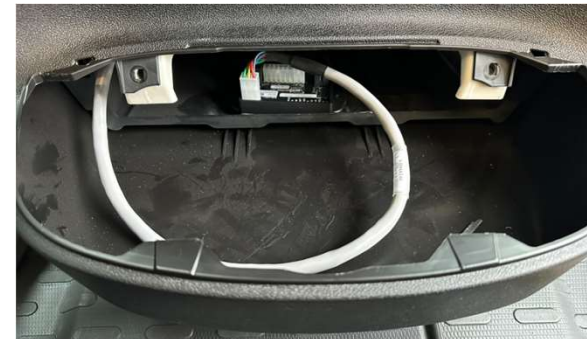
Image 4

6. Mount the Interface Module to the chassis using VHB tape. Connect the plug from the extension harness and the new Winnebago harness to the CAN Interface Module. See Image 4.

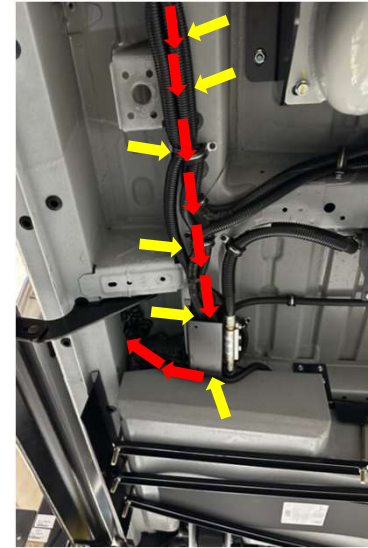
Image 5

5. Route the new harness from the passenger stepwell back through the LP manifold mounting bracket. Bring the new harness branch with AWP, TD, ASY, and FFT up into the Galley cabinet 1.25" hole. See Image 5, red arrows. Cut a split into a 1.25" grommet, install it on the harness, and then into the floor from above.

7. Secure the new harness up to the existing Winnebago harnesses or chassis mounting holes using zip ties or to the chassis rib using P clamps. See Images 4, 5 and 6, yellow arrows. The new harness should not be allowed to sag below the existing harnesses. The 1.25" holes in the chassis can be filled with Manus to prevent water intrusion.

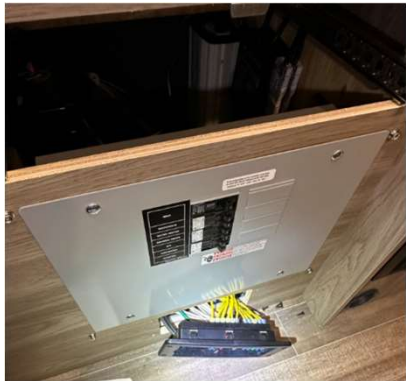
Image 1

1. On the coach interior, gain access to the galley cabinet interior by removing the drawers.
2. Gain access to the area behind the fuse panel in the bed cabinet. This can be done by removing the drawer above the fuse panel and unmounting the fuse panel itself. See Image 1.

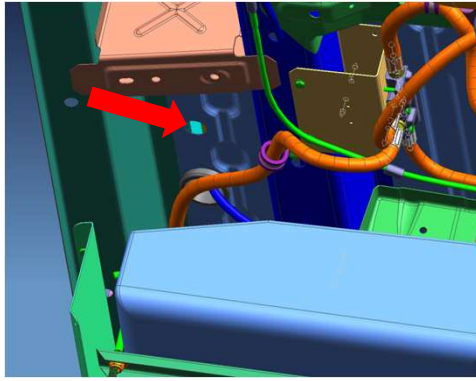
Image 2

3. Below the coach, drill a 1.25" hole up into the galley cabinet. This hole should be 4" towards the front of the coach as compared to the existing 2" wire routing hole. See Image 2, red arrow. Ensure when drilling that no wiring inside the Galley cabinet will be damaged. Prime the bare metal around the cut hole to prevent rust.

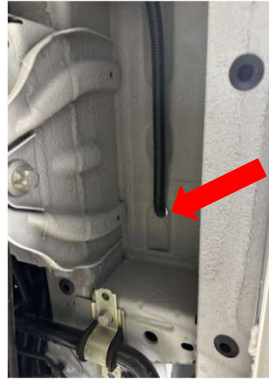
4. Below the coach, drill a 1.25" hole up into the bed cabinet, see Image 3 red arrow. The new hole should be in the edge of the last section of rib right next to the driver side leaf spring's forward pivot. Ensure when drilling that no wiring inside the bed cabinet will be damaged. Prime the bare metal around the cut hole to prevent rust.

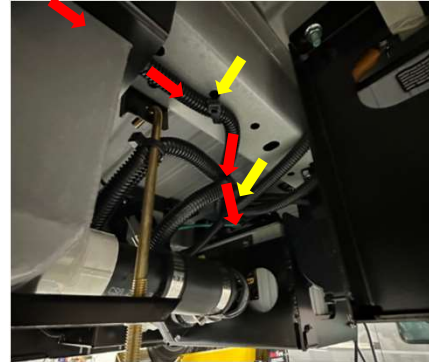
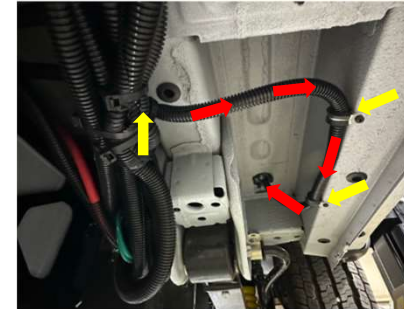
6. Route the new harness branch NM through the grey tank mounting brackets, over the rearward battery, and into the new bed cabinet 1.25" hole. See Image 4 and 6, red arrows. Cut a split into a 1.25" grommet, install it on the harness, and then into the floor from above.

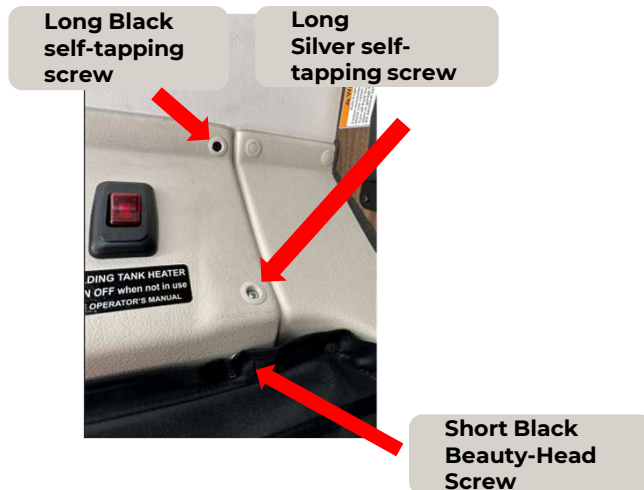
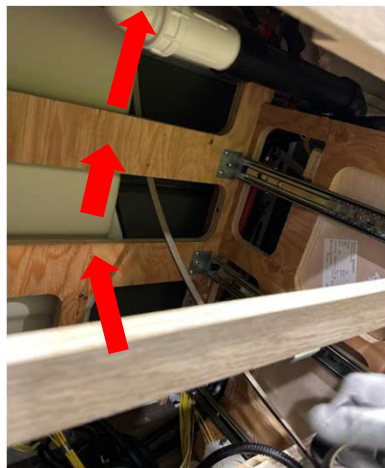
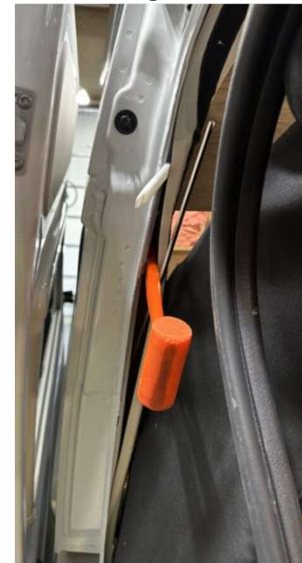
1. Partially unmount the abs closeout panel above the sliding door. The closeout panel is secured to the roof, sidewall rib, and screen door. Only remove screws as needed to pull away panel, the BT-12 and its connections should now be accessible. See Image 1 for screw locations.
2. Take AWP, ASY, and FFT-1 of the new harness and route it behind the cabinet, up through the plastic trim at the rear of the sliding door, and up to the BT-12. There is a recessed path that allows the wire to pass through without interfering with the abs panel fitment, see Image 2 and 4 red arrows for wire path. Use trim tools as needed to pry the panels away and fish tape to bring the circuits up, see Image 3. The sliding door seal can be removed for easier access.

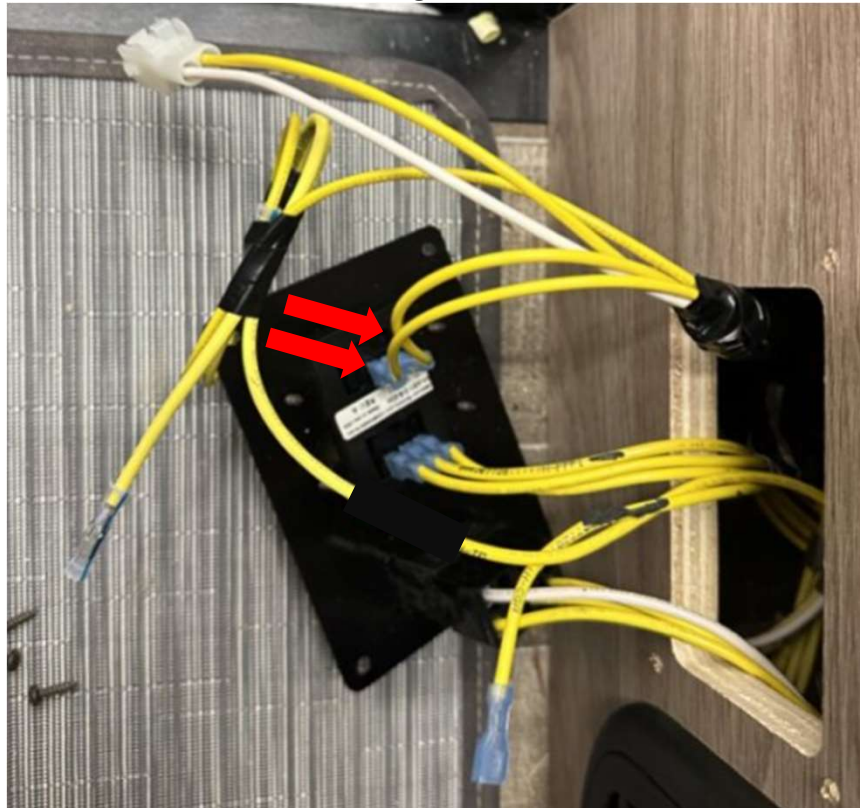
1. If the coach is equipped with the Carefree awning on/off switch, follow the below steps. Otherwise move onto the next page.
2. Connect the branch FFT and FFT-1 spade connector on the new harness to the awning on/off switch in place of the current connections. see Image 1 red arrows.
3. Remove the jumper from the new harness and discard. See Image 2.
4. Leave one of the TD connections on the new harness untaped and disconnected, this will be connected later once power is restored.
5. The remaining TD wire connection on the new harness will not be used, it can be taped up along with all other connections on the original harnesses in this area that are not labeled TD.

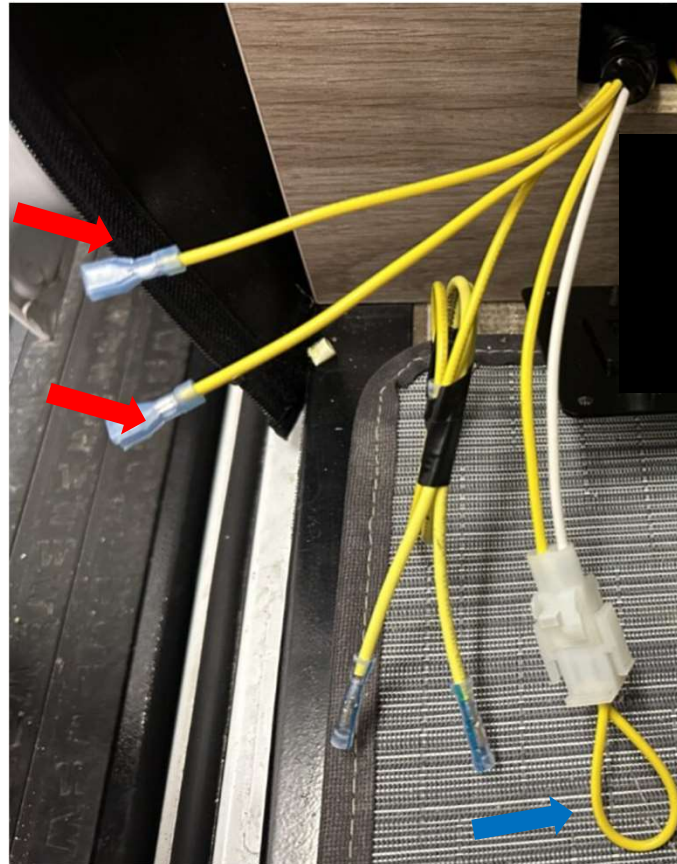
1. If the coach is not equipped with the Carefree awning on/off switch, follow the below steps. Otherwise move onto the next page.
2. Leave the jumper from the new harness installed. This makes it so connections to the spades FFT and FFT-1 are not necessary, these can be taped up. See Image 1 red arrows for unneeded spades and blue for jumper installed.
3. Leave the TD connections on the new harness untaped and disconnected, this will be connected later once power is restored.

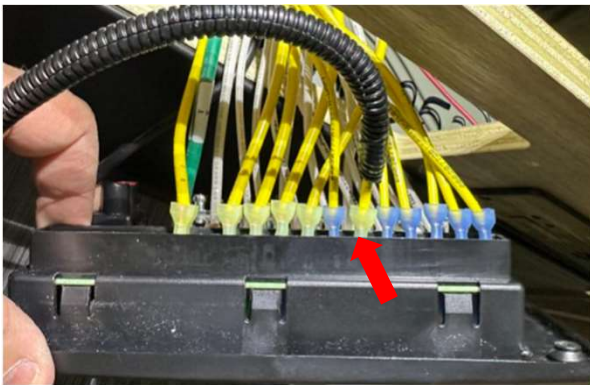
Image 1

1. As needed, unmount the Coach 12v Fuse Panel.
2. Connect the spade connector on NM to an open spade terminal on the back of the Coach 12v Fuse Panel. See Image 1, red arrow.
3. Install a 15A fuse on the front of the Coach 12v Fuse Panel into the matching space and label this fuse "Awning". See Image 2 and 3 red arrows.
4. Attach RY to the ground bar of the Coach 12v Fuse Panel, see Image 4.

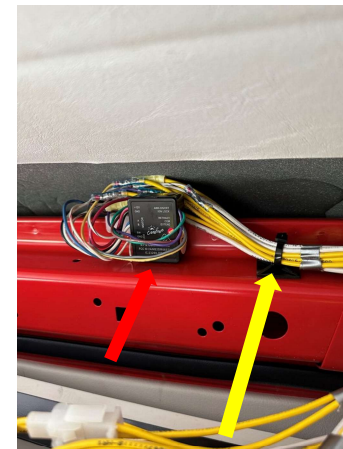
5. Use adhesive on the BT-12 to permanently mount it to the chassis rib behind the closeout, see Image 2 Red Arrow. Secure with additional wire ties as needed to create strain relief and ensure drip loop, see Image 2 Yellow Arrow. Be sure to prep surfaces prior to using any adhesive connection.

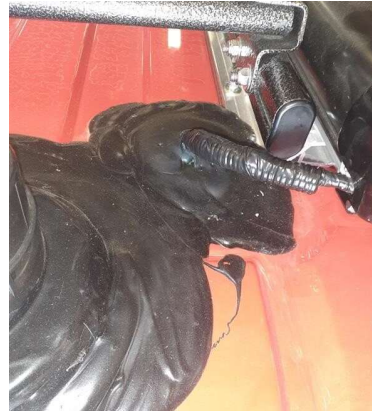
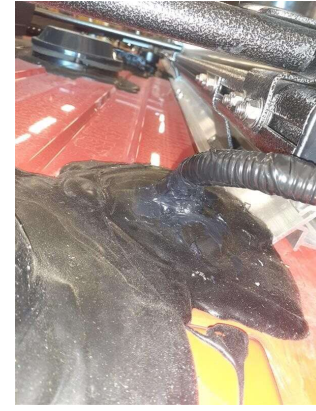
1. Go to the coach roof and locate the wiring on the awnings left hand side.
2. Remove electrical tape wrap without damaging wires to gain access to the interior of the convolute tubing, see Image 1.
3. Insert nozzle of cartridge gun into convolute tubing as far into the coach as you can, seal the inside tubing back to 2 inches up from the roof, see Image 2. Ensure sealant oozes out to confirm the convolute is fully filled. Wipe off excess, prep, and retape convolute starting from the roof and wrapping up to the awning creating a shingled effect. See Image 3
4. Using Manus, reseal on top of the existing self-leveling around the base of the convolute and tool to ensure no gaps are present, see Image 4.

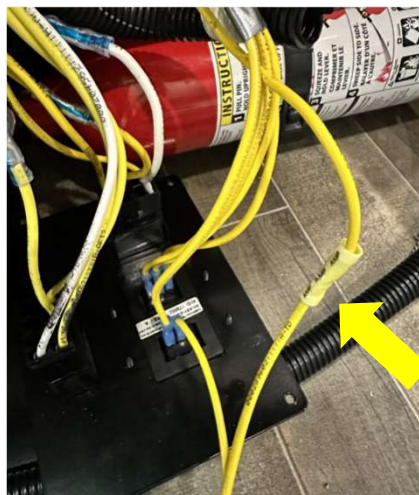
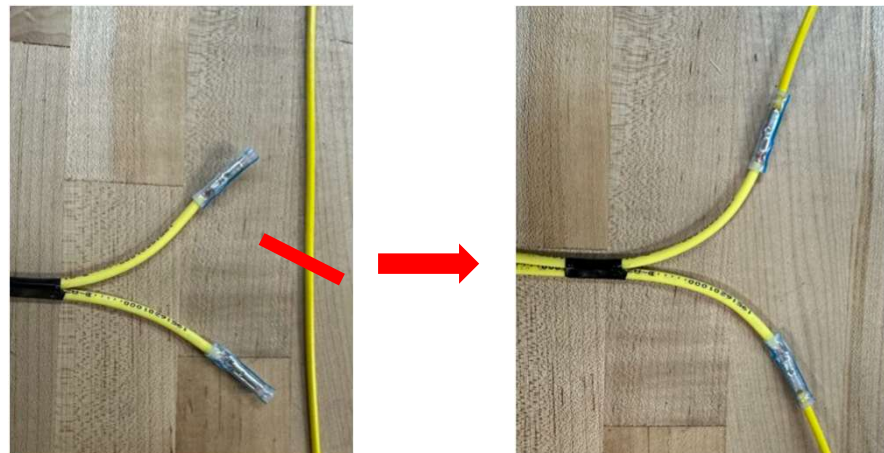
1. In the galley cabinet near the awning switch, locate the circuits labeled TD on the existing harnesses.
2. Note: Some of the existing TD circuits may have been fully disconnected during the recall and will no longer carry chassis power. These circuits can be taped off or removed as they are no longer a useable connection.
3. Using a multimeter, test these circuits to find one that shows 12v power now that chassis power is restored.
4. For units with the Carefree Switch: Splice the new harness to one of the hot TD circuits. See image 1 yellow arrow. The other unused TD circuit connections, if any, can be taped up.
5. For units without the Carefree Switch: Splice the 2 TD connections in line with the hot TD circuit. See image 2.

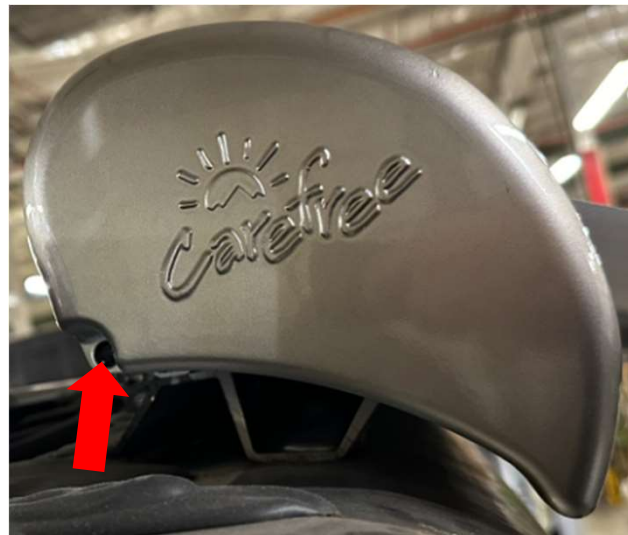
Image 2

2. If the awning is an angle gear motor, gain access to the backside of the motor by removing the case end cap, see Image 2. Some coaches may require the mounting screws be removed and the awning to be slid back on the mounting extrusion in order to access the cover. When doing this be careful to not pop the awning out of the mounting extrusion as it could fully detach from the coach.

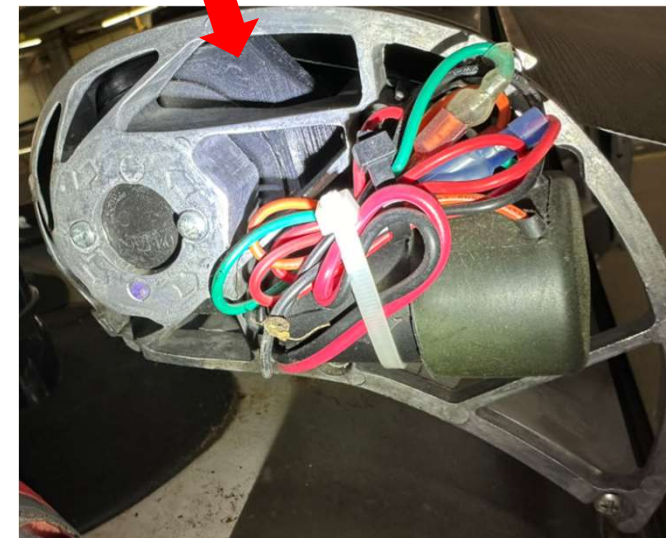
3. Confirm that a wedge is not installed, Image 3 shows a motor with a wedge already installed.
 4. If your coach does not have the wedge and requires one, move onto the next page and follow the wedge installation.

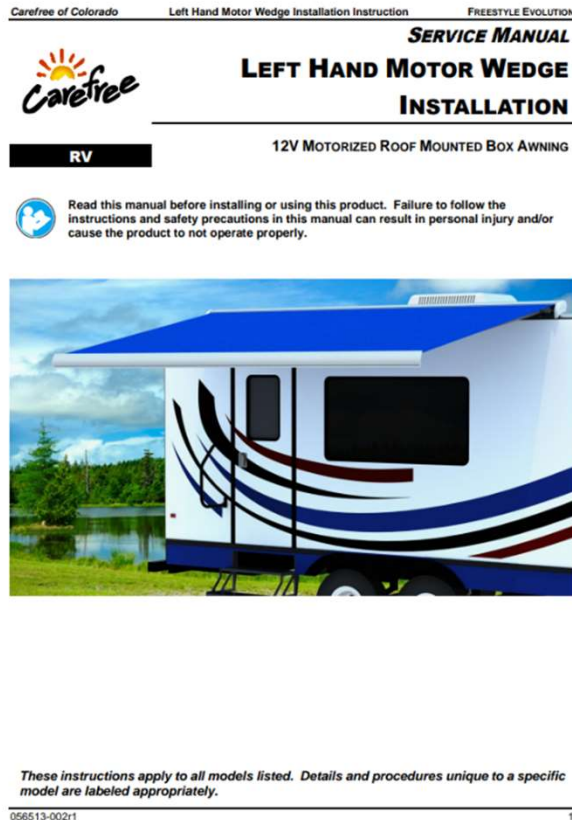
1. Review and complete the following documents, all units with a BT-12 require a firmware update.
 - Carefree Motor Wedge Installation service manual, 056513-002R1(LH) or 056513-001R5(RH) . (For angle gear awnings without a wedge already installed)
 - Carefree Connects Firmware Update service manual, 056513-004r1 (All awning with a BT-12)

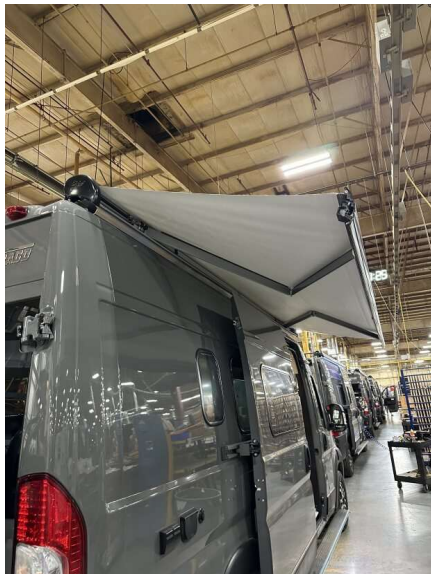
Image 2

- See the chart in Image 1 and confirm that all 'With' situations result in the correct actions when the extend and retract commands are operated.
 - Note:** awning will need to be partially extended to confirm auto-retraction, see Image 2.
 - Note:** the relay module will hold the park brake signal from when the park brake is engaged until the engine is started or the module loses power. This is due to the chassis going to sleep and needing to hold the park brake signal.
- With the engine off and the parking brake and 12v coach power on, bring the awning to a partially extended position, see Image 2. Locate the edge of the awning with the wind sensor and shake the awning to simulate high winds. The awning should automatically retract when the sensor reads the awning movement.
- If all the above actions result in their defined outcomes the rework is complete.
