2023 or newer Ram Promaster Chassis Travato K/KL Awning Rework: Gen 4

RC7927-24-776 Gen 4 K/KL

2023 or newer Ram Promaster Chassis Travato K/KL Awning Rework:

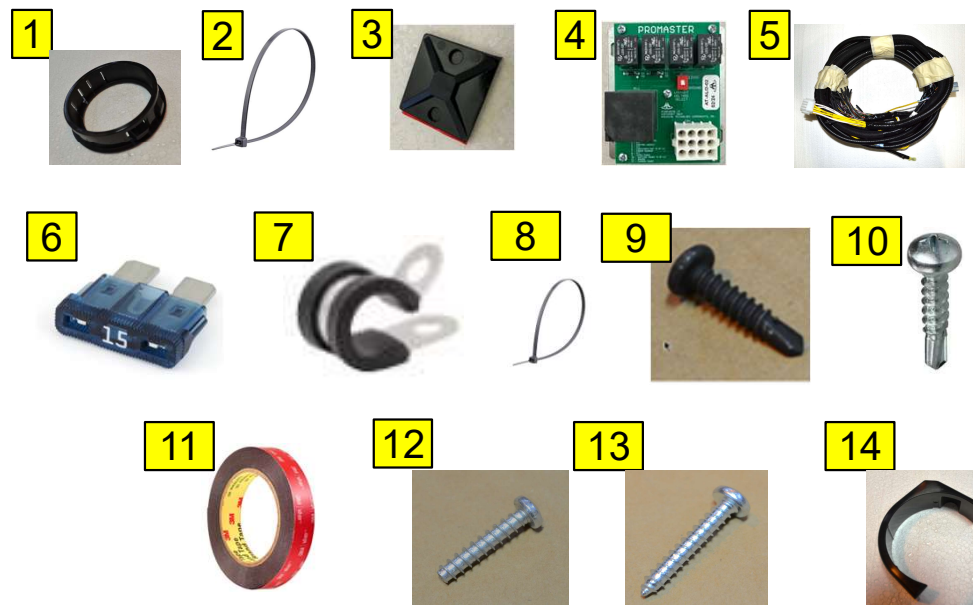
Parts required:

1. 1.25" Grommet – 114208-07-000 (3)
2. Large zip ties - 008343-04-000(25)
3. Adhesive zip tie mounts - 357004-01-000 (2)
4. Awning Control Module (Gen 2) - 358901-01-000 (1)
5. Wire Asm - Awning – 358843-01-000 (1)
6. 15A Fuse – 062901-05-000 (1)
7. P clamp - 083610-01-000 (3).
8. Small zip ties - 008343-03-000(10)
9. Black Self-tapping screw – 000G39-10-12T (3)
10. Silver Self-tapping screw – 000G39-08-12B (4)
11. Double Sided Tape – 076322-22-000 (4")
12. Screws M4 X 20 – 339810-01-703 (2)
13. Screws #8 x 1", T20 – 339810-01-704 (5)
14. Carefree LH Motor Wedge – 339810-01-709 (1)

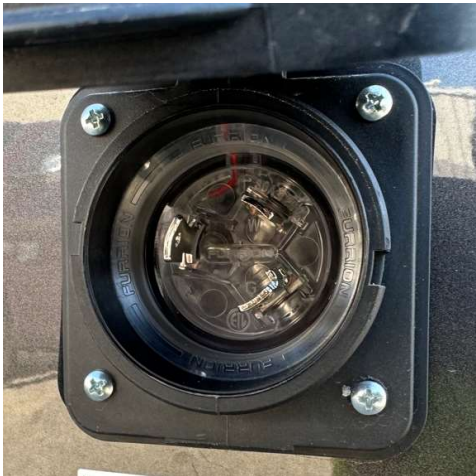
Image 1

1. Disconnect the shore power cord from the coach – See Image 1.
2. Turn off the house disconnect switch – See Image 2.
3. Disconnect the 12v chassis battery ground. Refer to the Promaster user manual to disconnect the ground cable from the battery.
4. NOTE: If the chassis battery ground is not disconnected before performing the rework, chassis faults may occur that will require a Promaster service center. This cost is not covered under this recall.

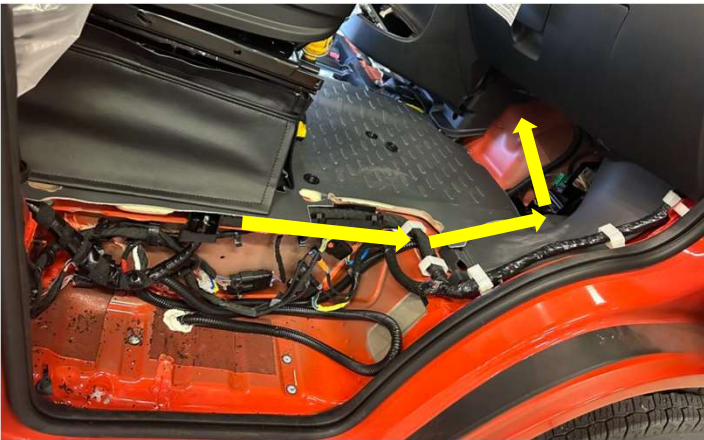
Image 1

1. Locate and remove the passenger side stepwell covers using a screw gun with Philips bit, see Image 1.
2. Using the Unibit, drill a 1.25" hole going through the chassis as shown, see Image 2 red arrow. The hole should be at most 1" away from the vertical walls. Prime the bare metal around the cut hole to prevent rust.
3. Mount the new Awning Control Module using self-tapping screws on the vertical wall of the stepwell closest to the seat, see Image 3. Creating a pilot hole may assist with the installation and avoid damage to the relay board.
4. Connect the 12-pin plug on the new harness to the Awning Control Module.
5. IMPORTANT: The switch on the Awning Control Module controls needs to be set to GROUND– See Image 4.
 - o Setting the switch to GROUND will auto retract the awning when the engine is started.
 - o 12VDC would disable the auto retract function.

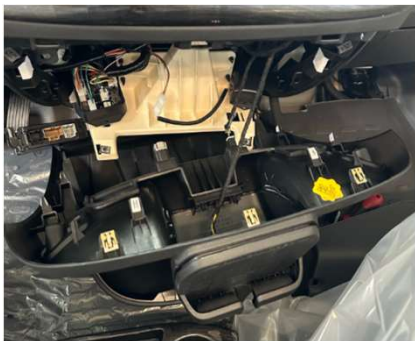
Image 1

1. Pop out the center cup holder and screw covers from the center console plastic enclosure. It is held in with clips.
2. Using a screw gun with a T20 Torx bit and trim tools, remove the 4 mounting screws and pop the clips to detach the center console plastic enclosure from the chassis, see Image 1. Only enough room to access the VSIM module is required.

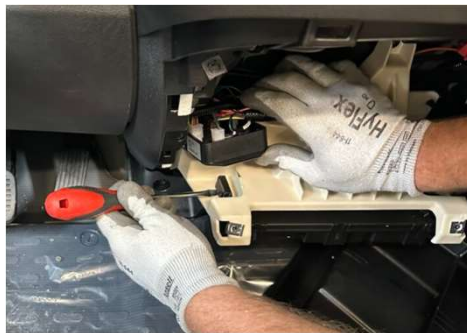
Image 2

3. Unmount the VSIM module from the chassis by depressing the mounting tab with a flathead screwdriver, see Image 2.
4. Route the wire wrapped section of the harness with 3 multi pin plugs up under the wheel well plastic trim and flooring, beneath the glovebox, behind the passenger kick cover, and back behind the center console area. See Image 3 and 4, yellow arrows. Secure harness and ensure that the harness is not visible to the user.

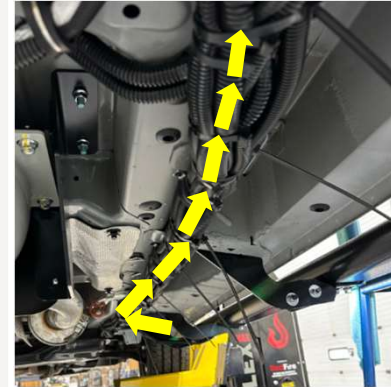
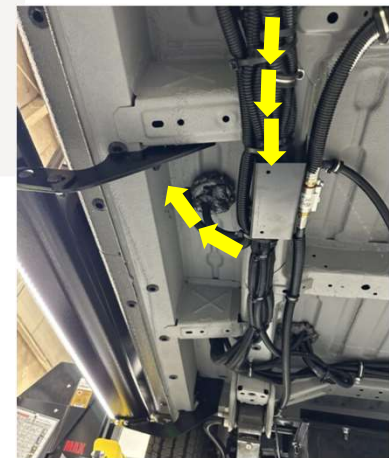
4. Secure the new harness up to the existing Winnebago harnesses using zip ties or to the chassis rib using P clamps. See Images 5 and 6, yellow arrows for the wire path. The new harness should not be allowed to sag below the existing harnesses. The 1.25" holes in the chassis can be filled with Manus to prevent water intrusion.

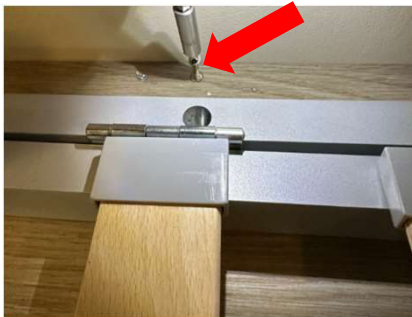
- b) Remove all mounting screws between the top panel and the rest of the cabinet. Behind the bed frame there are pairs of screws along the back edge, only the indicated screws need to be removed, see Image 2 red arrow. On the left side of the bed, one rib of the bed frame may have to be removed to access the mounting screws, see Image 3.

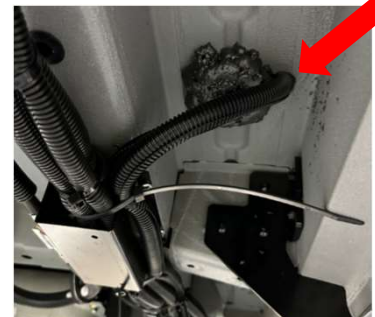
- c) Remove the panel assembly from the coach and set aside for reinstallation.
2. With the panel now removed, go below the coach and drill a 1.25" hole up into the bed cabinet, see Image 4 red arrow. The new hole should be about 3" towards the coach exterior compared to the original and should stay out of the existing Manus. Ensure when drilling that no wiring inside the bed cabinet will be damaged. Prime the bare metal around the cut hole to prevent rust.

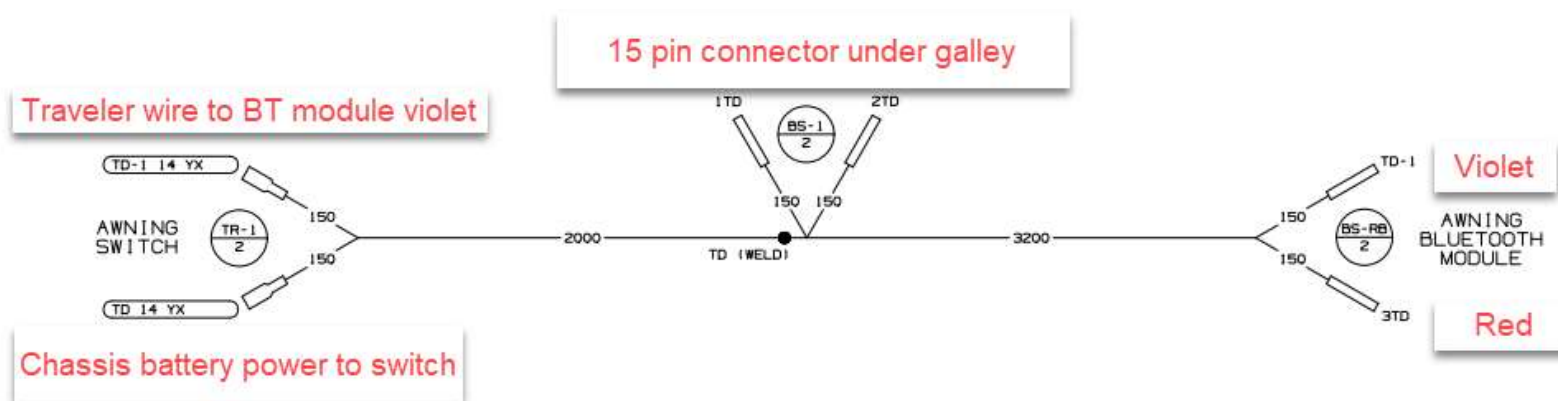
1. Some coaches may have recall 168 previously completed . This can be identified visually through the addition of the harness in Image 1 installed between the BT-12 and the awning switch.
 - The Part Number printed on the wires should be 000270094
2. If this harness is present, cut all connections and remove the harness.
 - Note: Because the harness is running up to the BT-12, it may be useful to tape the new harness to a section of the recall 168 harness and pull it through.
3. The continuity of the TD circuit on the original harness should be restored. This can be done using 1TD and 2TD on the New Harness.
 - If this is done, any following references to connecting TD can be disregarded.
4. Follow the proceeding pages for the other new connections.

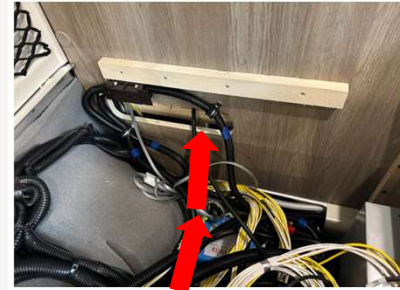
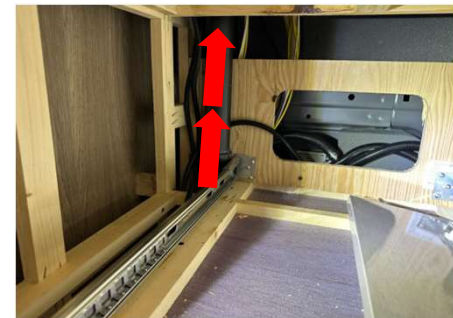
6. Remove the abs closeout in the upper corner of the shirt cabinet. This should expose the BT-12 unit and its connections. See Image 4 red arrow.
7. Using fish tape, route AWP, ASY, and FFT-1 up to the BT-12 by having it pass behind the drawer and behind the shirt closet paneling. See Image 5 and 6 red arrows for wire path. The access panel and drawer can be removed for better access, as necessary.

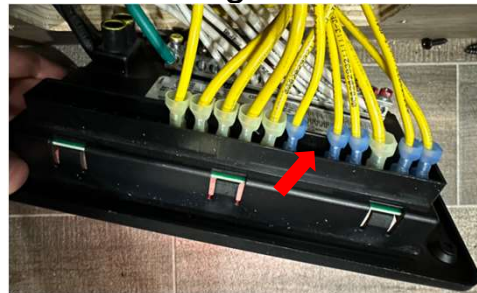
4. Take NM, AWP, ASY, and FFT-1 from the new harness and route them back through the bed cabinet towards the rear of the coach.
5. Connect the spade connector on NM to Space 6 on the back of the fuse panel. Install a 15A fuse on the front of the panel into space 6 and label this fuse "Awning". See Image 3 red arrow. Removal of the fuse panel may be necessary for proper access.

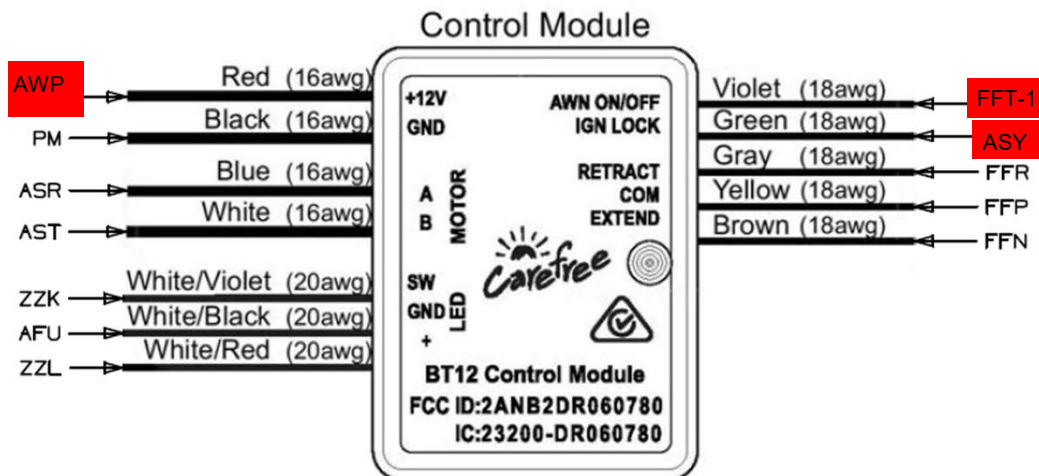
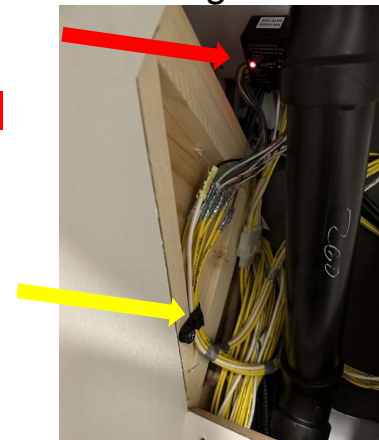
1. Cut the current connection to the red, green, and violet wires of the BT-12 module. Wrap these original circuits with tape, they will no longer be used.
2. Splice the below connections from the new harness to the BT-12:
 - AWP to Red
 - ASY to Green
 - FFT-1 to Violet
3. Check the wiring connections at the BT-12 module and verify that every circuit is properly connected. See Image 1 or the Wiring Diagram –BT-12 page at the back of this packet for proper connections.
4. Use the adhesive on the BT-12 to permanently mount to the ceiling in the shirt cabinet's closeout, see Image 2 Red Arrow. Ensure the wires come down creating a drip loop. Secure wire with additional wire ties as needed to create strain relief and ensure drip loop, see Image 2 Yellow Arrow.
5. Reinstall the closeout panel, fuse panel, bed panel and bed, and the passenger stepwell cover.

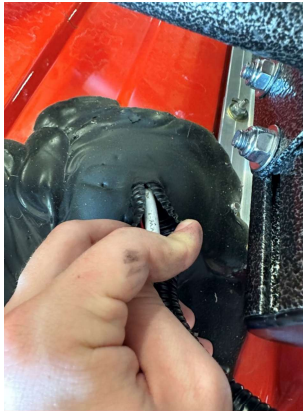
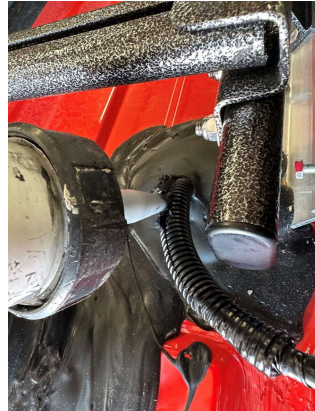
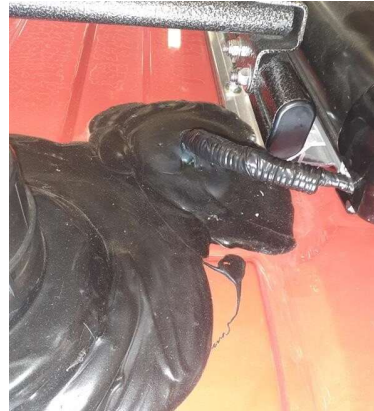
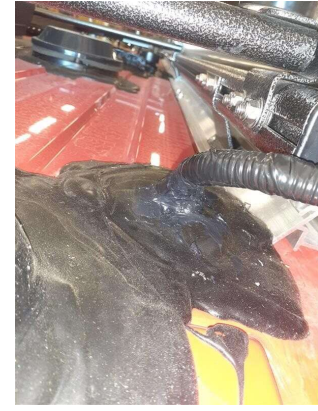
1. Go to the coach roof and locate the wiring on the awnings left hand side.
2. Remove electrical tape wrap without damaging wires to gain access to the interior of the convolute tubing, see Image 1.
3. Insert nozzle of cartridge gun into convolute tubing as far into the coach as you can, seal the inside tubing back to 2 inches up from the roof, see Image 2. Ensure sealant oozes out to confirm the convolute is fully filled. Wipe off excess, prep, and retape convolute starting from the roof and wrapping up to the awning creating a shingled effect. See Image 3
4. Using Manus, reseal on top of the existing self-leveling around the base of the convolute and tool to ensure no gaps are present, see Image 4.

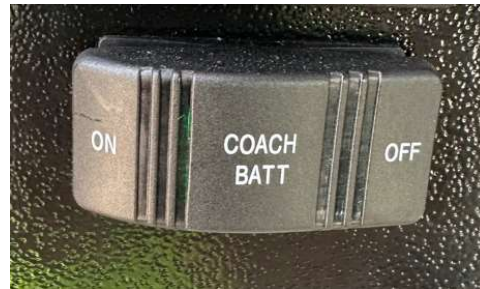
Image 1

1. Turn on the 12v house disconnect switch – See Image 1.
2. Reconnect the 12v chassis battery ground. Refer to the Promaster user manual to disconnect the ground cable from the battery.

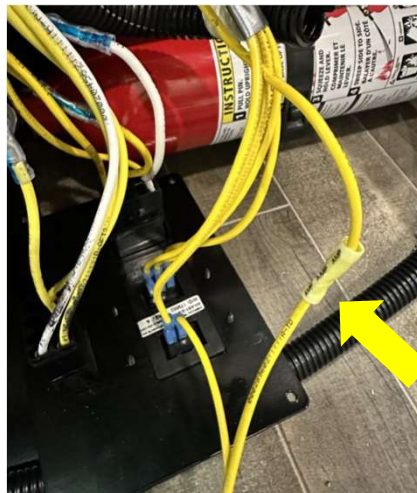
Image 1

1. In the bed cabinet near the awning switch, locate the circuits labeled TD on the existing harnesses.
2. Using a multimeter, test these circuits to find one that shows 12v power now that chassis power is restored.
3. Note: Some of the existing TD circuits, either on the original harness or rework harnesses, may have been fully disconnected during the recall and will no longer carry chassis power. These circuits can be taped off or removed as they are no longer a useable connection.
4. Splice the new harness to one of the hot TD circuits. See image 1 yellow arrow.

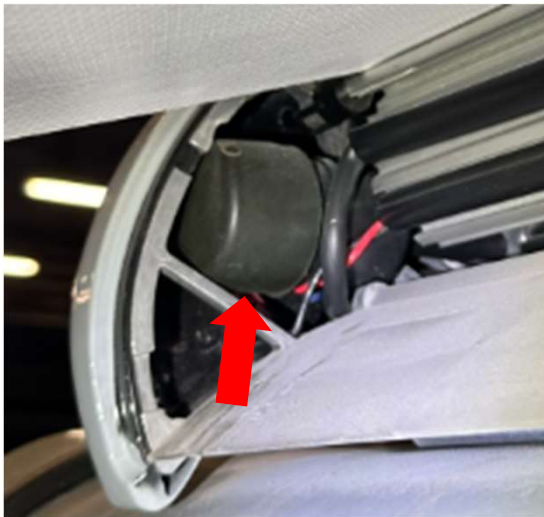
1. Confirm that the awning is an angle gear motor, this style of motor is the one that requires the wedge. See Image 1 for an example of what the angle gear motor looks like with the awning extended. Tubular style motors, where the motor is housed inside the awning fabric roller, do not require a wedge.

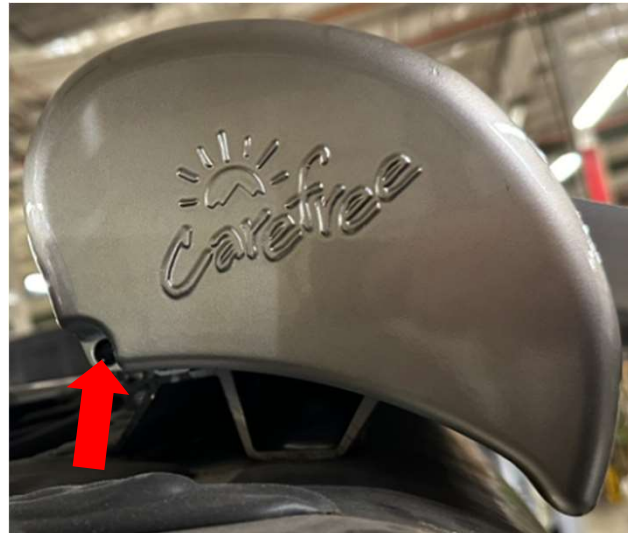
Image 2

2. If the awning is an angle gear motor, gain access to the backside of the motor by removing the case end cap, see Image 2. Some coaches may require the mounting screws be removed and the awning to be slid back on the mounting extrusion in order to access the cover. When doing this be careful to not pop the awning out of the mounting extrusion as it could fully detach from the coach.

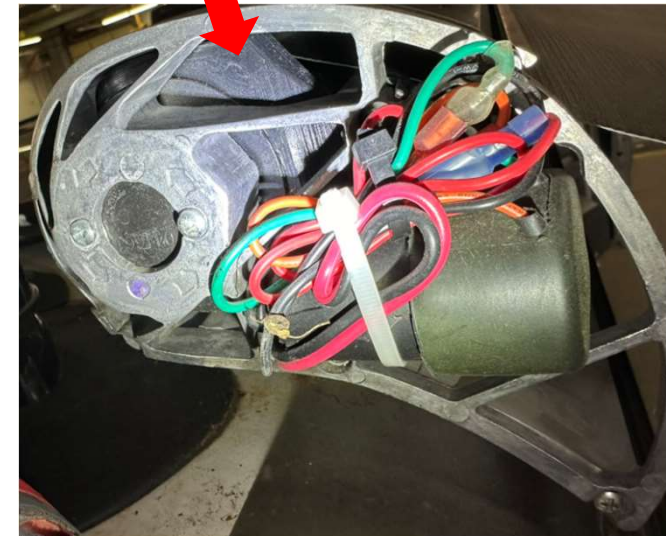
3. Confirm that a wedge is not installed, Image 3 shows a motor with a wedge already installed.
 4. If your coach does not have the wedge and requires one, move onto the next page and follow the wedge installation.

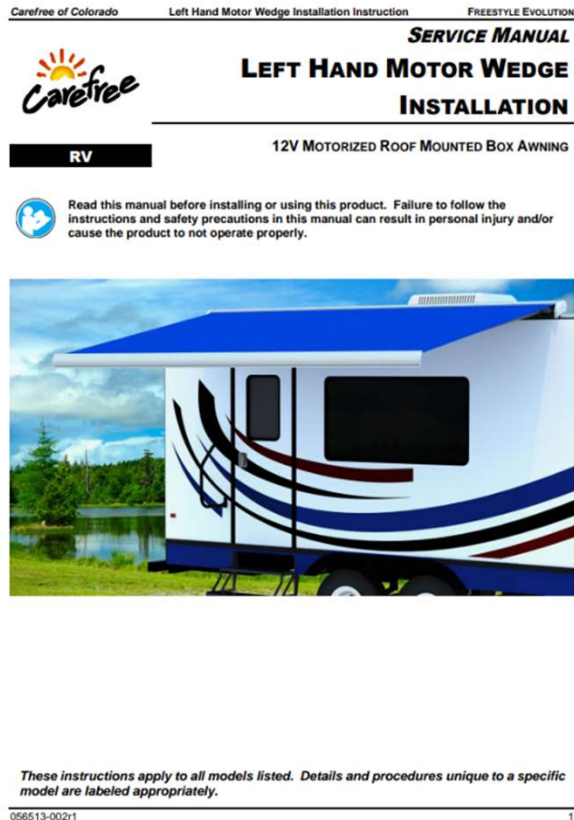
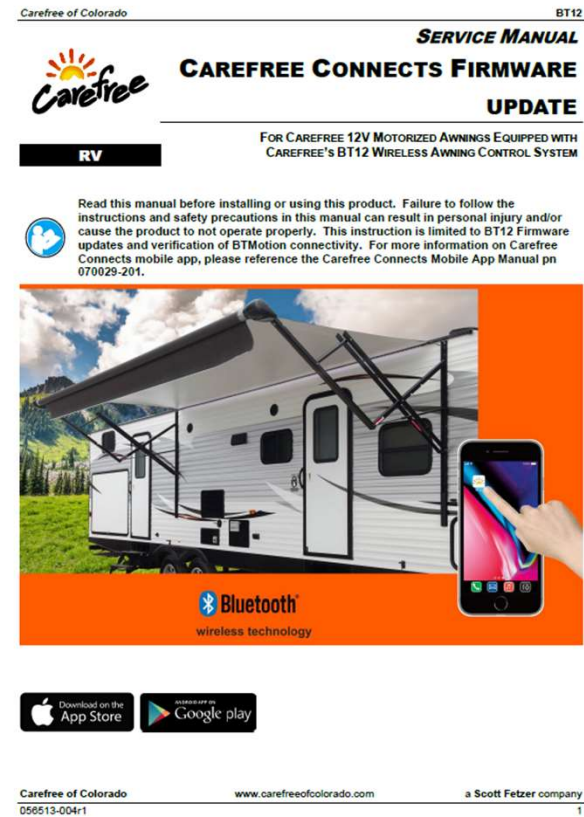
1. Review and complete the following documents, all units with a BT-12 require a firmware update.
 - Carefree Motor Wedge Installation service manual, 056513-002R1(LH) or 056513-001R5(RH) . (For angle gear awnings without a wedge already installed)
 - Carefree Connects Firmware Update service manual, 056513-004r1 (All awning with a BT-12)

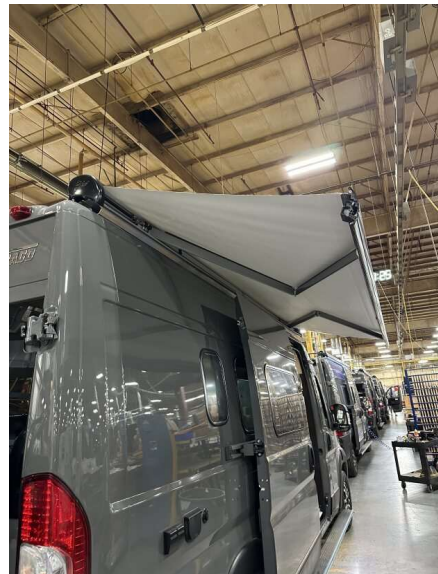
- See the chart in Image 1 and confirm that all 'With' situations result in the correct actions when the extend and retract commands are operated.
 - Note:** awning will need to be partially extended to confirm auto-retraction, see Image 2.
 - Note:** the relay module will hold the park brake signal from when the park brake is engaged until the engine is started or the module loses power. This is due to the chassis going to sleep and needing to hold the park brake signal.
- With the engine off and the parking brake and 12v coach power on, bring the awning to a partially extended position, see Image 2. Locate the edge of the awning with the wind sensor and shake the awning to simulate high winds. The awning should automatically retract when the sensor reads the awning movement.
- If all the above actions result in their defined outcomes the rework is complete.
