Technical Service Bulletin	GROUP	NUMBER
	RECALL	24-01-004G
	DATE	MODEL(S)
	JANUARY 2024	GV70 (JK1) GV80 (JX1) G80 (RG3)
SUBJECT: LOW PRESSURE FUEL PUMP REPLACEMENT (RECALL 016G)

This TSB supersedes TSB 23-01-083G to add information on page 4, step 1 to exercise caution when removing the Low-Pressure Fuel Pump Assembly from the Fuel Tank Assembly.

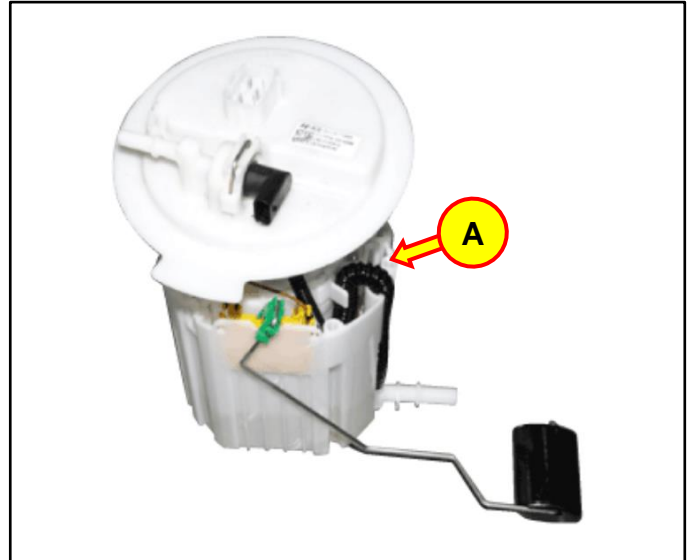
1. Remove the Low-Pressure Fuel Pump Assembly (A).

To prevent fuel spillage inside the cabin when removing the Low-Pressure Fuel Pump Assembly, place absorbent material in the surrounding area. Discard absorbent material appropriately after repairs are completed.

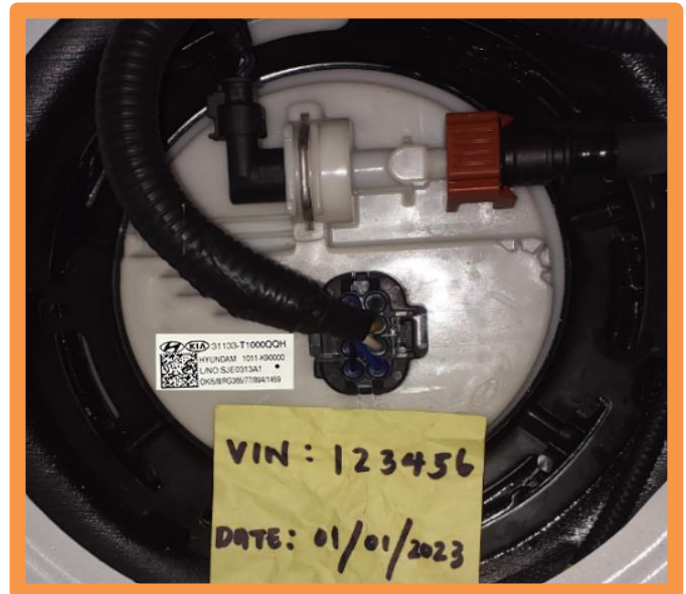
3.

Using STUI, take a photo of the New Low Pressure Fuel Pump installed on the fuel tank clearly showing the "QQH" label of the pump and a piece of paper with the last 6 digits of the VIN and date of the repair.

Upload the photo to STUI.
