GROUP	NUMBER	
GENESIS		RECALL	23-01-083G	
		DATE	MODEL(S)	
Tech	nnical Service Bulletin	OCTOBER 2023	GV70 (JK1) GV80 (JX1) G80 (RG3)	
SUBJECT: LOW PRESSURE FUEL PUMP REPLACEMENT (RECALL 016G)

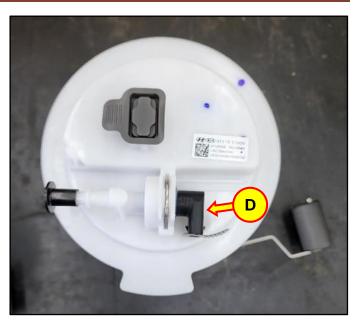
2b. For G80 (RG3):

Remove the Fuel Pressure Sensor (D) and reinstall to the **New** Fuel Pump Kit.

On G80 (RG3) vehicles, the Fuel Tank Pressure Sensor (FTPS) is mounted on the fuel tank, so removal of the FTPS is not required.

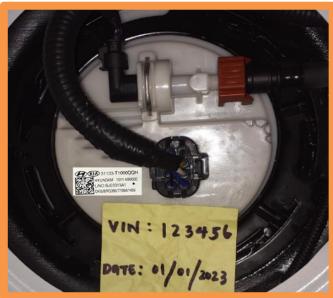
3.

Using STUI, take a photo of the New Low Pressure Fuel Pump installed on the fuel tank clearly showing the "QQH" label of the pump and a piece of paper with the last 6 digits of the VIN and date of the repair.

Upload the photo to STUI.
