Subject: RIG Set-Back Extension

Date: November 30, 2023 Rev.: FR No.: B23015

Re.: RIG Set-Back Inspection and Correction. Type: Safety

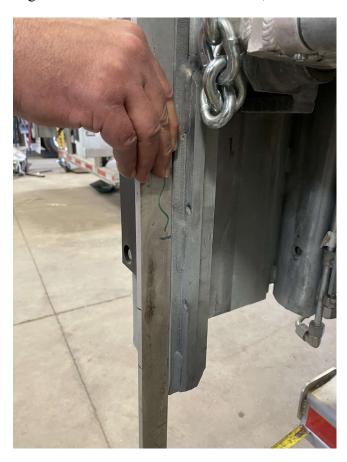
First, take a straight edge and hold it vertically against the rear most surface of the lift gate post, excluding the dock bumper. Measure the distance from the rear face of the bumper tube to the straight edge. For measurements of 12" or less, no action is required. The unit can be put back into service.

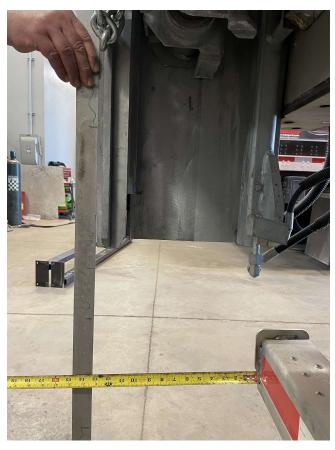
If the measurement taken is over 12 inches as shown in Fig 2, then the unit is non-compliant and needs a bumper extension installed as described in the following pages.

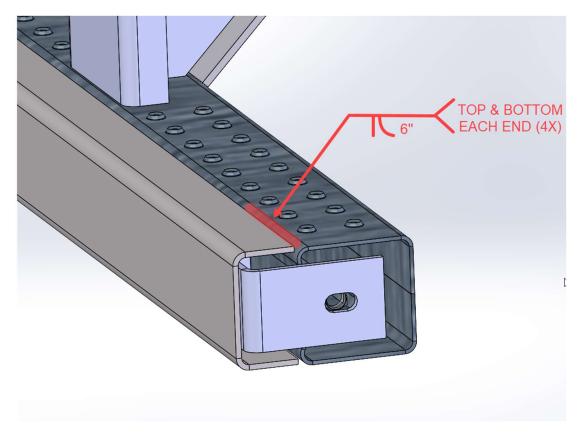
Some Stainless-Steel bumper assemblies may not have an end cap installed on the bumper tube. In this case, welding the ends of the extension to the bumper tube is an acceptable mounting solution.

It is preferred that 209 solid weld wire or stick electrode be used when welding the bumper extension to the bumper tube. Use a C Clamp to eliminate any gap between the extension and tube if necessary and place a six-inch weld top and bottom on both left and right ends where the bumper extension meets the bumper tube as shown above.
