GROUP	NUMBER
RECALL	24-01-013H
DATE	MODEL(S)
FEBRUARY 2024	KONA (SX2)

REAR SEAT BELT RETRACTOR RETAINER FASTENER PIN INSPECTION AND REPLACEMENT (RECALL 250)

**Description:** The rear lefthand and righthand seat belt assemblies in the subject vehicles may have undergone improper pin installation, potentially inhibiting extension of the seat belt webbing. An inability to fasten the seat belt in an occupied seat poses a failure to comply with Federal Motor Vehicle Safety Standard ("FMVSS") number 208, "Occupant Crash Protection," and FMVSS number 209, "Seat Belt Assemblies," increasing the risk of injury in a crash.

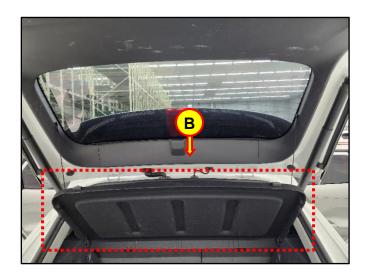
P/N: G0DKDNN039

1. Connect the VCI-II into the vehicle's DLC connector under the driver side instrument panel and connect to the VCI-II on STUI to take pictures using the borescope (A).

2. Remove the center covering shelf (B).

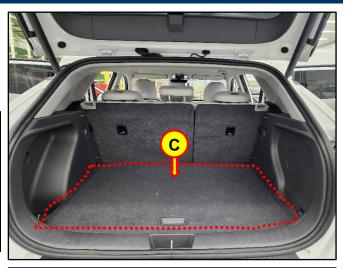
3. Remove the luggage covering mat and luggage board (C) and the rear transverse trim (D).

- 1. Remove the 2 holding clips (1) on the sides.
- 2. Carefully pry open one of the sides (2) in order to disengage the holding clip (2).
- 3. Carefully work towards the opposite side by popping the 4 retaining clips (3).
- 4. Remove trim.

Do not pull from bottom of the trim as trim may crack.

Pry open from one of the sides first and carefully pop clips to remove trim.

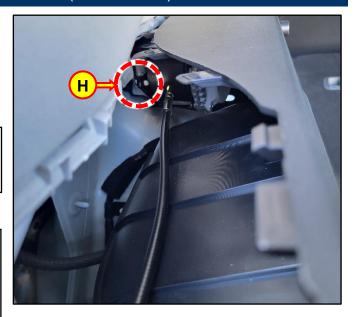
8. Open the LH luggage side trim as shown in the picture on the right to check the mounting of the retainer fastener pin (H) with the borescope camera.

Attach the 90-degree camera lens on the borescope for best view of the fastener pins. There were two camera lenses (a straight and a 90-degree lens) included in the initial borescope kit to dealers.

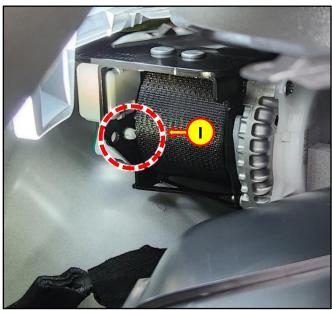
Using the borescope camera, check the LH rear seat retainer fastener pin (I) is mounted.

View to the fastener pin is partially obstructed by the seat belt webbing when fully retracted.

Extending seat belt out will provide better visibility to the fastener pin.

Sample to the right is a 'Good' photo using the GIT borescope.

A 'No Good' photo would have the pin missing in the center.

10. If retainer fastener pins are installed, then reassemble in the reverse order to complete the procedure for the LH.

If fastener pins are missing, follow procedure in Step II to replace the rear seat belt after inspection of RH seat belt fastener pins.

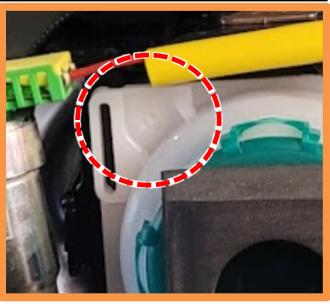
Take a photo of the RH rear seat retainer fastener pin using the borescope and upload to STUI.

Sample to the right is a 'Good' photo using the GIT borescope.

A 'No Good' photo would have the pin missing in the center.

**Note**: The `Good' and `No Good' views are for reference only. They show if the pins are installed (good) and if pins are not installed (no good) if the panel is removed.

13. If retainer fastener pins are installed, then reassemble in the reverse order to complete the inspection procedure.

Continue to Step II to replace the rear seat belt(s) if necessary.

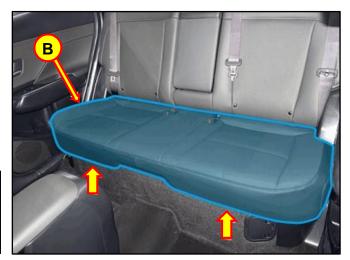
15. Remove the rear seat cushion assembly (B).
