Technical Service Bulletin

GROUP
RECALL

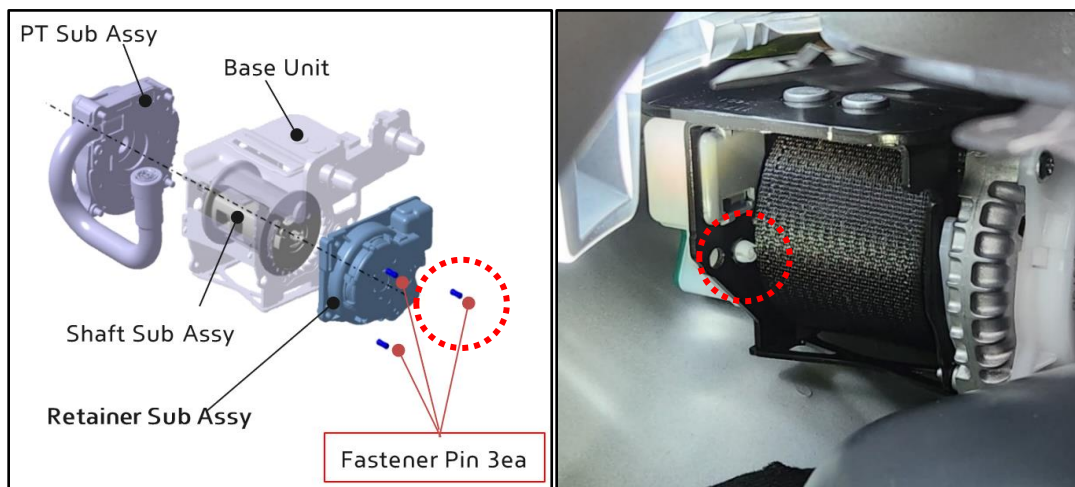
Applicable Vehicles (Certain):

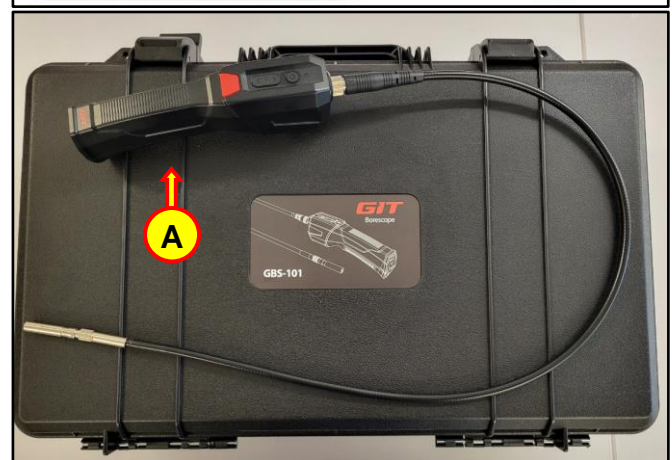
For technical assistance or replacement parts, contact GIT America at (888) 437-0308.

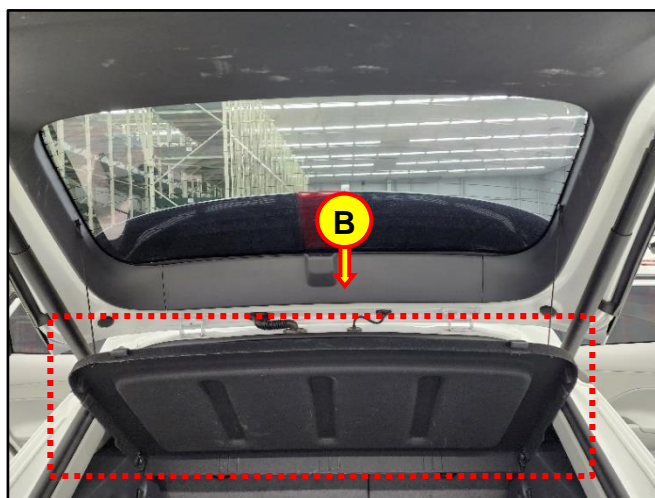
3. Remove the luggage covering mat and luggage board (C) and the rear transverse trim (D).

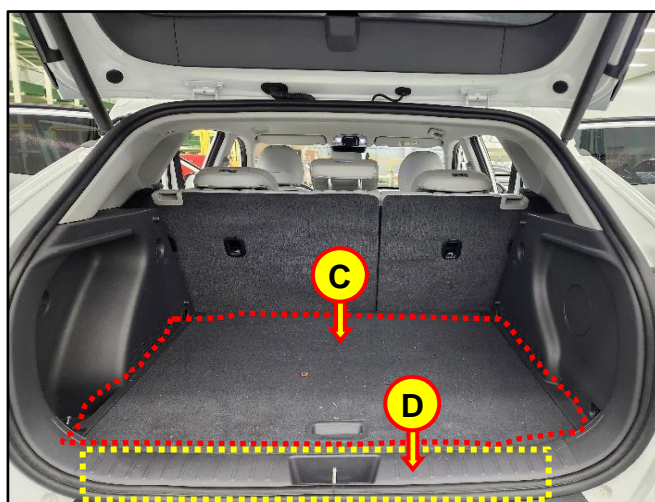
4. Fold the LH/RH rear seat as shown on the right (E).

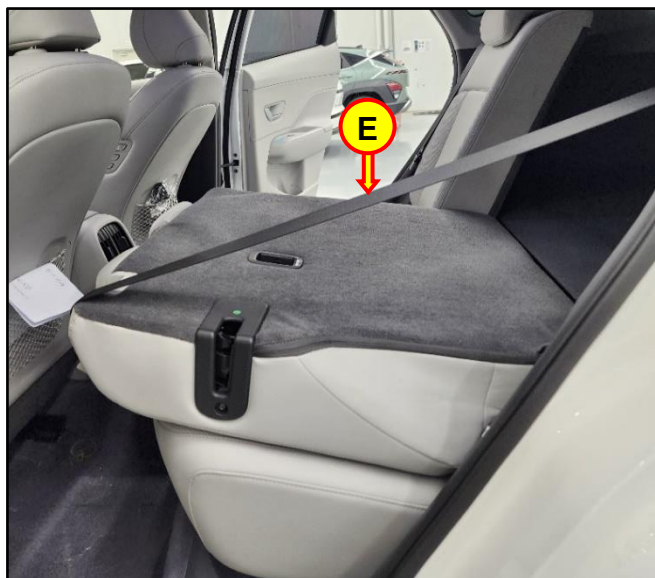
**SUBJECT: REAR SEAT BELT RETRACTOR RETAINER FASTENER PIN
INSPECTION AND REPLACEMENT (RECALL 250)**

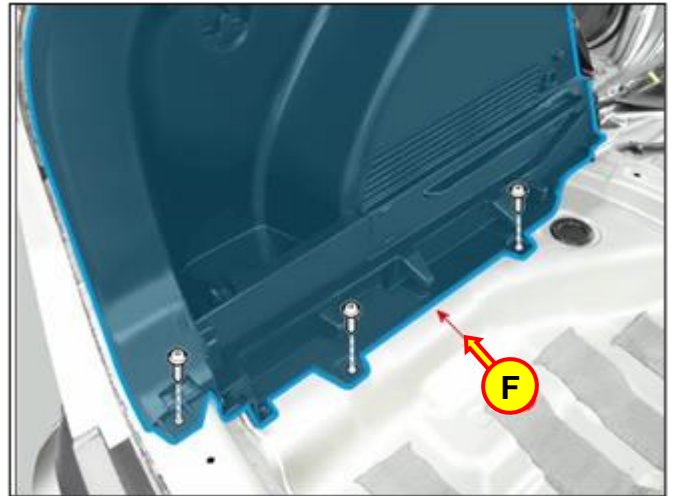
6. Remove the RH luggage side trim fixing screws (G).

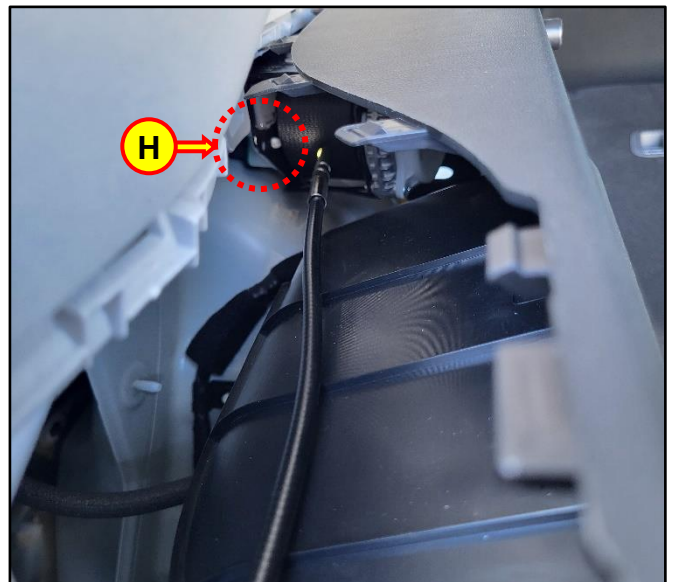
SUBJECT: REAR SEAT BELT RETRACTOR RETAINER FASTENER PIN INSPECTION AND REPLACEMENT (RECALL 250)

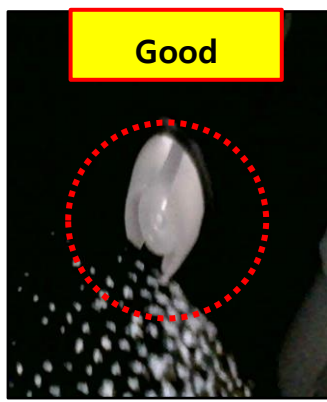
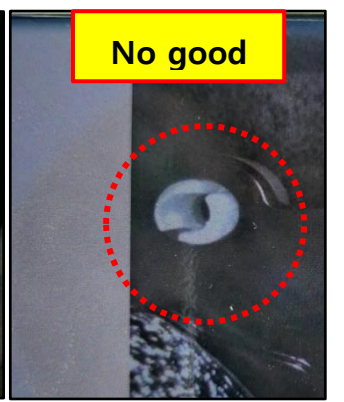
**SUBJECT: REAR SEAT BELT RETRACTOR RETAINER FASTENER PIN
INSPECTION AND REPLACEMENT (RECALL 250)**

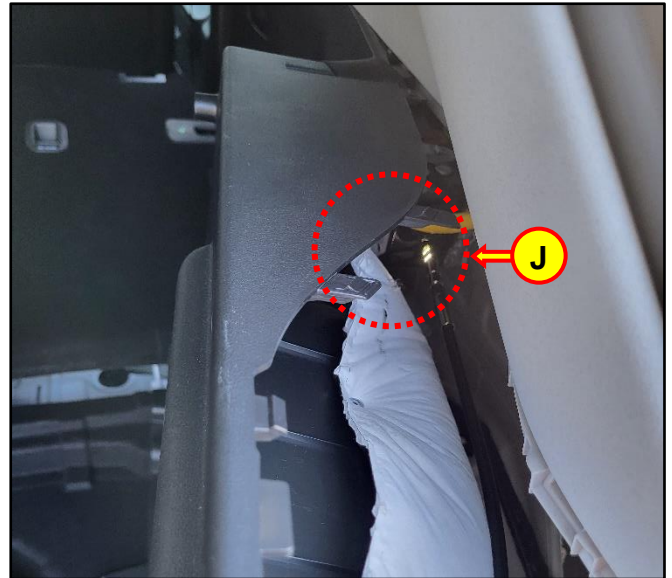
11. Check the installation of the RH rear seat retainer fastener pin (K) using the borescope camera.

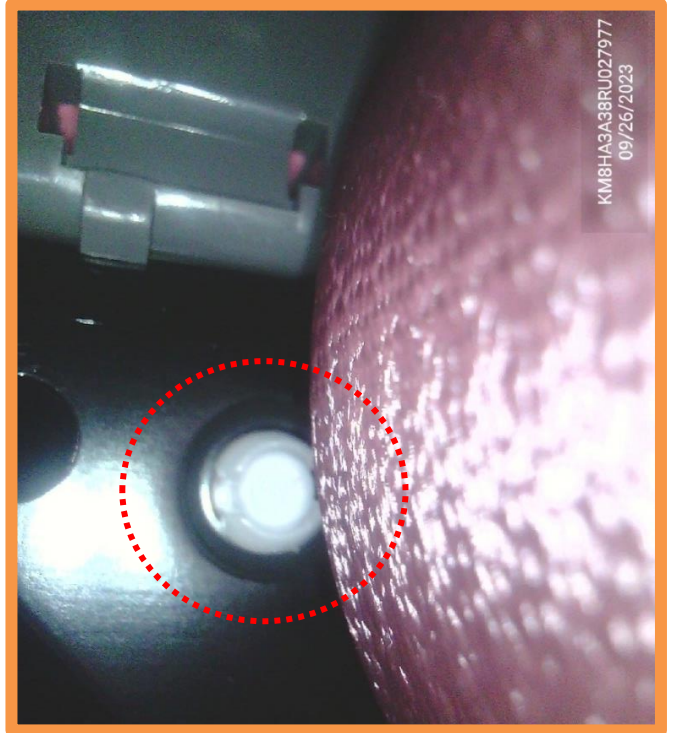
12. If retainer fastener pins are installed, then reassemble in the reverse order to complete the inspection procedure.

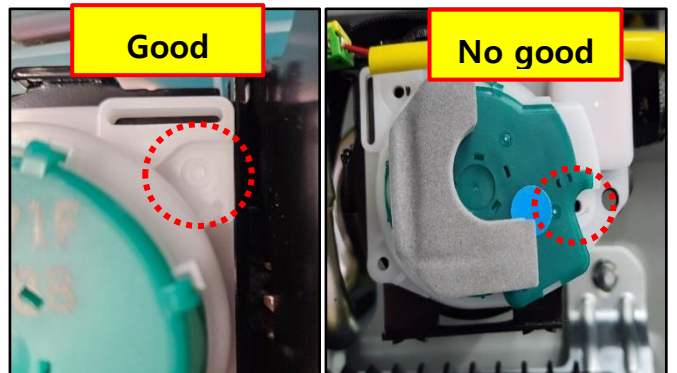
II. REAR SEAT BELT REPLACEMENT PROCEDURE

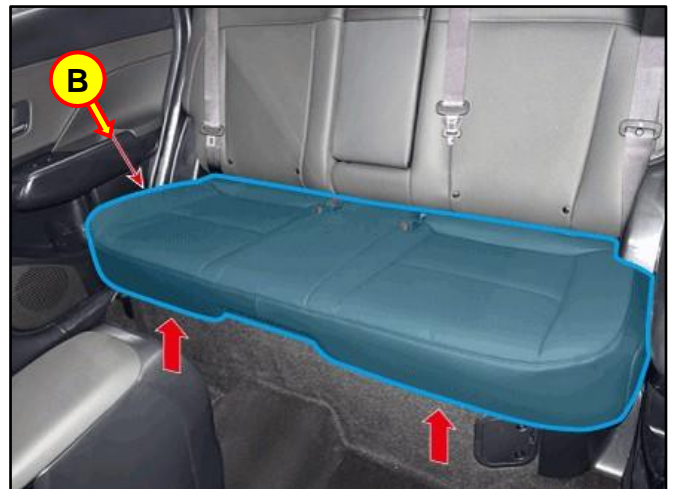
SUBJECT: REAR SEAT BELT RETRACTOR RETAINER FASTENER PIN INSPECTION AND REPLACEMENT (RECALL 250)

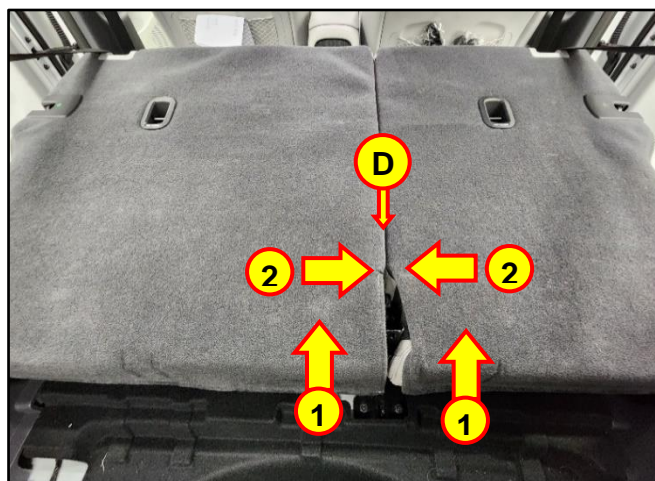
16. Remove the LH/RH rear seat to the side by lifting it in the direction of the right arrow on the picture (D).

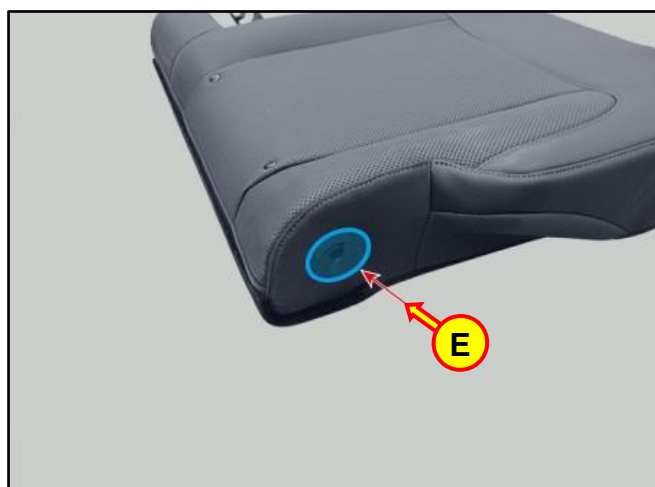
SUBJECT: REAR SEAT BELT RETRACTOR RETAINER FASTENER PIN INSPECTION AND REPLACEMENT (RECALL 250)

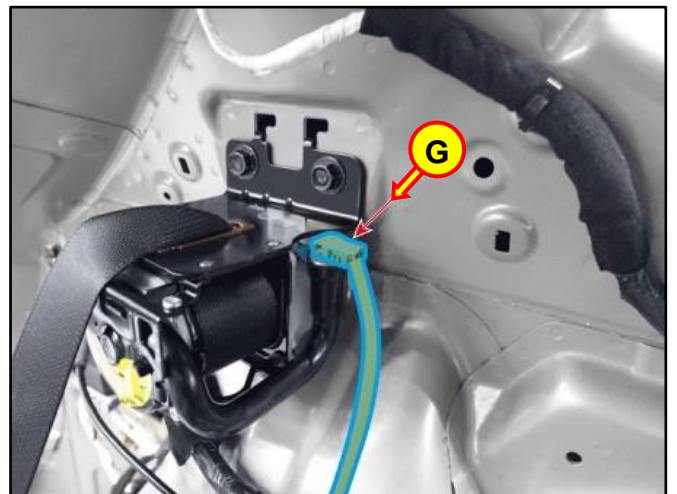
19. Loosen the mounting bolts and remove the rear seat belt retractor (H).

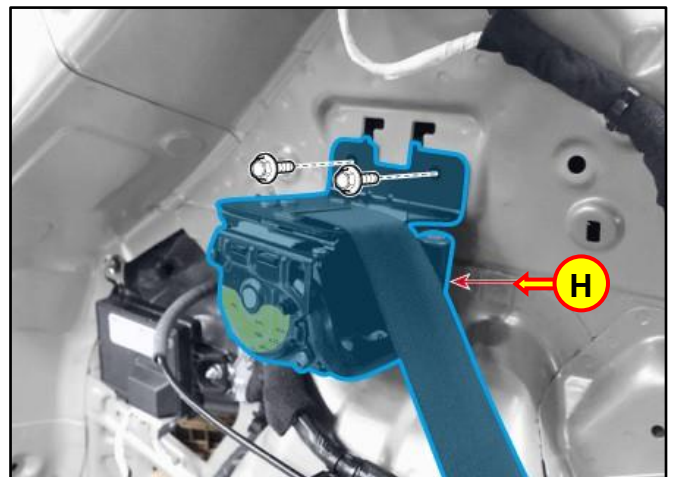
SUBJECT: REAR SEAT BELT RETRACTOR RETAINER FASTENER PIN INSPECTION AND REPLACEMENT (RECALL 250)

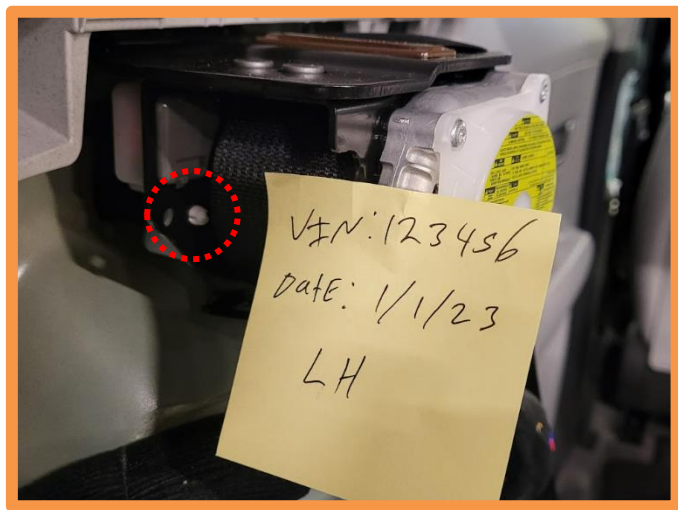
Upload the photo to STUI.
