GROUP	MODEL
Safety Recall Campaign	2011-2015MY Optima (TF)
NUMBER	DATE
SC284TF	May 2024

HECU MULTI FUSE REPLACEMENT (SC284TF)

This bulletin provides information to replace the multi fuse of the Hydraulic Electronic Control Unit (HECU) and junction box fuse cover and install an updated junction box label on certain 2011-2015MY Optima (TF) vehicles produced from August 12, 2010 to July 23, 2015. An engine compartment fire may occur in the area where the HECU is located. The HECU may experience an internal electrical short circuit condition that can result in overcurrent, thereby increasing the risk of an engine compartment fire while the vehicle is driven or while parked. Dealers are to install new fuses to prevent an electrical short circuit condition in the HECU's electrical circuit board. Customers may experience illumination of the Malfunction Indicator Lamp (MIL), ABS warning light, burning/melting smell, and/or smoke from the engine compartment. Follow the procedure outlined in this publication to install a new multi fuse, junction box fuse cover and label on the applicable vehicle. Before conducting the procedure, verify that the vehicle is included in the list of affected V

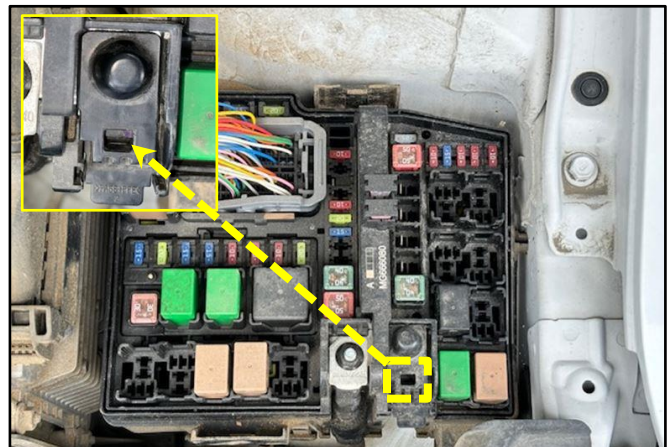
4. Disengage the clip and pull up to remove the bolt cover (A).

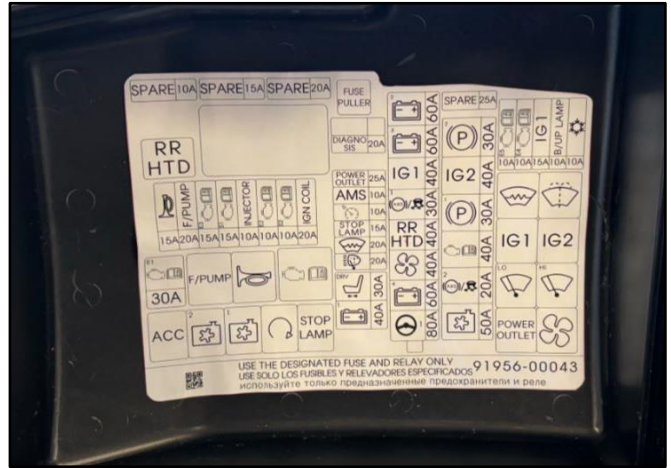
6. Adhere the new fuse label to the bottom of the new junction box fuse cover, as shown.
