GROUP	MODEL
Safety Recall Campaign	2011-2013MY Optima Hybrid (TF HEV)
NUMBER	DATE
SC284TE (Rev 1, 10/01/2024)	May 2024

### HECU MULTI FUSE REPLACEMENT (SC284TE)

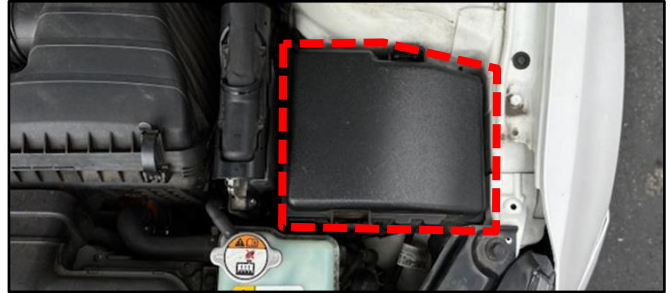
1. Open the hood.
2. Disconnect the negative (-) battery terminal.
3. Remove and discard the junction box fuse cover.

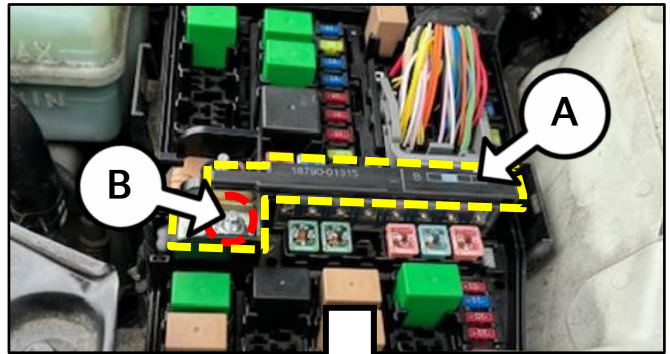
- 4a. Locate the Multi Fuse (A) for ESC1 and loosen the 10mm Multi Fuse retaining nut (B) and remove the Multi Fuse.

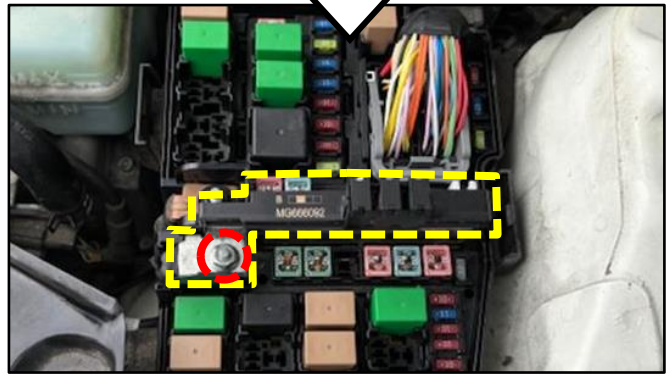
- 4b. Install the new Multi Fuse (A) and tighten the retaining nut (B).

Note: There are 2 different new multi-fuse designs. They are interchangeable.

**Tightening torque for retaining nut (B):**  
7.2 - 8.7 lb.ft (9.8 - 11.8 N.m)

**Note: Drill a hole through the center of the removed Multi Fuse. DO NOT reuse.**

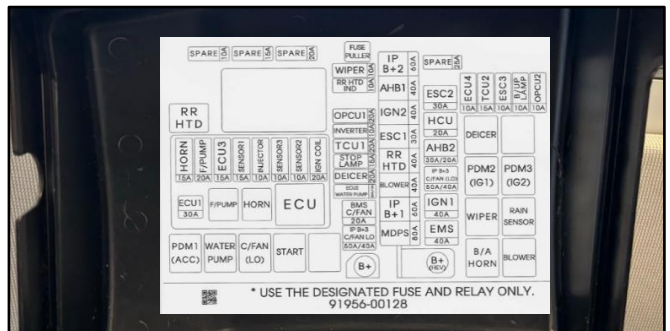
5. Adhere the new fuse label to the bottom of the new junction box fuse cover, as shown.
