GROUP	MODEL
Safety Recall Campaign	2012-2013MY Optima (QF)
NUMBER	DATE
SC284QF (Rev 1, 9/25/2024)	April 2024

HECU MULTI FUSE REPLACEMENT (SC284QF)

This bulletin provides information to replace the multi fuse of the Hydraulic Electronic Control Unit (HECU) and install an updated junction box label on certain 2012-2013MY Optima (QF) vehicles produced from August 12, 2011 through July 11, 2013. An engine compartment fire may occur in the area where the HECU is located. The HECU may experience an internal electrical short circuit condition that can result in overcurrent, thereby increasing the risk of an engine compartment fire while the vehicle is driven or while parked. Dealers are to install new fuses to prevent an electrical short circuit condition in the HECU's electrical circuit board. Customers may experience illumination of the Malfunction Indicator Lamp (MIL), ABS warning light, burning/melting smell, and/or smoke from the engine compartment. Follow the procedure outlined in this publication to install a new multi fuse and junction box cover label on the applicable vehicle. Before conducting the procedure, verify that the vehicle is included in the list of affected VINs.

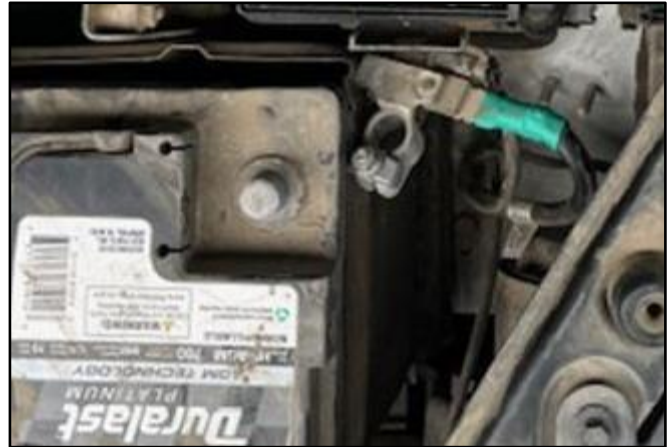
2. Disconnect the negative (-) battery terminal.

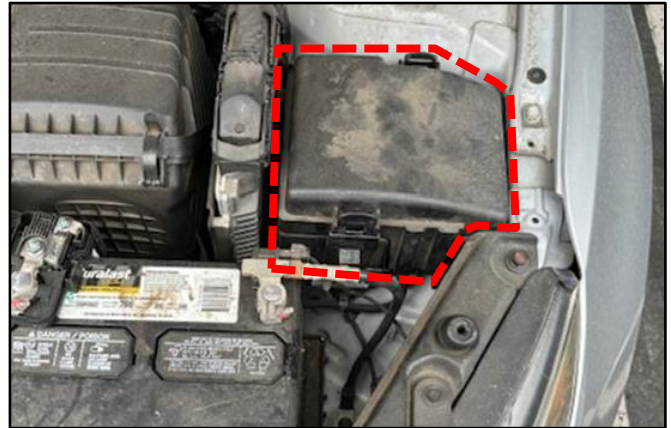
3. Remove and discard the junction box fuse cover.

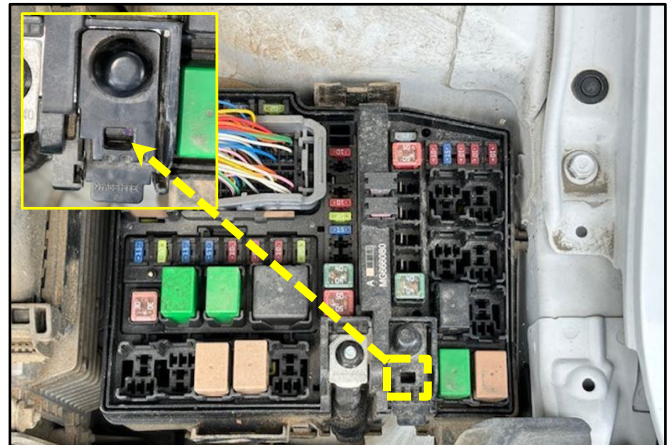
4. Disengage the clip and pull up to remove the bolt cover (A).

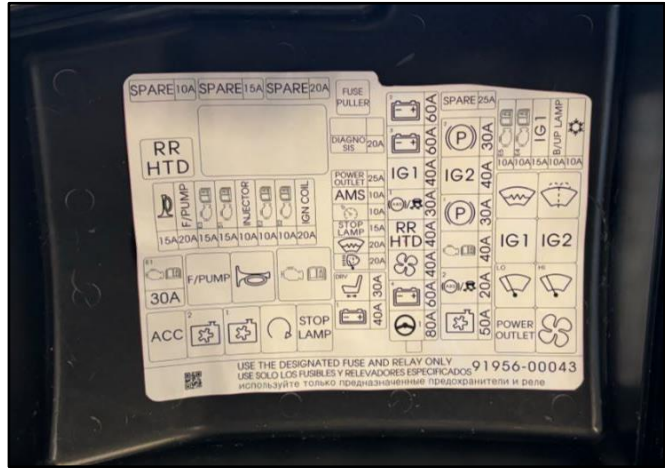
- 6. Adhere the new fuse label to the bottom of the new junction box fuse cover, as shown.
