SAFETY RECALL

SR23-85

EMERGENCY EXITS DECALS
9700 (B13R)

On the vehicles affected by this recall, certain emergency window exit identification and operating instructions labels could be absent.

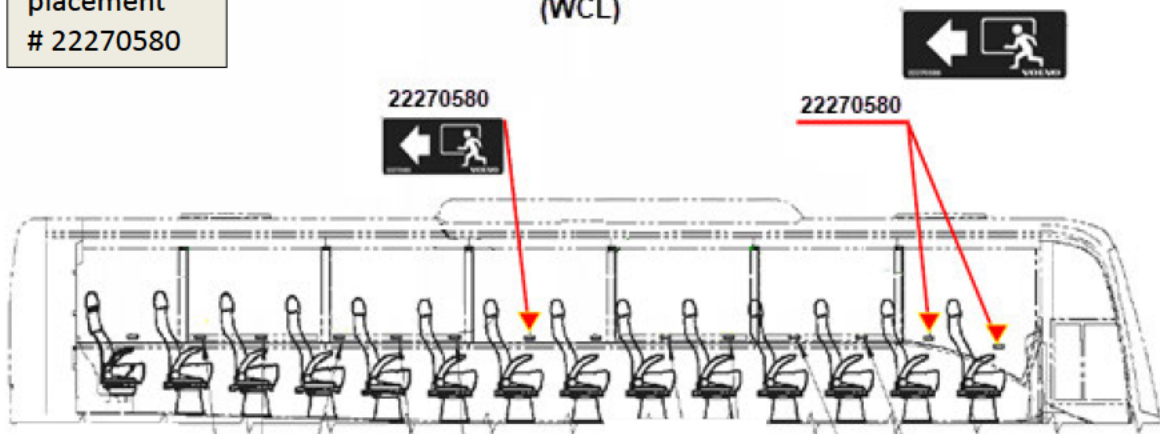
LEFT SIDE INTERIOR WITHOUT WHEELCHAIR LIFT (WCL)

Note: Decals placement # 22270580

1. Clean the area where the decals are going to be installed using an appropriate product (alcohol or residue free cleaner).

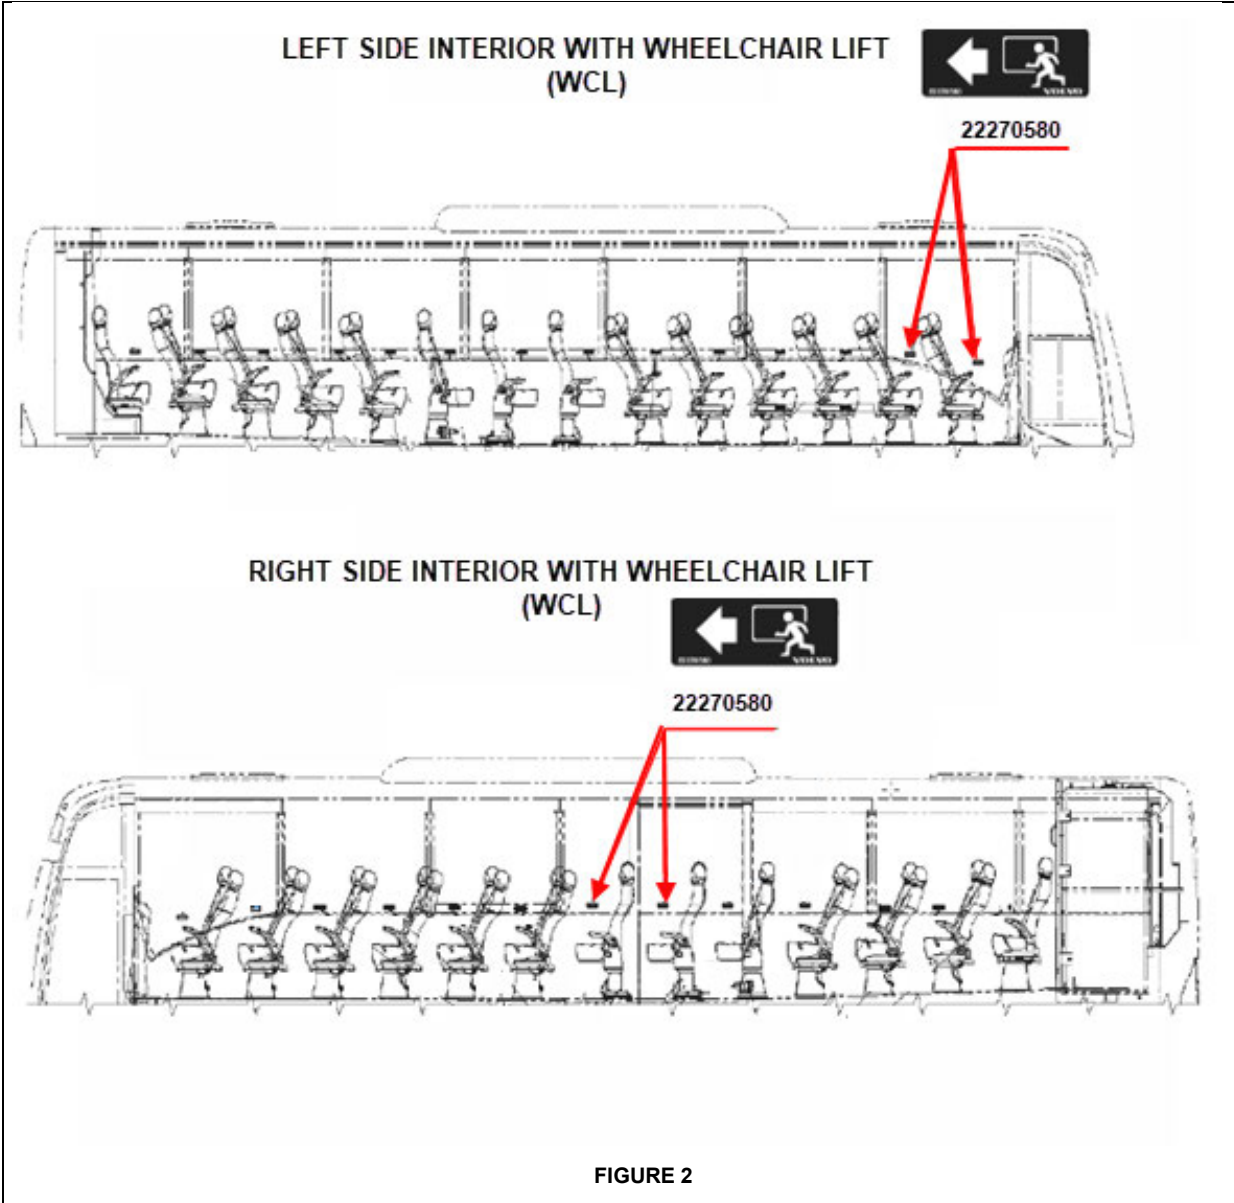
FIGURE 1

Emergency Exit Decals 22270580 Position

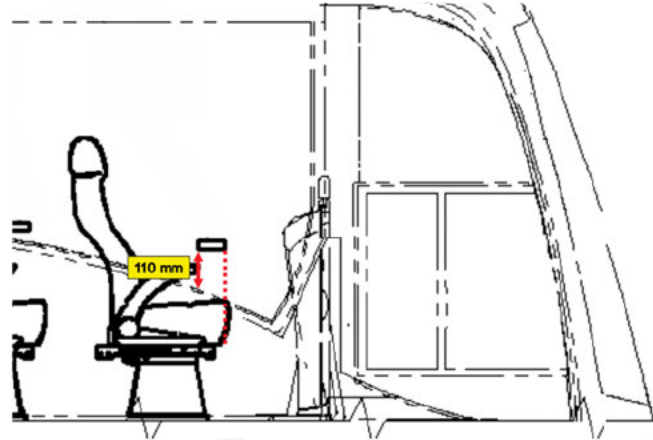
FIGURE 3

2. Install the decal on the first seats row according to the illustration.

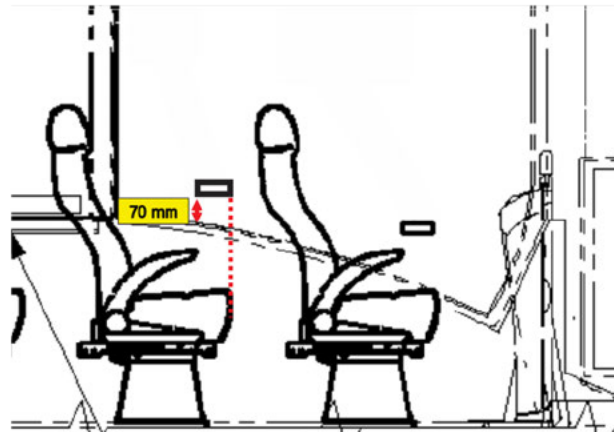
FIGURE 4

3. Install the decal on the first seats row according to the illustration.

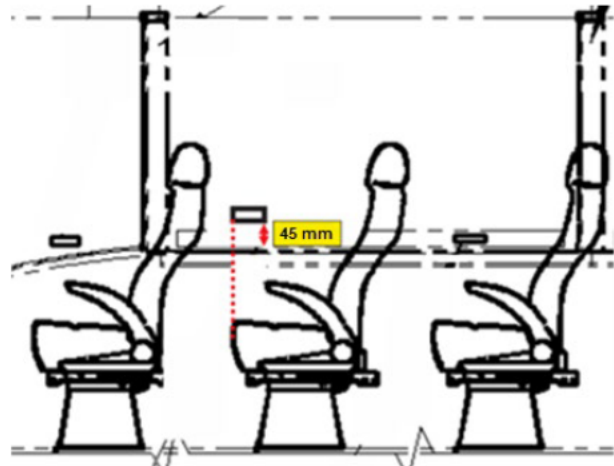
FIGURE 5

4. Install the decals between seats using as reference the seat edge and the cover as shown.

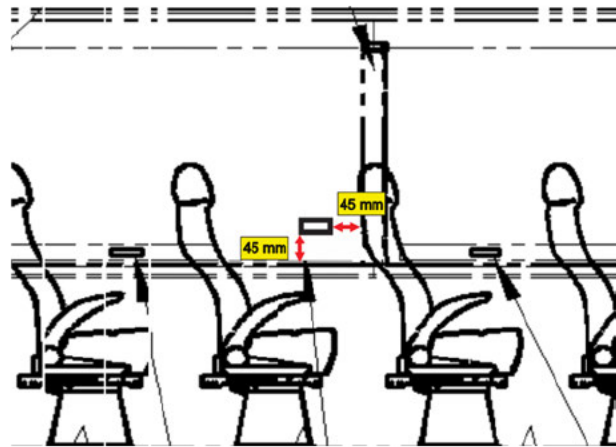
FIGURE 6

5. Install the decals between seats using as reference the seat edge and the cover as shown.

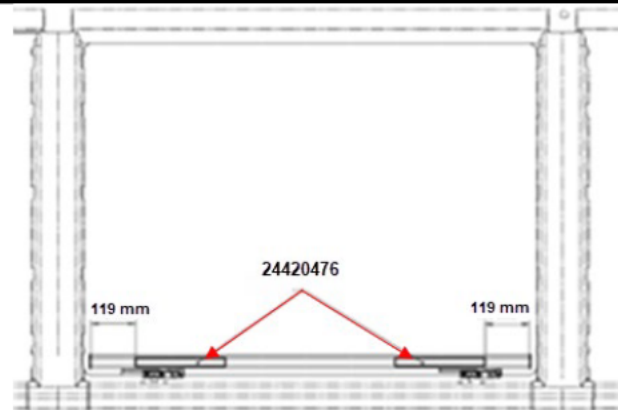
FIGURE 7

1. Clean the emergency window mechanism surfaces where the decals are going to be installed using an appropriate product (alcohol or residue free cleaner).
2. Position two Emergency Window Decals ENG/SPA on each emergency window mechanism as in the image.
