Emergency Window Shade

Bulletin Type:	Recall	Publication Date:	October 2023
Bulletin #(s):	23V-673 USA 2023-536 Canada	Make(s):	Jayco Entegra Coach
Job Code(s):	9903592	Model(s):	Precept (36A, 36C) Vision XL (36A, 36C)
Flat Rate(s):	9903592A .10 HR – Egress Window Valance/Shade Inspection 9903592B .60 HR – Egress Window Valance/Shade Inspection and Replacement	Model Year(s):	2024

Incident:	Installed cassette window shade reduced opening of the window. The opening size was not large enough to meet egress requirements.	
Affected Units:	2024 Jayco Precept; Entegra coach Vision XL 36A-UA/36C-UC units with cassette shade mounted in the rear passenger side slideout.	
Parts List:	Parts Kit: 23V-673Kit1	Serial Numbers Affected
	<p><u>36A (UA) Dover Wooden Valance Assembly:</u> 1 – VALANCE,35X2.5(1)(3UA)(4UA) – Dover 1 – SHADE,NIGHT 32.00X24.00 BLK SBN 3 - SCREW,PAN QUAD 10.00X1.00 A ZC 2 - SCREW,RW QUAD 8.00X1.75 .67 DT 17 STAT BRNZ0207792 1 - SCREW,RW QUAD 8.00X1.25 .67 DT STAT BRNZ 2 - SCREW,PAN QUAD 6.00X1.25 DT PL T17</p>	<p>1UJMJABU9R1UA4051 1JSMEABU0R1UA8058 1JSMEABU2R1UA8059</p>

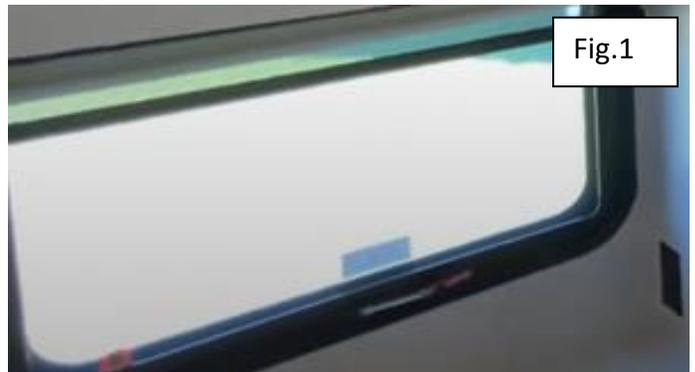
Fig.1

1. Proceed to the instructions if the egress window has a cassette shade as shown in Figure 1.

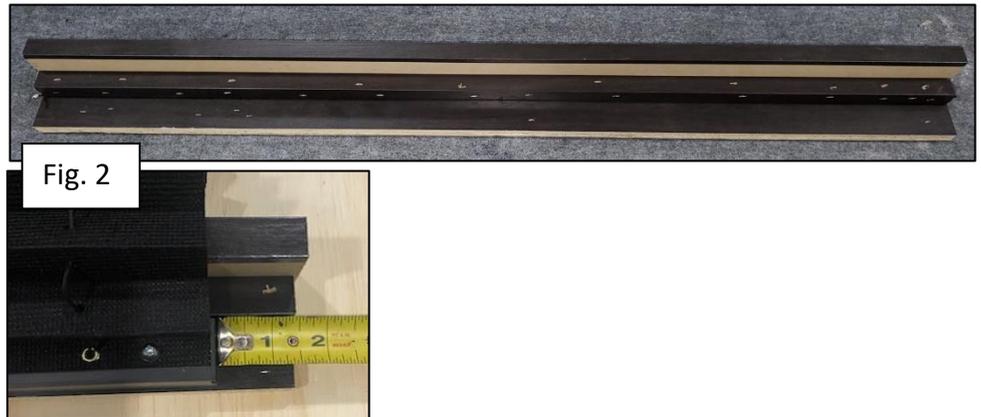
Fig. 2

1. Shade Prep: Using a screwgun with square bit, secure the shade to the wooden valance assembly – three locations. NOTE: the shade should be centered on the wooden valance assembly – approximately 1-1/2” from each end. (Fig. 2)

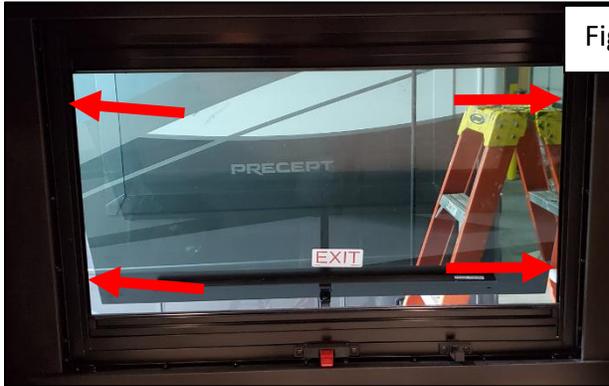
Fig. 3

- a. With a screwgun and phillips bit, locate and remove the (3) fasteners securing the cassette window shade (Fig. 2) to the window track. NOTE: The fastener will need to be completely removed. An additional screwdriver may be needed. (Fig. 4)

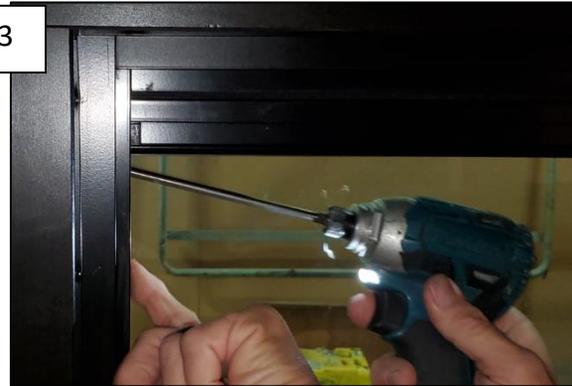
Fig. 5

- b. Open the window and lock into the open position. (Fig. 5)
- c. Remove the cassette shade: Push out the lower corner, pull down on the upper corner and slide the shade out of the window track. (Fig. 6)

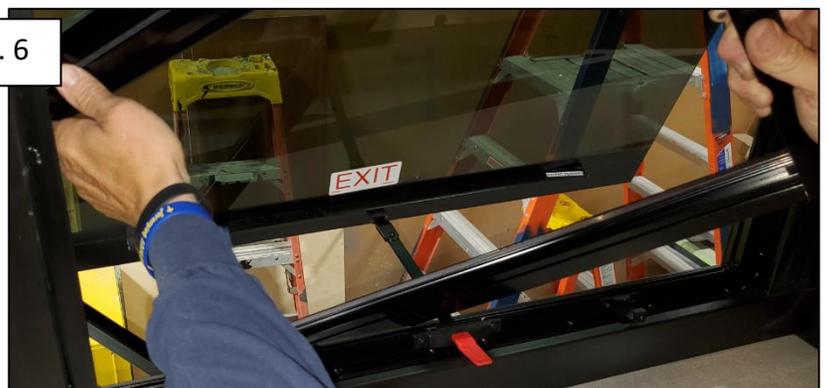
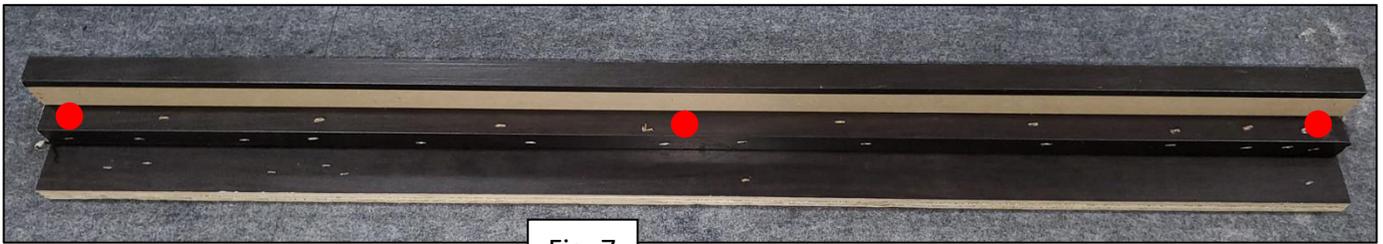
Fig. 7

- a. With a screwgun and square bit, secure each end of the wooden valance assembly with a 2-1/2" screw – through the 1x1. (Fig. 7)

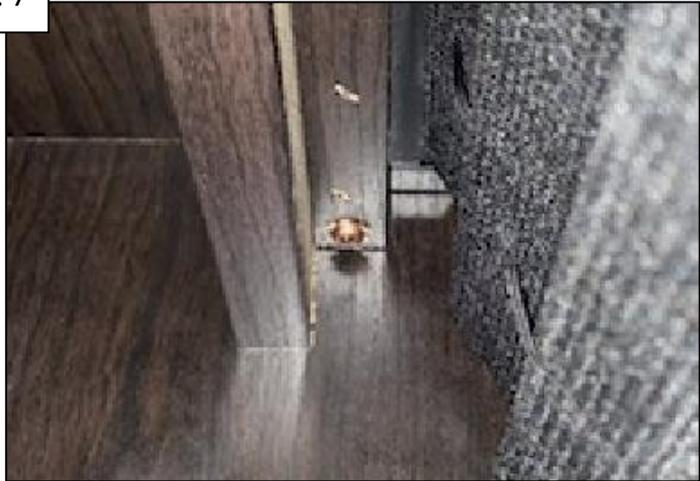
- b. Lift the shade and secure the strings to the lower hardwood stile. (Fig. 8)
- 4. Verify the shade moves freely to the Up and Down positions. (Fig. 9)
