# Recall Campaign Bulletin

Campaign No. 2023100011, October 2023

SUBJECT: **Model EQB (243 platform)**  
**Model Year 2022**

## **Replace Child Seat Anchor Covers on the Second-Row Seats**

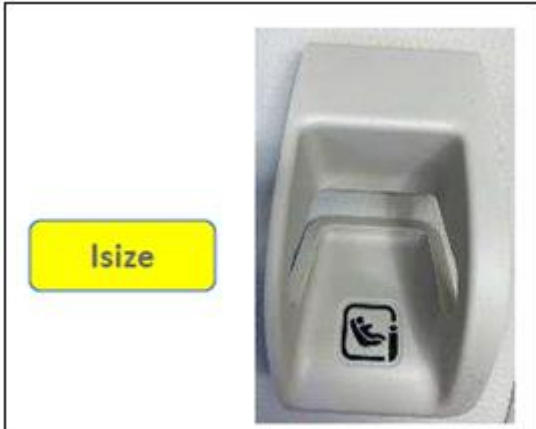
**Picture 1**  
Code 8U8: **Not OK** (i-Size version)

- a. Installed child seat anchor covers type: Isize (**Picture 1**): Carry out **work procedure**.
- b. Installed child seat anchor covers type: ISOFIX (**Picture 2**): **End measure**.

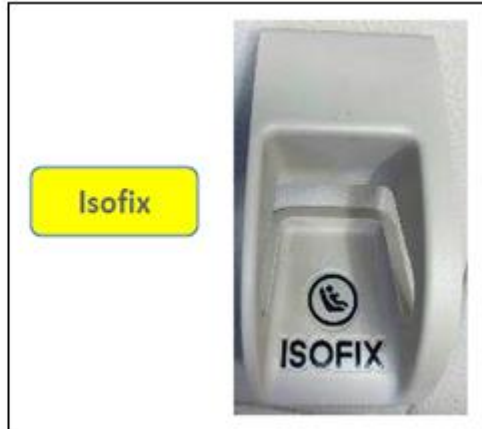
**Picture 2**  
WITHOUT code 8U8: **OK** (Isofix version)

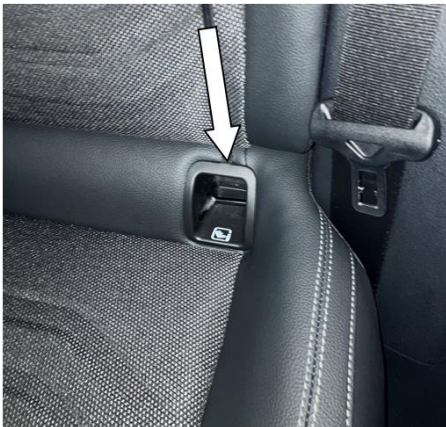
**Figure 3**

**i** Use a suitable tool to release and remove the child seat anchor covers in the area of the arrow (**Figure 3**).
