# Safety Recall

## N232420460 B-Pillar Trim May Interfere with Roof Rail Airbag Deployment

**Release Date:** November 2023

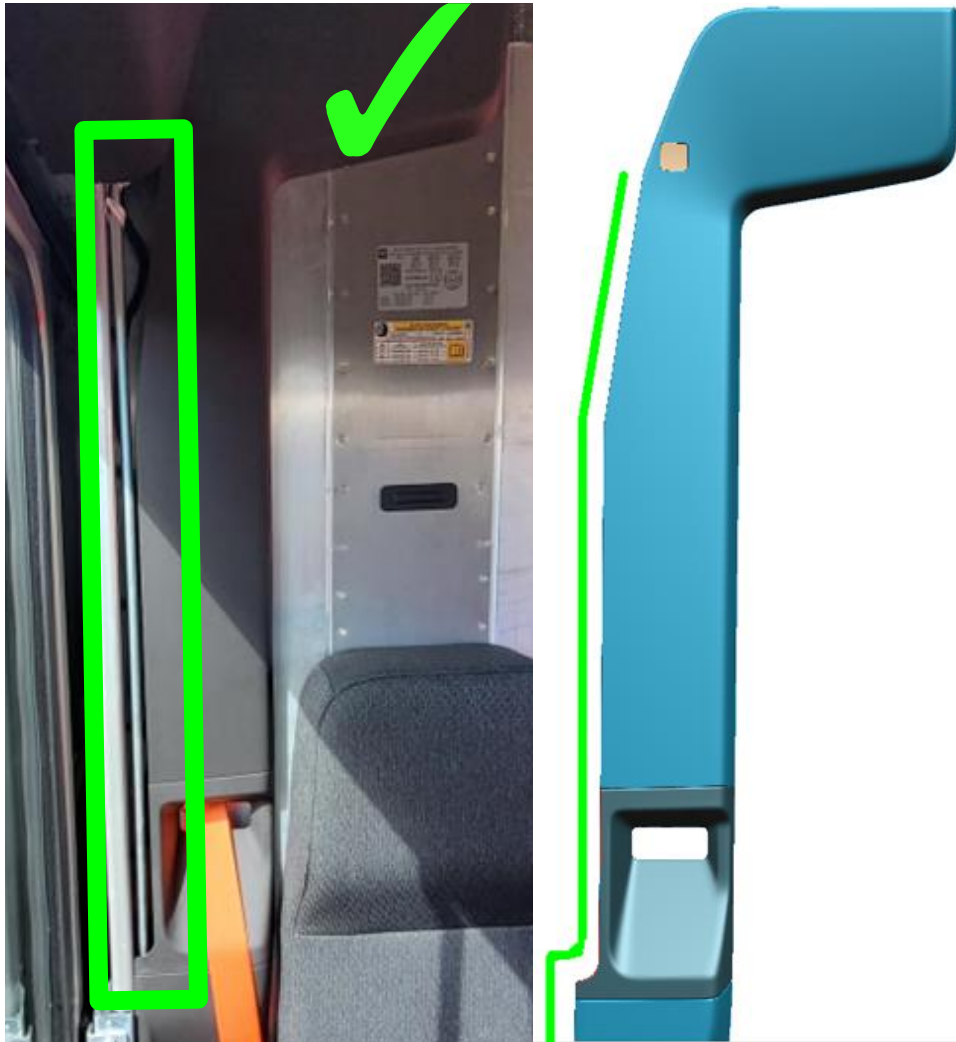
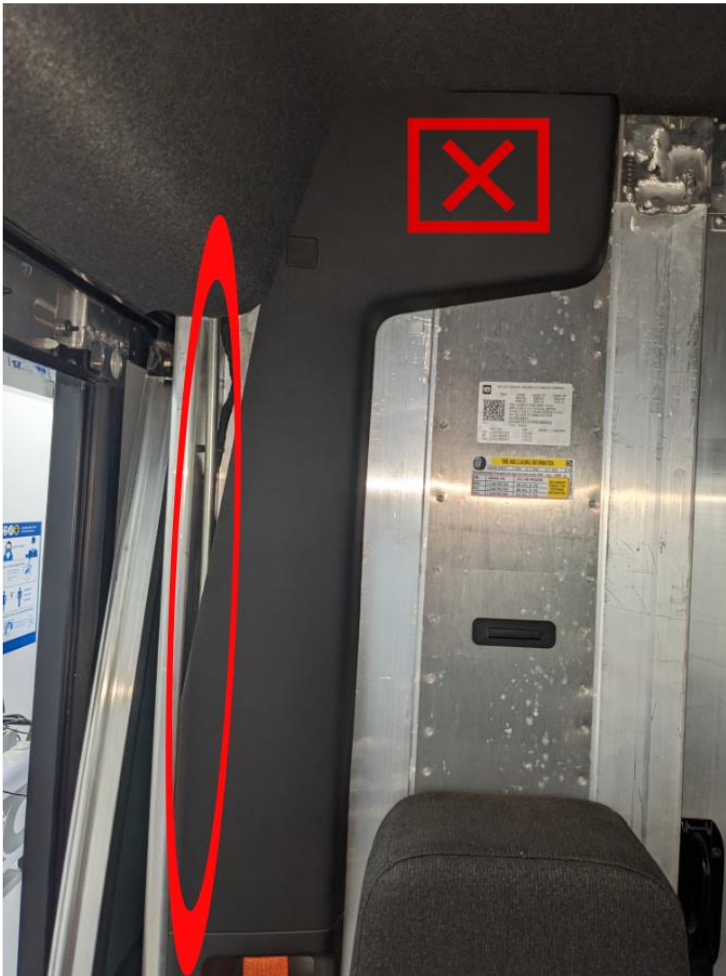
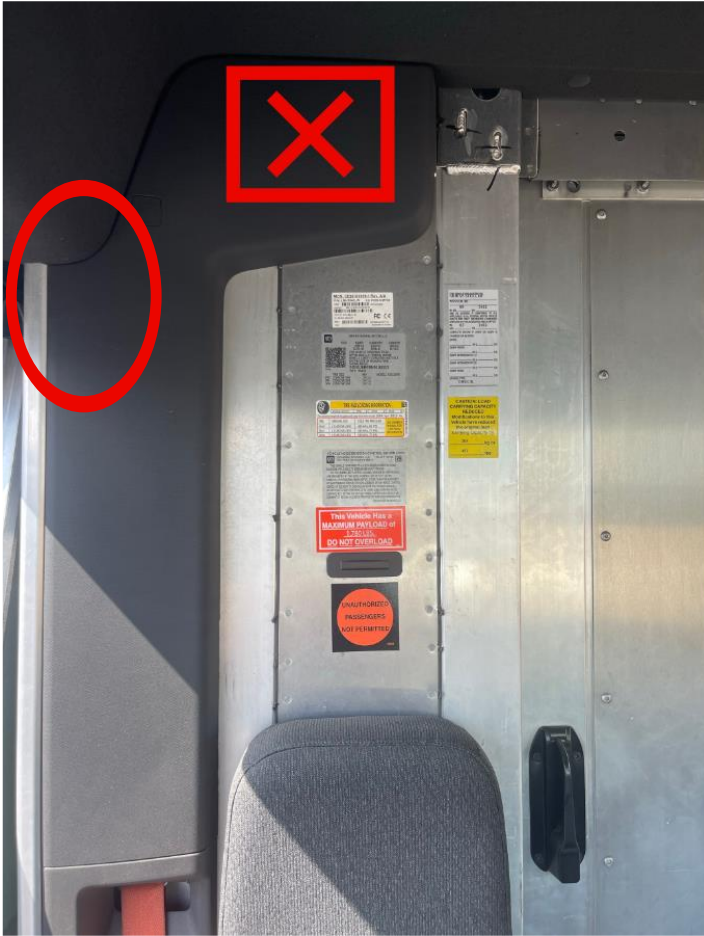
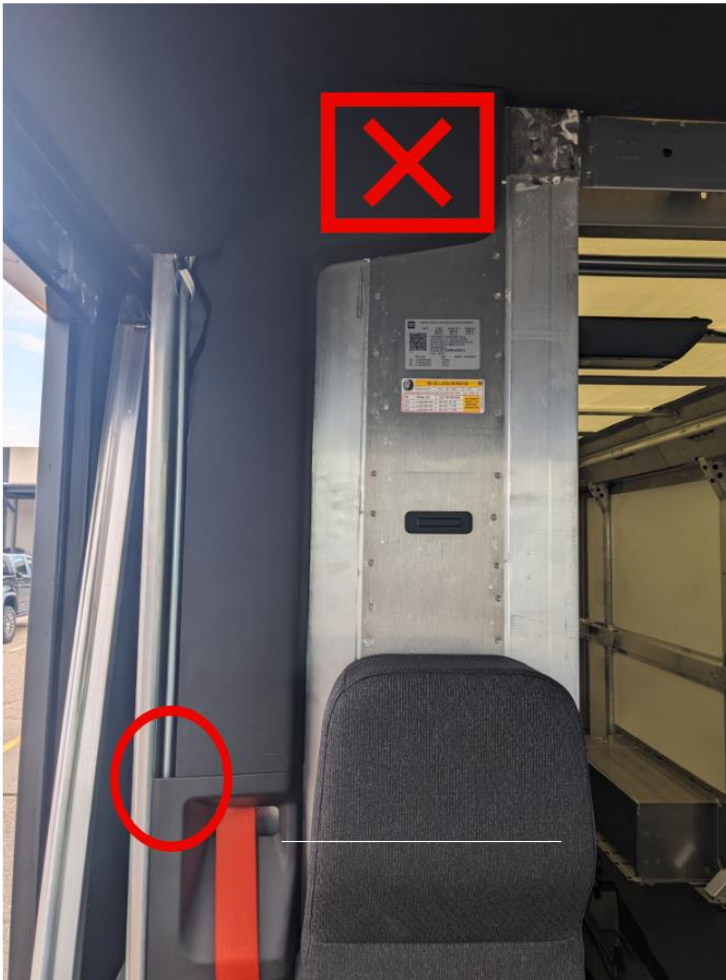
1. Inspect the B pillar trim panel on the passenger's side to determine if it is the correct variant per the above pictures.
  - If the B pillar trim panel is diagonally trimmed in the top left corner AND the airbag rail is visible all the way down to the bottom of the seatbelt bezel portion of the trim panel, no further action is required.

- If the B pillar trim panel has any of the following conditions, replace it. Refer to *Center Pillar Upper Trim Panel Replacement - Right Side* in SI.

- i. The B pillar trim panel is diagonally trimmed in the upper left portion, but the airbag rail is NOT visible all the way down to the bottom of the seatbelt bezel portion of the panel.

- ii. The B pillar trim panel not trimmed at all in the upper left portion, and the airbag rail is not visible at all.
    - iii. The B pillar trim panel is diagonally trimmed and the airbag rail is visible, but only to the TOP of the seatbelt bezel portion of the panel.
