GROUP	MODEL
Safety Recall Campaign	2009-2014MY Borrego (HM)
NUMBER	DATE
SC286	November 2023

### ADHESIVE TAPE APPLICATION ON HEADLINER PLATES (SC286)

This bulletin provides information to further secure the headliner plates with industrial-grade adhesive tape on all 2009-2014MY Borrego (HM) vehicles produced from May 02, 2008 through May 14, 2013. The subject vehicles are equipped with headliner plates designed as part of the energy absorbing structure of the headliner. Under certain circumstances, the headliner plate(s) may detach from the headliner upon deployment of the side curtain airbags thereby increasing the risk of injury to the vehicle occupants. Follow the procedure outlined in this publication to add the supplied adhesive tape in the specified locations on the applicable vehicle. Before conducting the procedure, verify that the vehicle is included in the list of affected VINs.

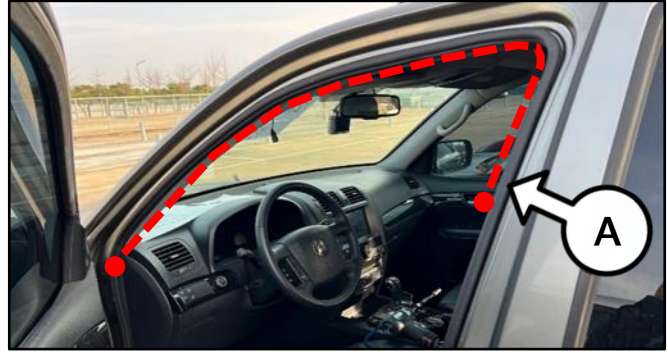
1. Open the left (driver) front door and partially detach the door weatherstrip (A).

Wear disposable latex gloves to prevent soiling the headliner.

Be careful not to damage trim panels or covers while removing/installing

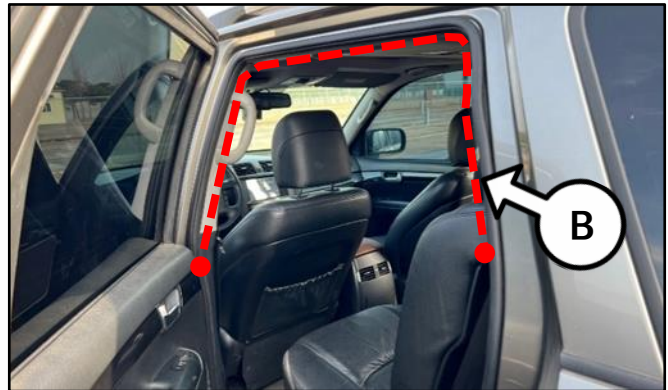
2. Open the left rear door and partially detach the door weatherstrip (B).

Use a non-marring trim removal tool (such as Snap-on® Part Number PBN5 or equivalent) to avoid damaging trim pieces.

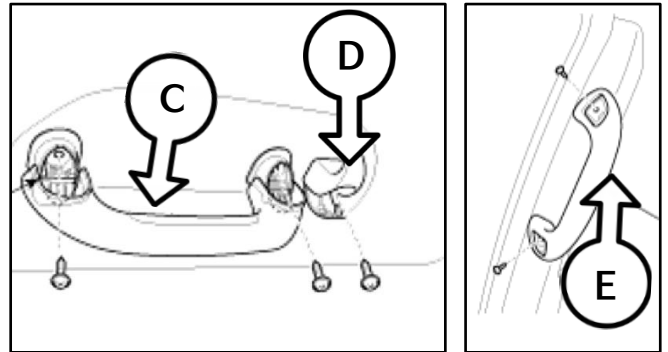
- 3a. Loosen the two (2) screws to remove the assist handle (C).
- 3b. Loosen the screw to remove the hook (D).
4. Loosen the two (2) screws to remove the gate grip handle (E).

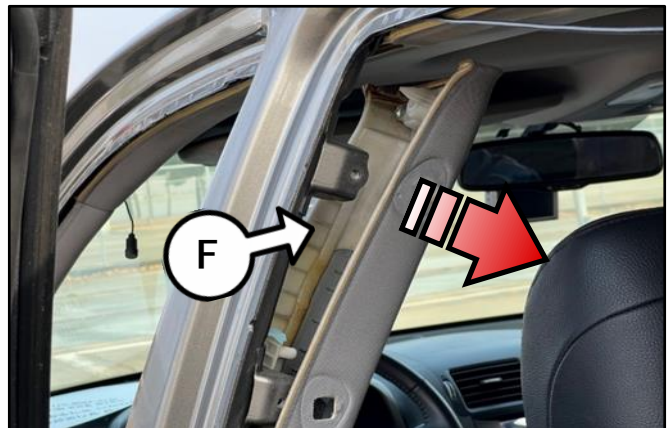
5. Carefully detach the B-pillar trim (F) by pulling away in the direction shown.

**Note:** The trim does not need to be removed. Only the top of the trim needs to be detached.

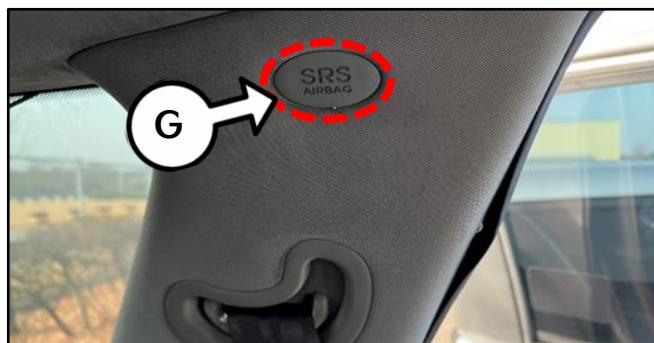
6. Using a pick tool remove the 'SRS Airbag' cover (G) from the C-pillar.

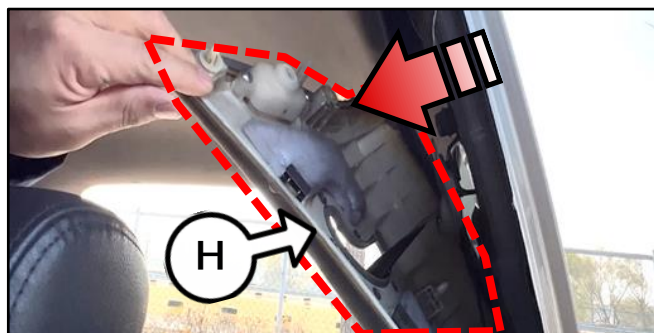
7. Carefully detach the C-pillar trim (H) by pulling in the direction shown.

**Note:** The trim does not need to be removed. Only the top of the trim needs to be detached.

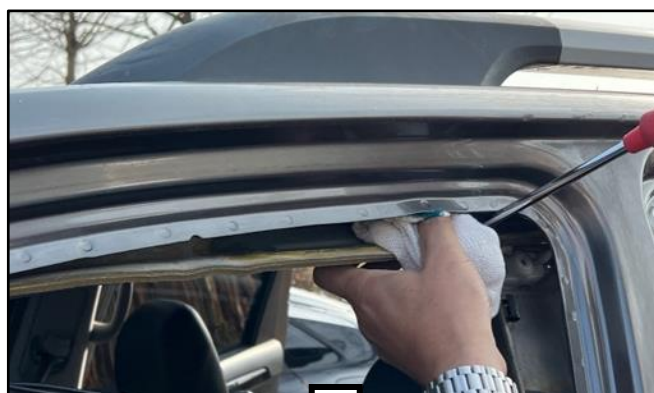
- 8a. Carefully and gently pull the headliner down from the (left and right) door openings to expose the metal plates (I) in the areas shown.

- 8b. Insert a clean rag (or foam pad) in the area shown to prevent damage to headliner and provide working space between the headliner and vehicle roof.

**Note:** The headliner DOES NOT need to be removed. The headliner shown on the right was removed for illustration purposes ONLY.

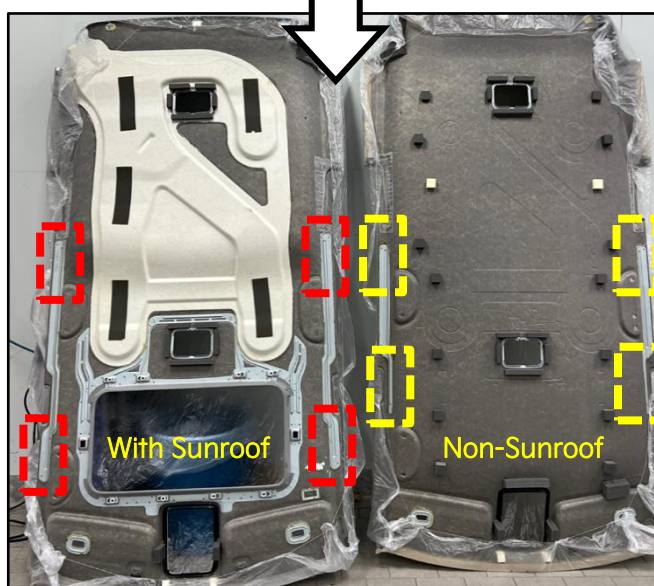
The headliner bracket size and location differ depending on the roof option (with or without sunroof). Refer to photo on the right for adhesive tape application location.

9. Adhere the provided tape over the end of the front left (driver) plate (**adhering outside of the plate directly onto the headliner**). Refer to the image on step 8b. for location.

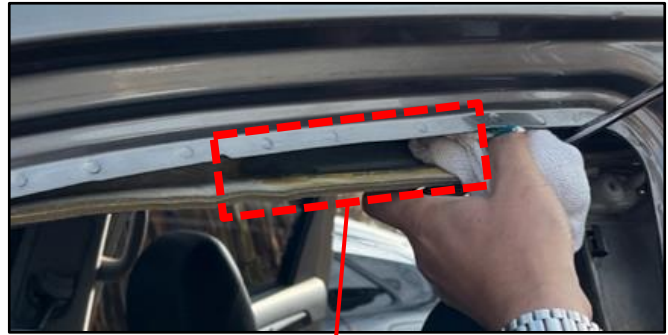
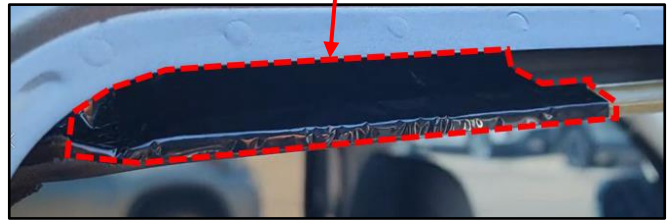
**Note:** Ensure no excess adhesive tape is exposed from headliner edge area.

Use one hand to apply downward pressure and the other hand to push upward, against the applied pressure area.

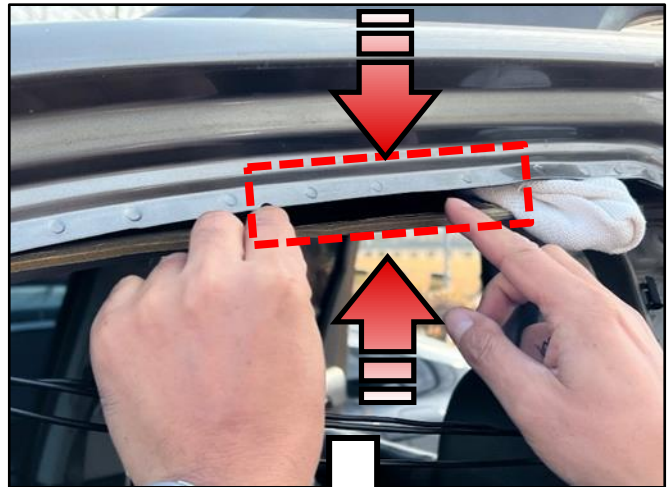
10. Repeat steps 8-9 for the left rear plate.
11. Repeat steps 8-9 for the right (passenger) front plate.
12. Repeat steps 8-9 for the right rear plate.

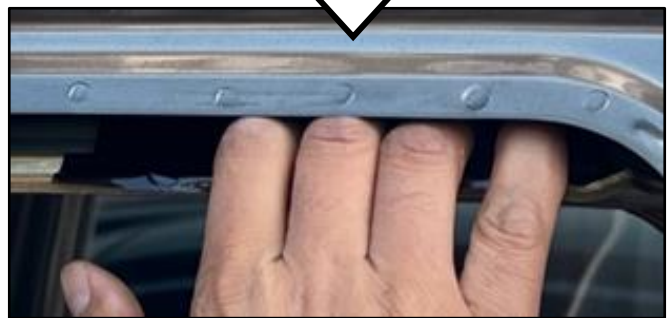
13. Carefully reinstall all removed parts in reverse order of removal.

**Note:** Replace any broken clips during removal.
