RECALL

Issue Date	11/21/2024
Revision Date	12/12/2024
Subject	800V Prodrive 1.0 Inverter Thermal Paste Recall
Description	Certain Phoenix Transit buses may lose propulsion due to inverter IGBTs overheating. This instruction set below provides the necessary information to remove and replace the vehicles inverter.
Model Affected	Service Specified Buses
Complete By	Next Service Opportunity
Service Campaign Number	SC-24-007
Remedy Description	Phoenix will replace the Danfoss inverter at no charge to the customer.
NHTSA Recall Number	23V697
Transport Canada Recall Number	TC-2023-559
Part Number	R066653 or R198-0303
Labor Operation Code	PD55V

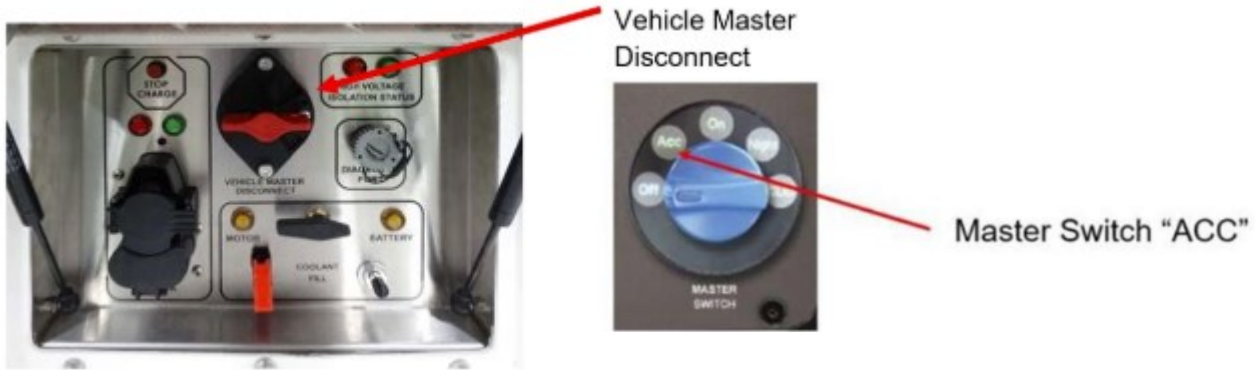
Step 27 (Inverter Programming):

Turn ON the rear master switch, and turn the dash switch to “ACC”, turn the hazards ON. Ensure the LV are charged and are able to run for 30 minutes with out high voltage turned on..

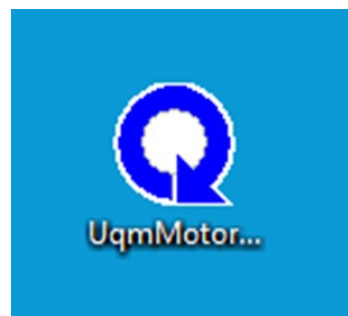
Step 31:

With all other programs closed, open the UQM Application “UqmMotor-v41210P”.

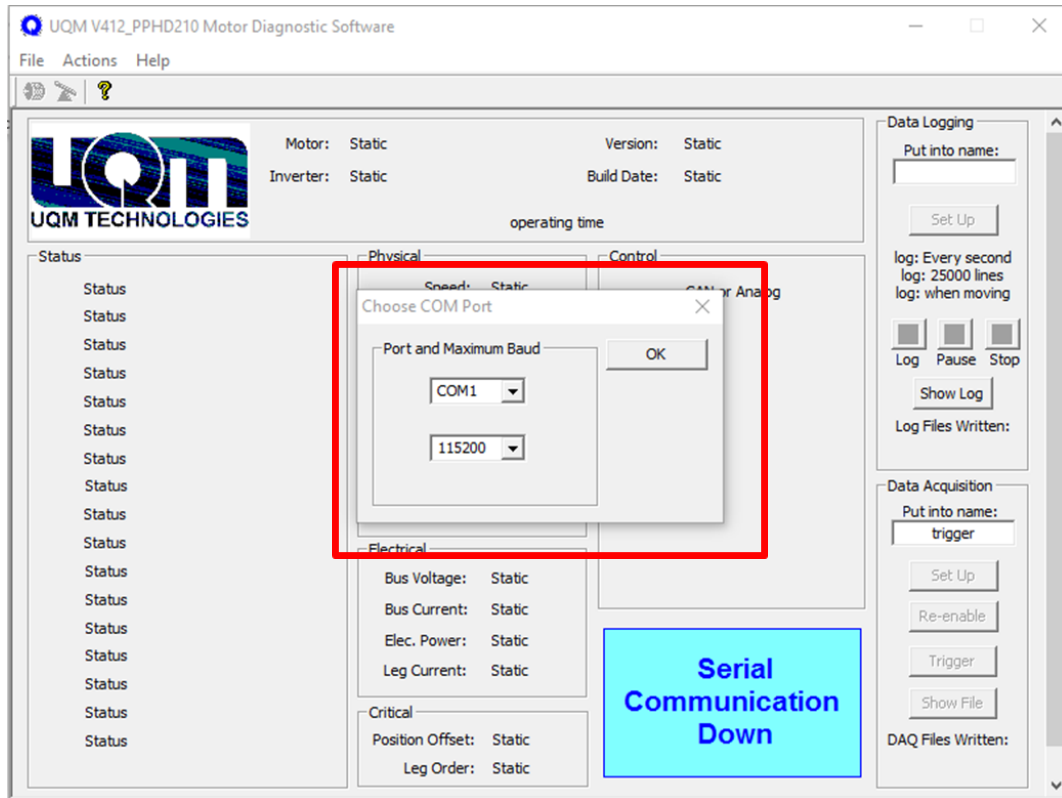
Step 32:

Once the UQM tool opens, select the USB COMM Port the USB Serial Converter is plugged into the laptop. Use the computer device manager if there is any question to which port is correct. Select the baud rate to be 115200.

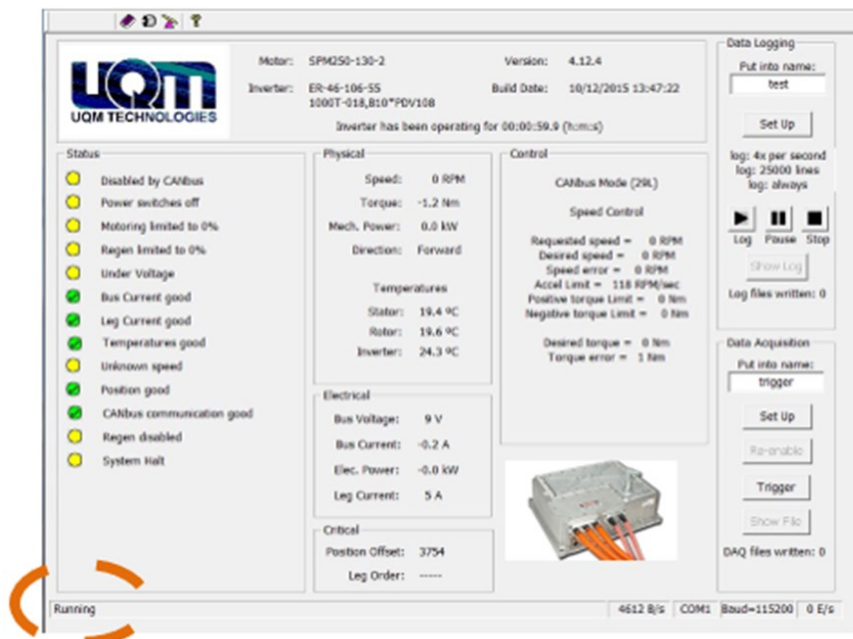
Step 33:

Ensure the USB device is communicating with the inverter, the screen should look similar to the image below, with the word "running" appearing in the bottom-left corner.

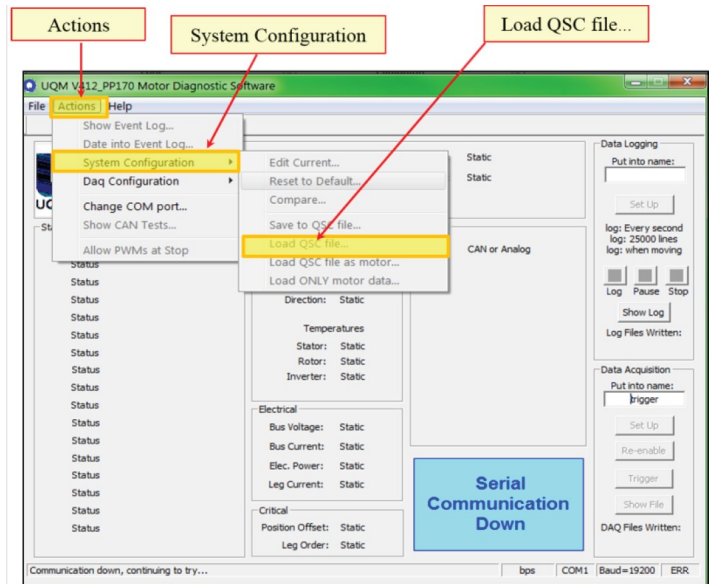
Step 34:

Loading the QSC file. Go to Actions, then System Configurations, then load QSC file.

This file “PP250_rev2.qsc” is the in the campaign file package. It is required the file is stored locally on your hard drive.

Select the file.
