**November 1, 2023**Version 3

## Safety Recall: 2022-24 Civic Touring/Sport EPS Inspection (Service Parts)

Supersedes 23-085, dated October 25, 2023, to revise the information highlighted in **yellow**.

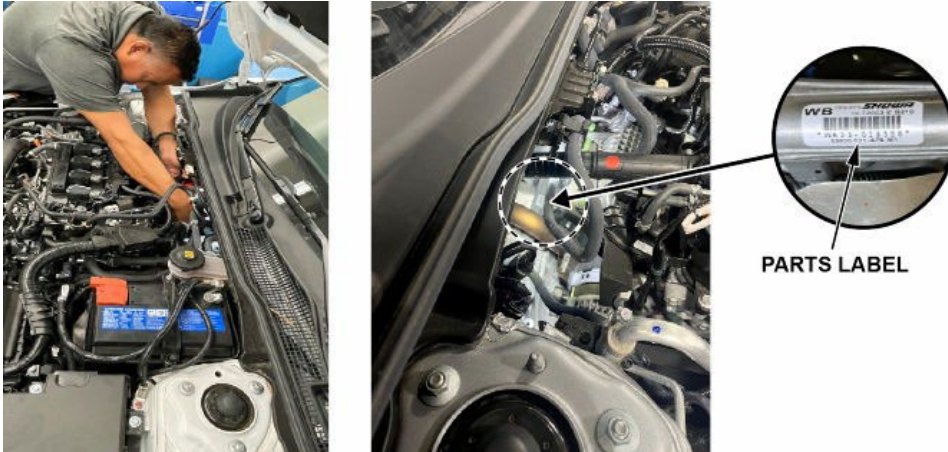
1. Open the hood and wait for the engine to cool down.
2. Locate the parts label on the EPS gearbox.

3. Inspect the label on the EPS and check the ID and part number on the label.
  - If the ID and part number is WA with P/N 53640-T21-3050-M1 or WB with P/N 53640-T21-3060-M1, take a picture of the label and attach it to the warranty claim. **Then, continue to step 4.**

- If the EPS has any other ID or part number, **no EPS gearbox replacement is needed.** Take a picture of the label and attach it to the warranty claim, **no further action needed.**

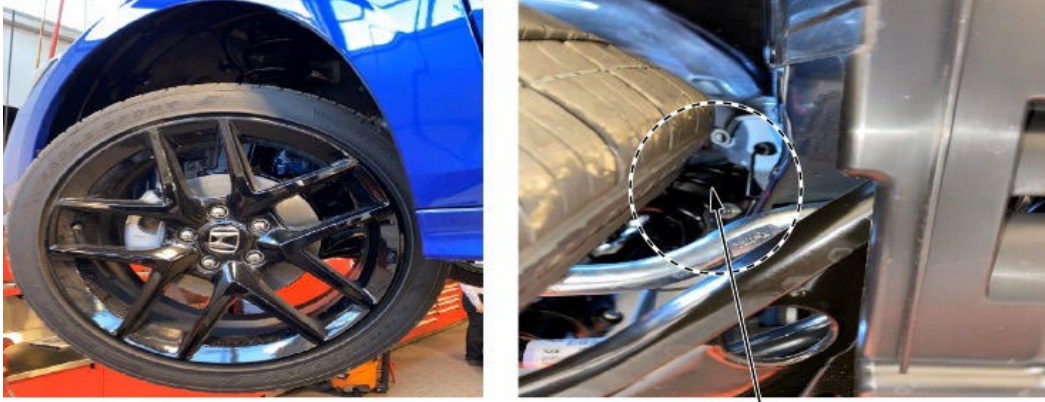
4. Place the vehicle on a lift and inspect both front tires inner side walls of the tire. Check both the front left and right for interference/rubbing marks with the lower control arm and/or outer tie rod.

INNER TIRE CONTACT WITH LOWER ARM AND/OR OUTER TIE ROD

Is there any sign of interference/damage marks on the inner tire with the control arm?

**YES** - Any tire with signs/evidence of interference requires replacement. Provide a clear image showing the interference condition and write the last seven characters of the VIN on the damaged tire. Contact your DPSM for consultation/approval. Go to the REPAIR PROCEDURE.

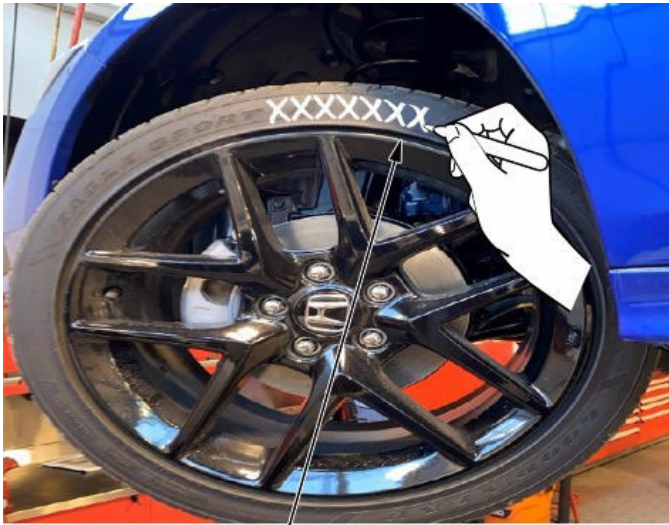
Write the last seven characters of the vehicles VIN.

NOTE: Failure to provide clear photos for tire replacement will be subject to debit.

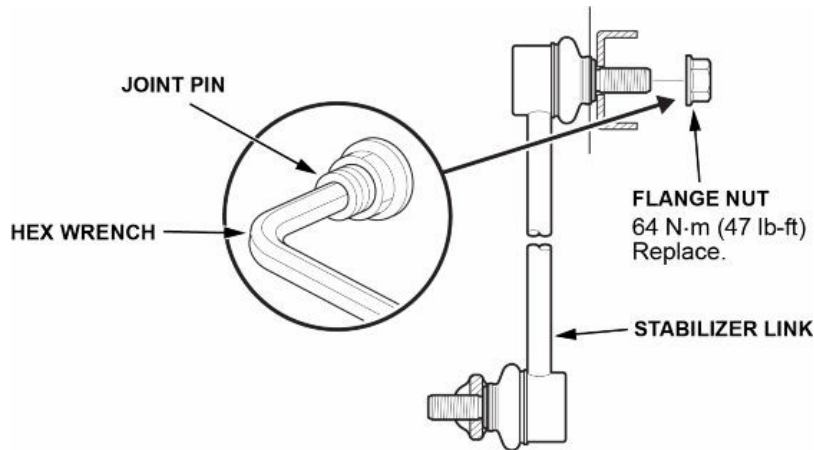
8. Disconnect the stabilizer links located on top.

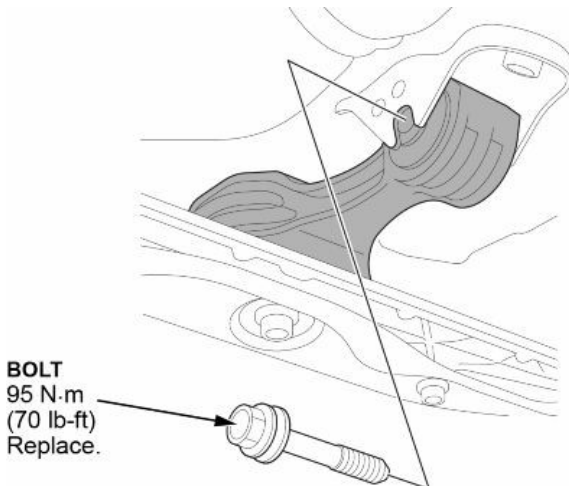
12. Remove the engine torque rod front bolt.

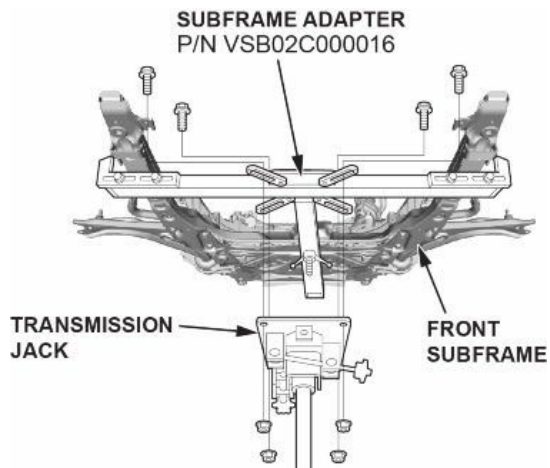
13. Attach the subframe adapter to the front subframe.

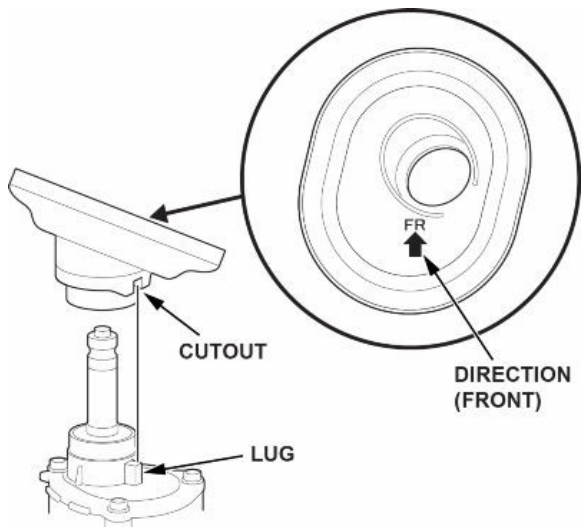
17. Transfer the steering shaft boot to the replacement gearbox.

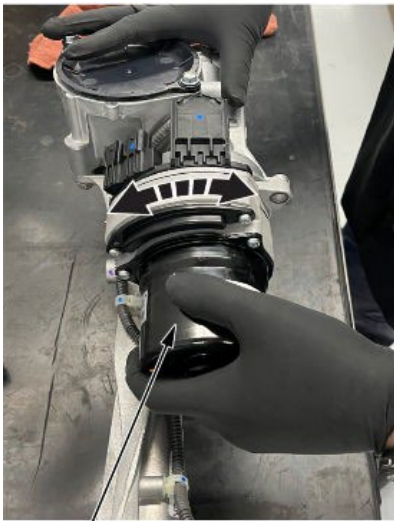
21. Install the EPS motor/control unit with the label facing up, but do not install the mounting bolts.

**EPS MOTOR CONTROL UNIT**  
Turn unit two or three times to the right and left (about 45 degrees).

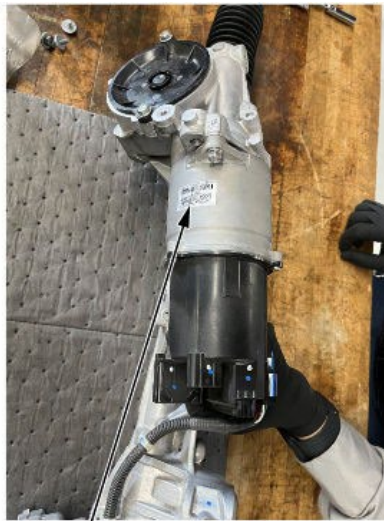
**BARCODE**  
Install with barcode facing up.

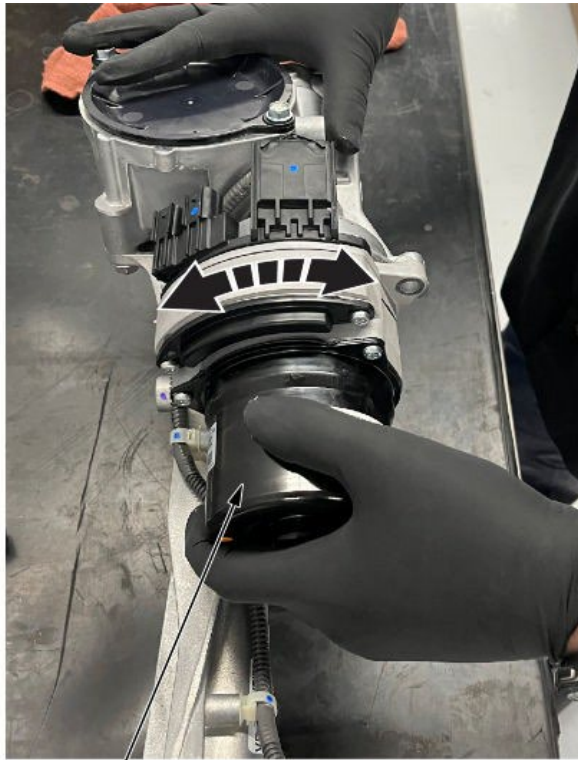
22. Turn the EPS motor/control unit **two or three times** to both the **left and right** in a **45° arc**.

**EPS MOTOR CONTROL UNIT**  
Turn unit two or three times to the right and left (about 45 degrees).

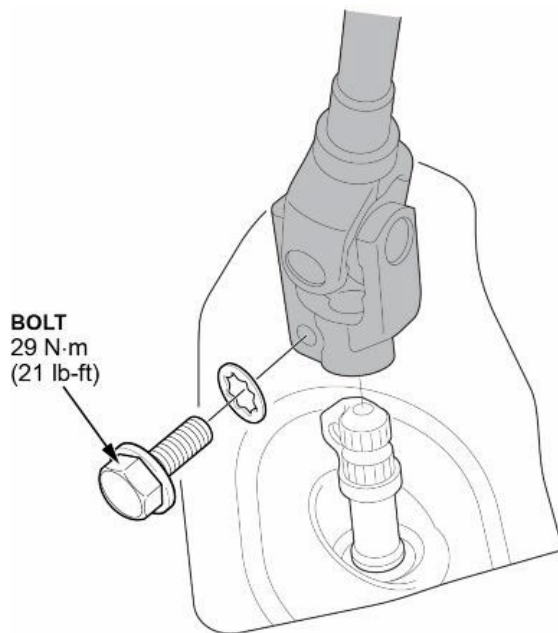
27. Install the pinion shaft to the steering joint **29 N·m (21 lb-ft)**.
