December 10, 2024

Product Update: 2022–24 Civic EPS Gearbox Inspection (Service Parts)Supersedes 23-089, dated December 8, 2023, to revise the information highlighted in **yellow**.**AFFECTED VEHICLES**

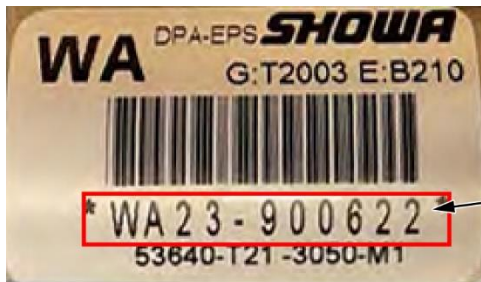
EPS SERIAL
NUMBER

- Attach the photo of the EPS gearbox label to the warranty claim form. Required photos must be included when submitting your claim, or the claim may be subject to debit. The photos must be clear; retake any unclear photos before submitting.

- Input the EPS serial number into the Test Code field in the warranty claim form when the claim is being submitted.

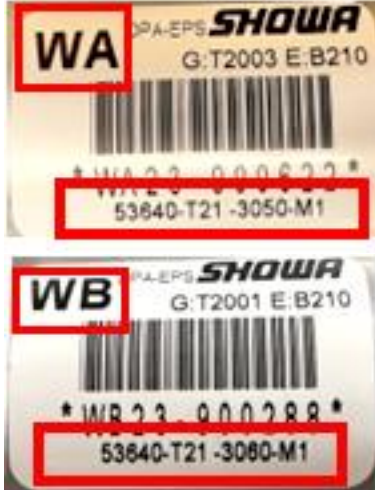
1. Open the hood and wait for the engine to cool down.
2. Locate the parts label on the EPX gearbox.
3. Inspect the label on the EPS gearbox and check the ID and part number on the label.
 - If the ID and part number is WA with P/N 53640-T21-3050-M1 or WB with P/N 53640-T21-3060-M1, **take a picture of the label and attach it to the warranty claim**. Then, go to the **REPAIR PROCEDURE**.

- If the EPS has any other ID or part number, no EPS gearbox replacement is needed. Take a picture of the label and attach it to the warranty claim, no further action is needed.

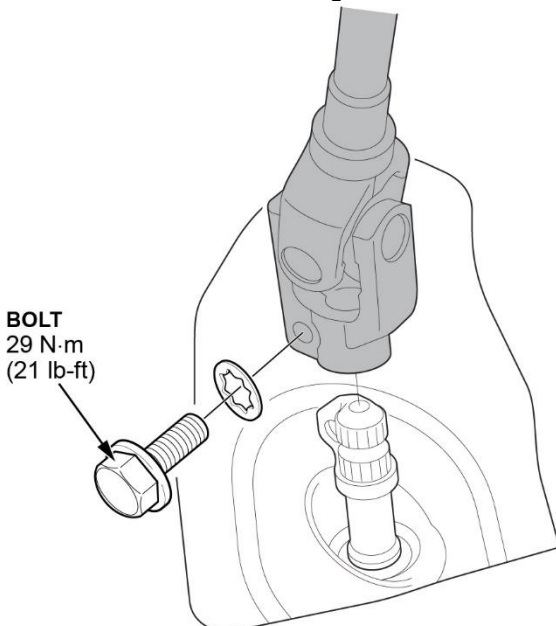
1. Disconnect the 12-volt battery terminals.
2. Disconnect the steering joint.

- Set the steering wheel straight ahead before disconnecting the shaft.
- **Do not turn** the steering wheel while disconnecting the steering joint.

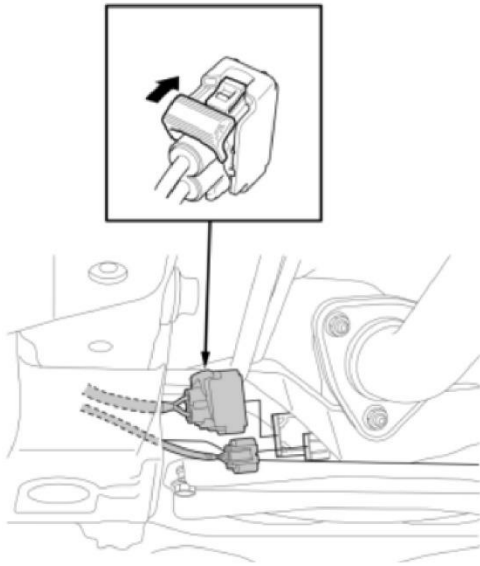
3. Raise the vehicle to a comfortable working height.
NOTE: Keep the vehicle elevated for the remainder of the procedure.
4. Remove the front wheels **108 N·m (80 lb-ft)**.
5. Remove the engine undercover
6. Disconnect the EPS harness connectors.

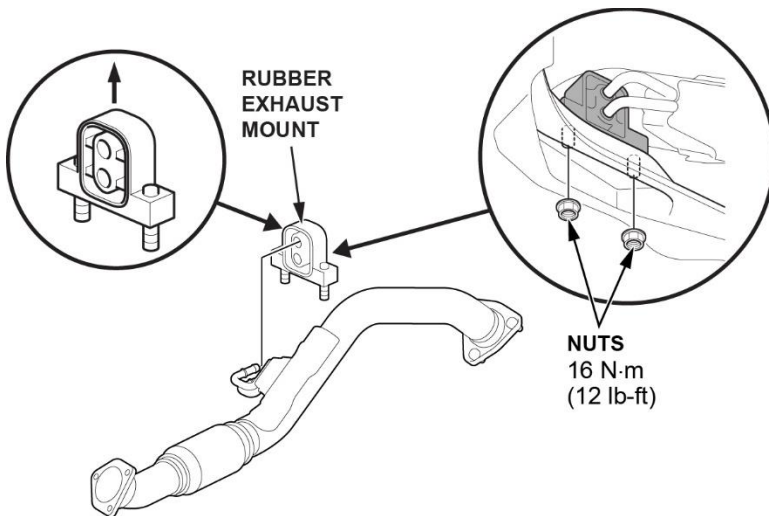
7. Remove the rubber exhaust mount.

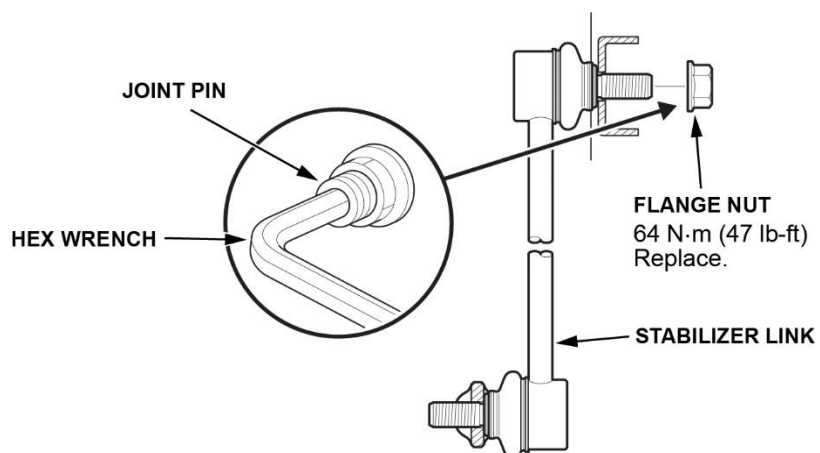
8. Disconnect the stabilizer links upper mounting locations (both sides).

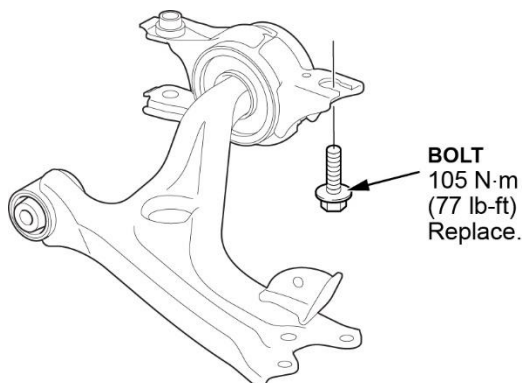
9. Remove the front lower assembly bolt (both sides).

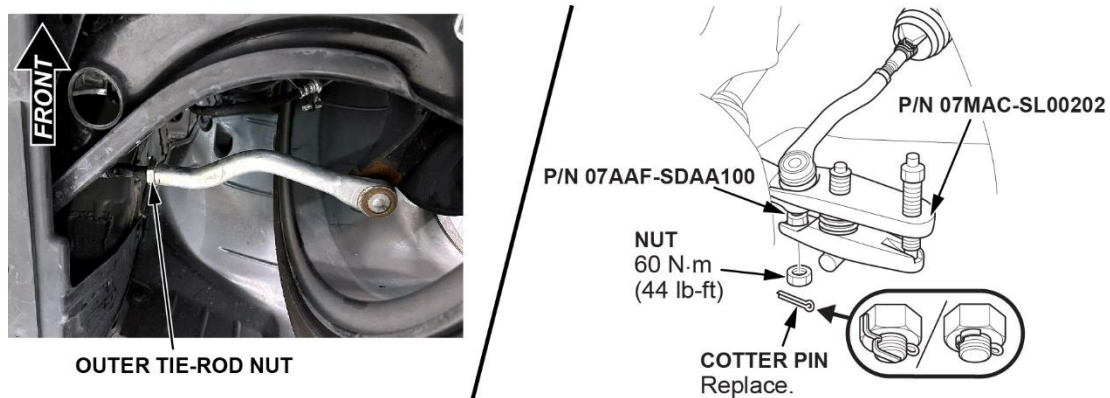
10. Loosen the outer tie-rod end nuts and disconnect the tie-rod end ball joints (both sides).

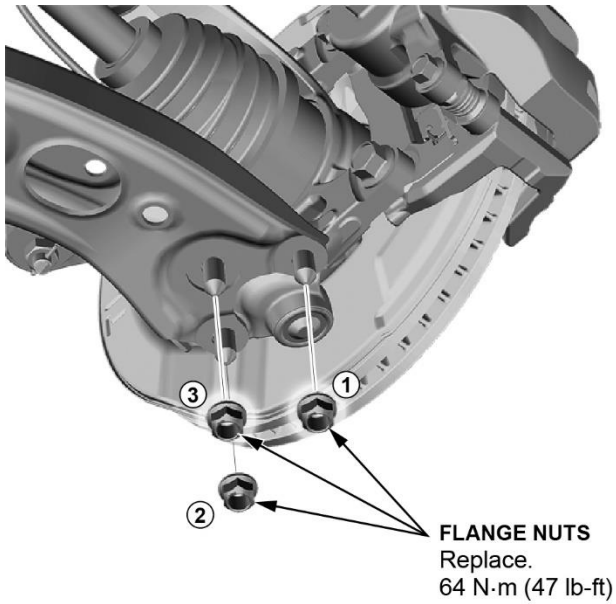
11. Disconnect the front lower arms.

NOTE: During reassembly, loosely install the new flange nuts, then tighten them to the specified torque in the numbered sequence shown.

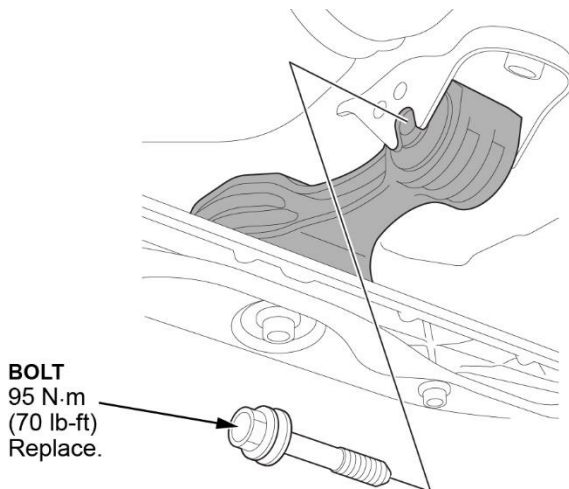
12. Remove the engine torque rod front bolt.

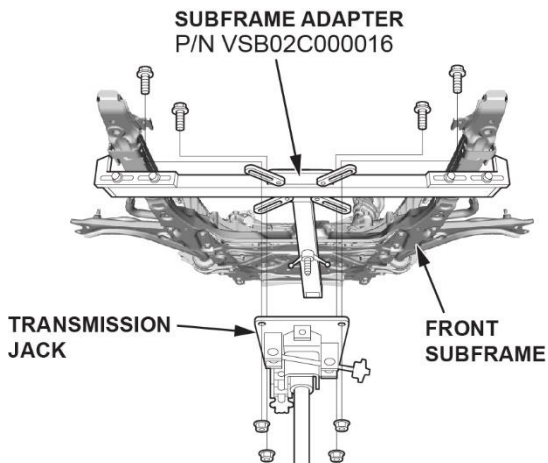
13. Attach the subframe adapter to the front subframe.

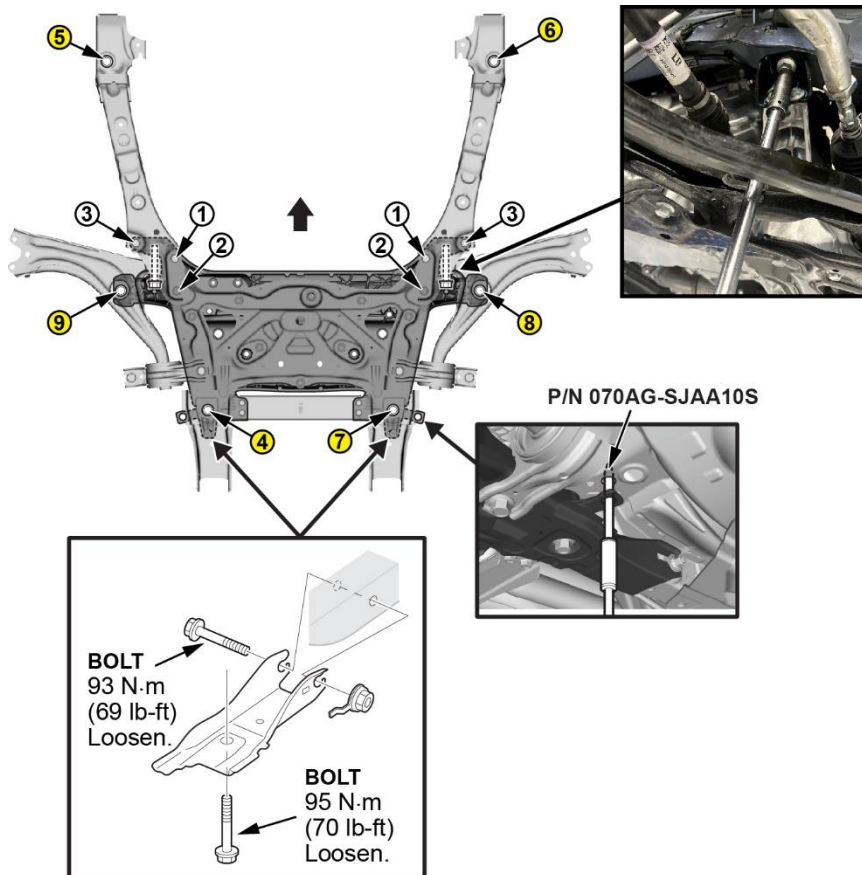
14. Raise a transmission jack and line up the slots in the subframe adapter arms with the bolt holes on the transmission jack base, then securely attach the four bolts. Then, remove the bolts highlighted in yellow only.

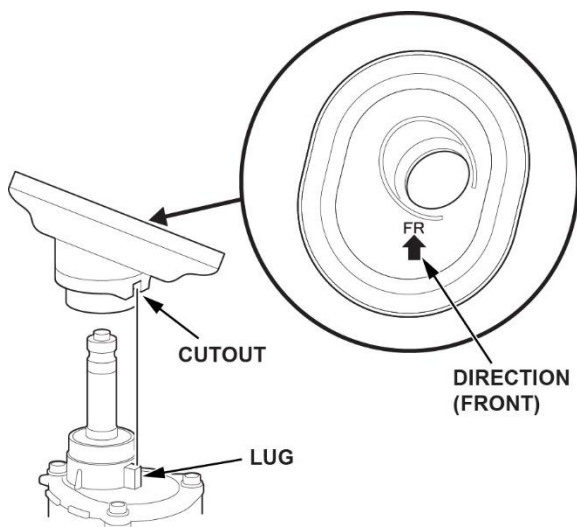
15. Remove the front subframe.
16. Transfer the tie-rod ends to the replacement gearbox.
17. Transfer the steering shaft boot to the replacement gearbox.

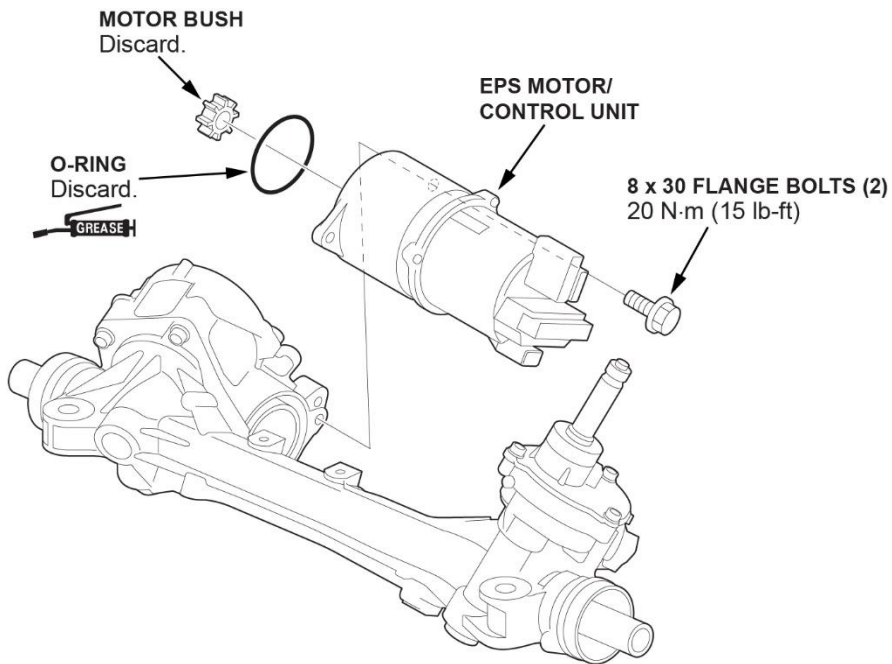
18. Remove the steering gearbox from the subframe.

19. Separate the EOS motor/control unit from the removed gearbox and retain for installation on new gearbox.

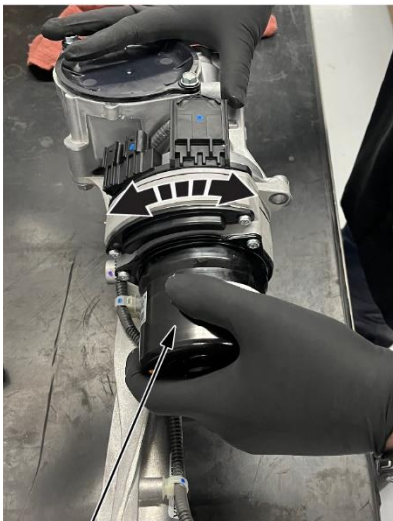
EPS MOTOR CONTROL UNIT
Turn unit two or three times to the right and left (about 45 degrees).

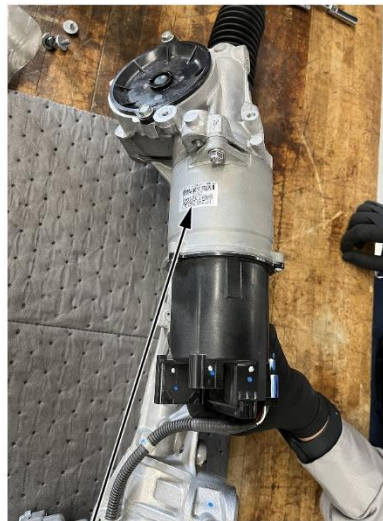
BARCODE
Install with barcode facing up.

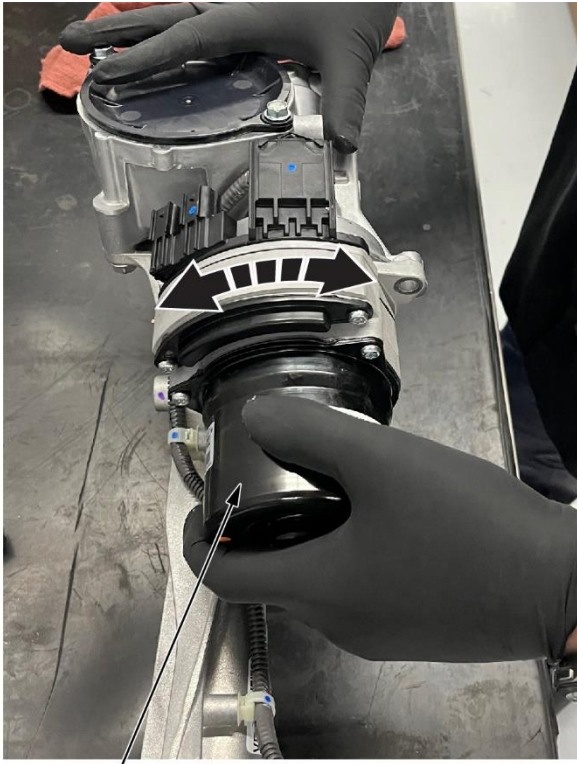
22. To seat the EPS motor/control unit turn it **two or three times** to both the **left and right** in a **45° arc**, as shown below.

EPS MOTOR CONTROL UNIT

Turn unit two or three times to the right and left (about 45 degrees).

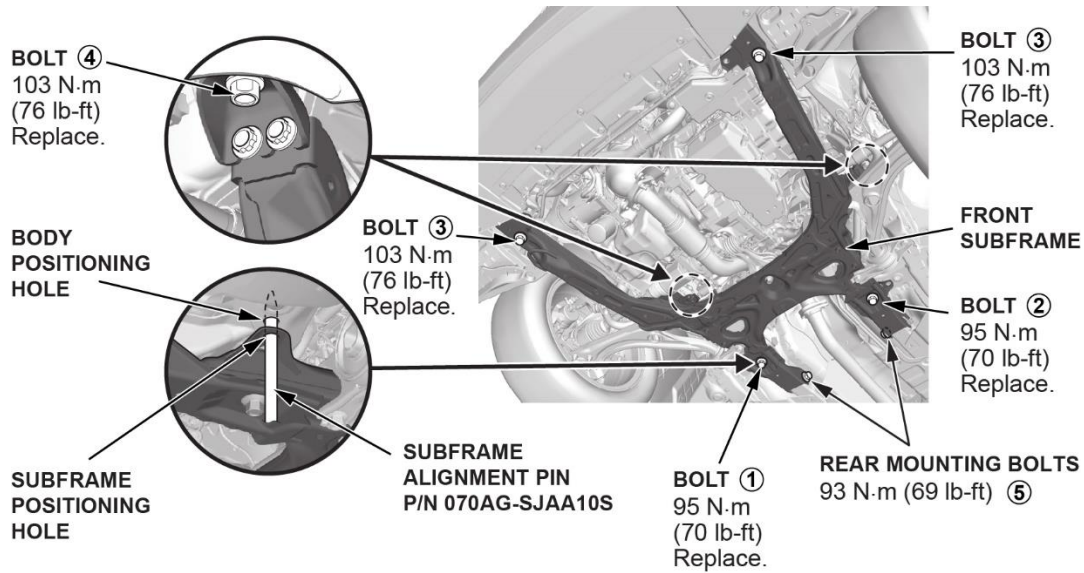
26. Raise the transmission jack with the subframe and use the alignment pins to position the subframe. Loosely install the subframe mounting bolts and the subframe rear stay mounting bolts. Torque the front subframe and rear stay bolts to specification.

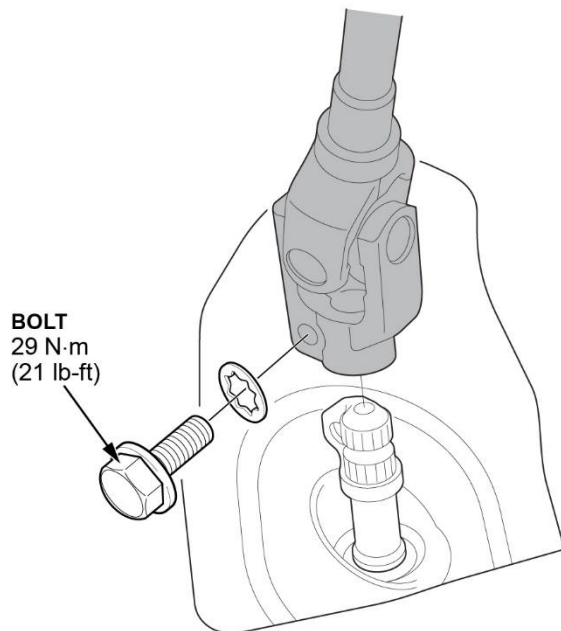
27. Install the pinion shaft to the steering joint and torque the bolt to specification.
