## RECALL 23V706 / 2023-567 REMEDY INSTRUCTIONS

Make(s): CONCORD Model(s): CNC321DSF Model Year(s): 2023 - 2024	Repair Code: RC-005-01-00-004434 Allotted Time: 6.00 HRS. Inspection Code: N/A Allotted Time: N/A
	Concern: Installation of current air ride suspension has resulted in an incorrect pinion to driveline angle.	Photo(s) Required: YES, SEE BELOW Prior Authorization Required: YES Part(s) Kit Number: F100480155 Part(s) Return: DESTROY IN FIELD

# 2023 Coachmen Concord/Autoflex Suspension

The factory installed upper torque arms (AF-F007-CCB15) do not have the proper length needed to ensure proper pinion angle on a stretched chassis. These arms are to be replaced with corrected arms (AF-F007-CCY58) to improve pinion and driveline angle.

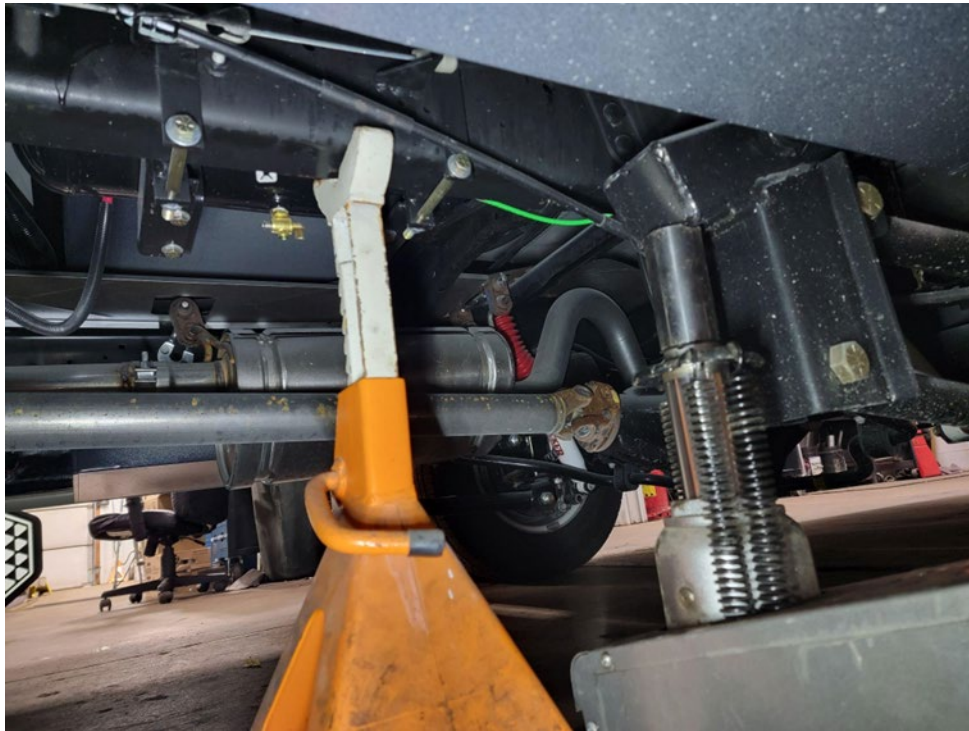
Figure 1 - Driver Side Shown

- Place vehicle in park on flat ground and remove key from ignition.
- Block front wheels to prevent vehicle from rolling.
- Jack up the rear of the RV by lifting in front of the rear axle along frame rail and support both sides with jack stands (See Figure 1). At this time the rear wheels may not be off the ground.
- Using a floor jack, lift the rear axle under the center of the differential until all rear wheels are off the ground.
- Remove all 4 wheels from the rear axle.

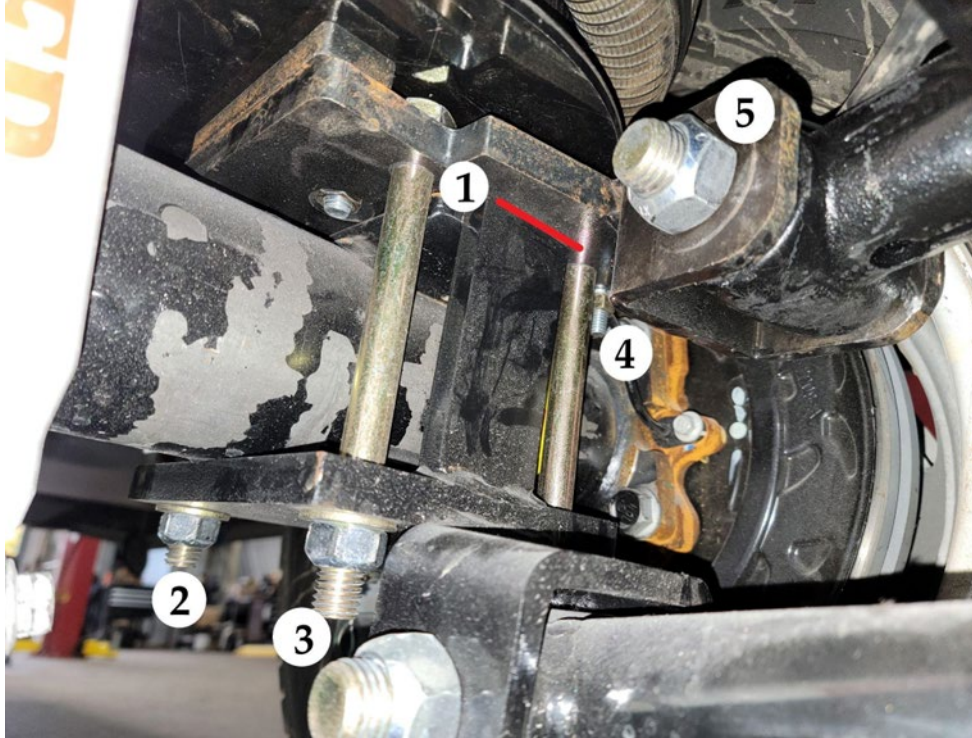
Figure 2 - Driver side Shown

- First check to make sure there is no gap between the upper and lower axle tube bracket on both driver and passenger side.
- The Red Line (No.1 on Figure 2) indicates where this gap might be. If there is no gap here and the four bolts (No.2 and No.3) are tight then skip step 4.

Note: NOT all 4 bolts (No.2 and No.3) can be seen from Figure 2.

- Remove the two 9/16 nuts (No.4 on Figure 2) from the bottom of the top axle tube bracket. (The second nut is on the back side of the axle tube and cannot be seen from Figure 2.)
- Remove the 3/4 Inch nut from the bottom of the air bag that is holding on the lower bag mount.
- Add the included round base plate to the bottom of the air bag, in between the airbag base and the anchor plate and re-install the lower bag mount to the air bag. Base plate shown below
- Do not re-install the lower bag mount yet if there is a gap found in step 2. If no gap, go to step 5.

- If you discover a gap on step 2 then you will need to loosen the rear bolts (No. 2 on Figure 2) using a 15/16 socket and wrench.
- Then tighten the front set (No.3 on Figure 2) to 145 lb-ft and ensure the gap is closed.
- Once tight, move to the rear set (No.2 on Figure 2) and tighten to 145 lb-ft.
- Recheck torque on all 8 Nuts and bolts.

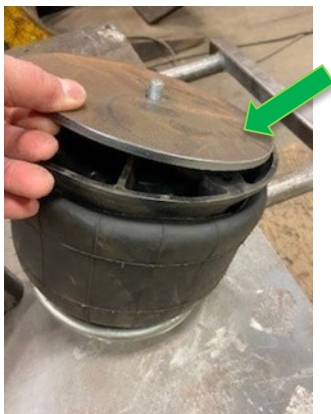
Note: Base plate, noted by the green arrow, shown on an uninstalled airbag for clarity and positioning. Its not required to remove the air bag for this procedure.

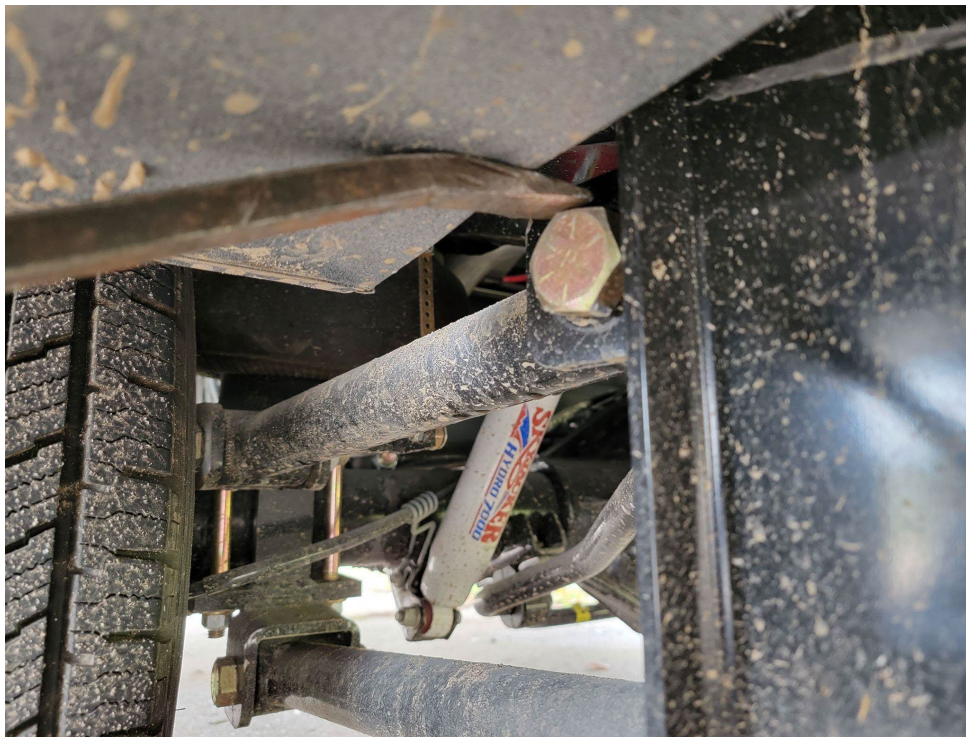
Figure 3 - Passenger side Shown

- Remove leveling valve linkages from both upper torque arms using a 7/16 socket and wrench. Remove both upper torque arms using a 1-5/16 socket and wrench.
- To remove front bolts it may be necessary to slightly bend the bottom of one or both cargo boxes (See figure 3). Using a pry bar or similar tool, carefully pry upward to bend the bottom of the box just enough to get a socket on the bolt. This will be fixed after the arms are replaced.
- Install the new torque arms and torque bolts to 400 lb-ft.

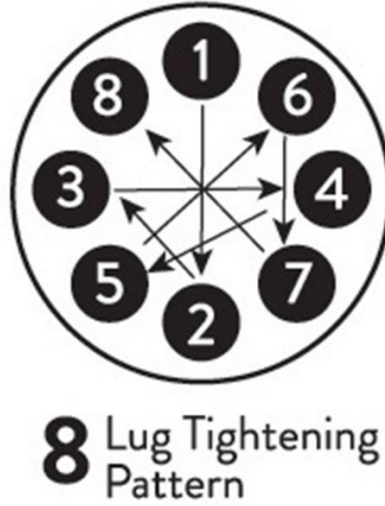
Figure 4 - Lug Tightening sequence

HiSpec wheels - 140 ft/lbs; identified as using the original black Ford lug nuts.  
Ion wheels - 120 ft/lbs; identified as using conical chrome plated lugs

- Reinstall wheels and lower vehicle. Torque wheels using proper torque sequence and specification (see figure 4).
- Start the vehicle and allow air compressors to fill the tank.

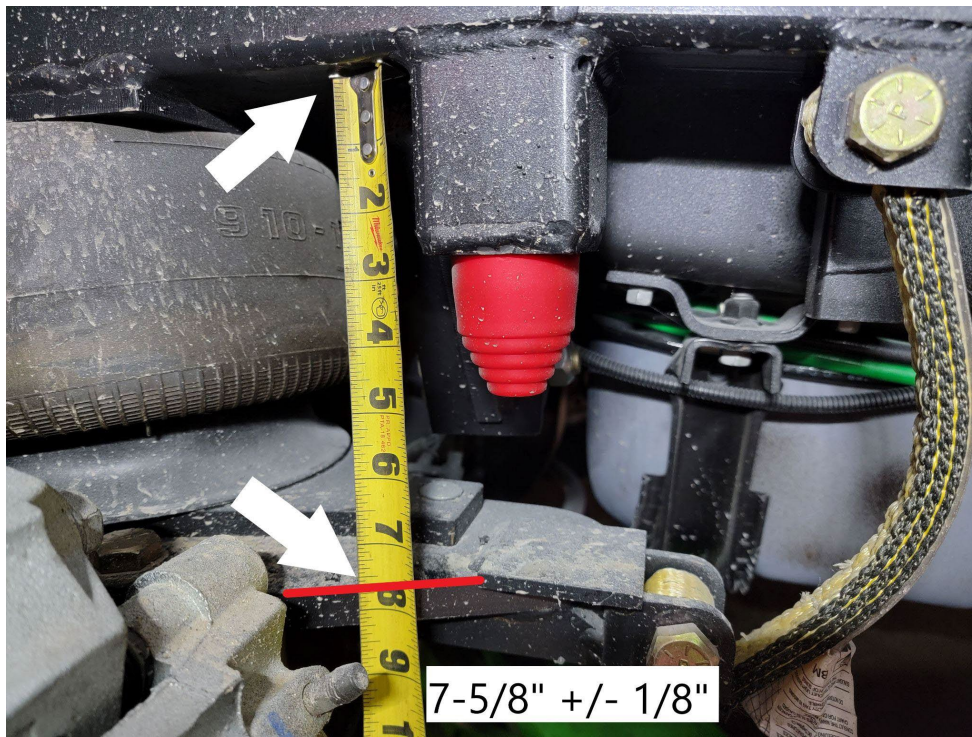
Figure 5 - Driver side Shown

- Once rear bags are inflated, place jack stands back under the frame as a precaution while checking and adjusting ride height.
- Ride height is measured behind the airbag and just in front of the bump stop. This should measure 7  $\frac{5}{8}$  inch +/-  $\frac{1}{8}$  inch. (See Figure 5)

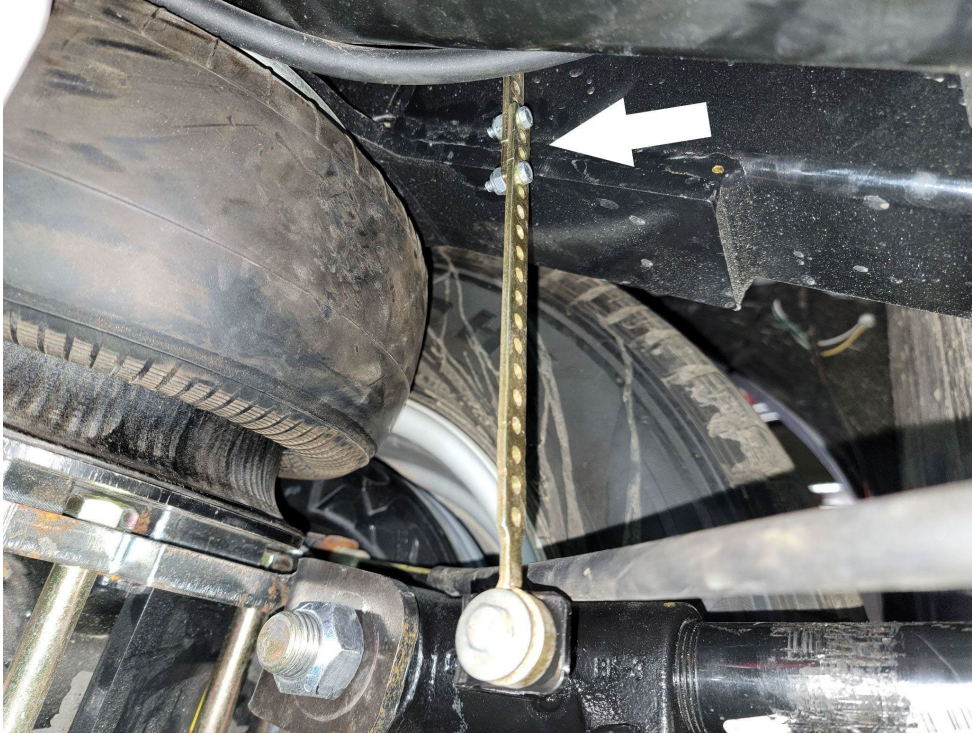
Figure 6 - Driver side Shown

- If you don't have the correct ride height you will need to adjust the leveling valve adjustable link (See Figure 6). Moving the linkage by 1 hole changes ride height roughly  $\frac{1}{2}$  in. Make the linkage longer to raise the vehicle and shorter to lower the vehicle.

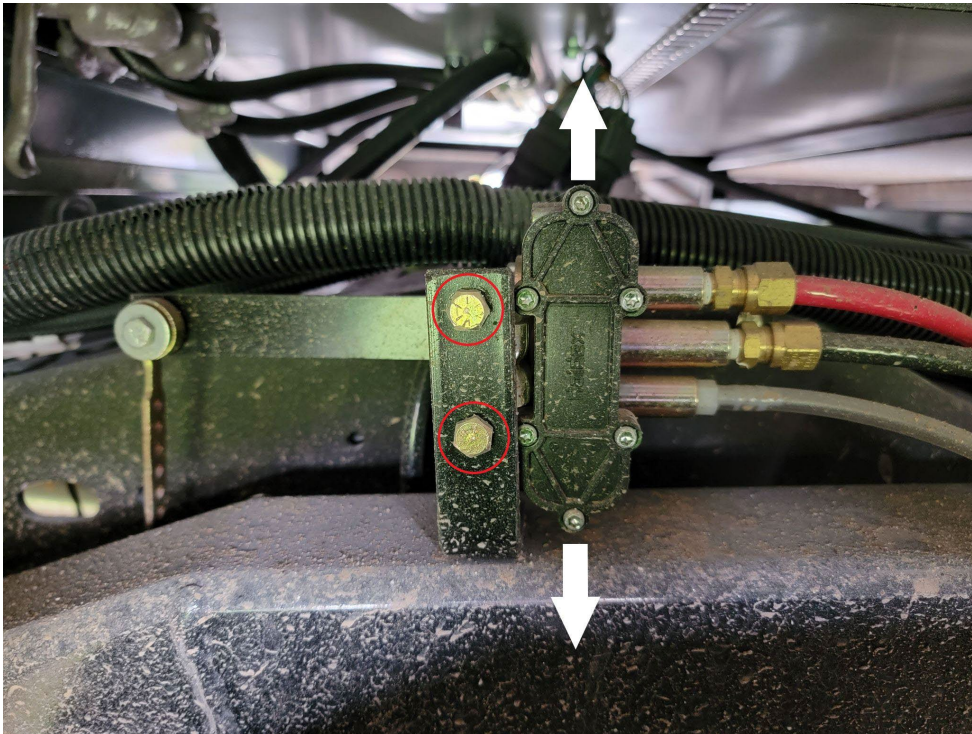
Figure 7 - Driver side Shown

- If you need more precise adjustment, It may be necessary to loosen the 2 bolts holding the leveling valve in place and tip it up or down as needed (See Figure 7).

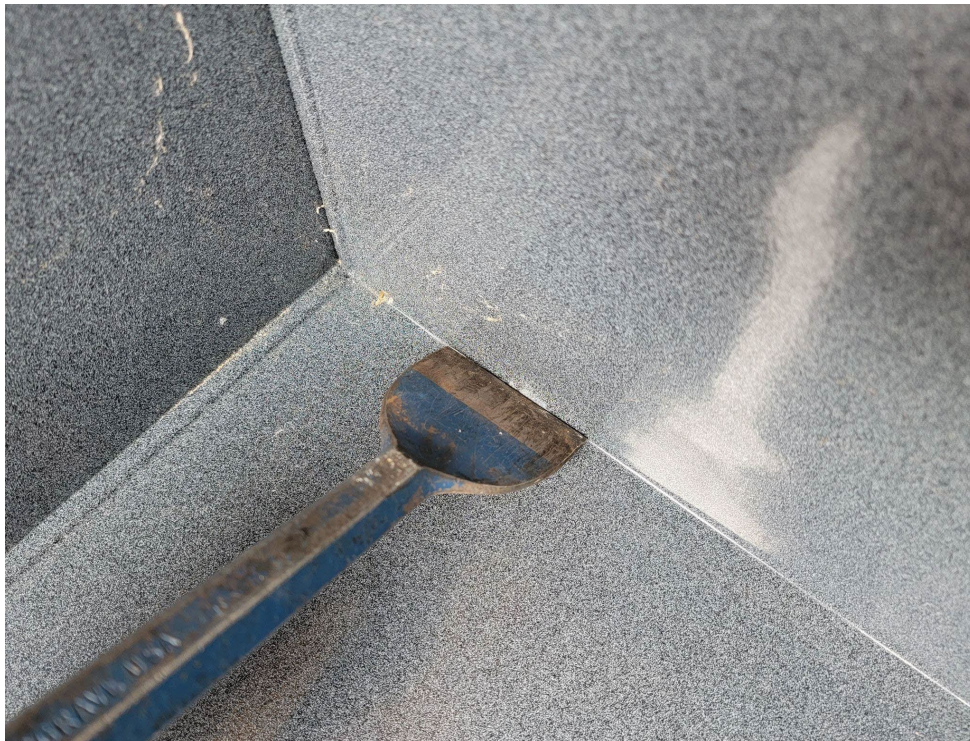
Figure 8 - Storage Compartment Box Interior

- **Important!** Make sure to correct the bottom of the cargo boxes if you needed to bend them.
- Using a rubber mallet or other non-marring large face hammer, carefully tap the floor of the cargo box back down.
- Then using an extra wide flat chisel punch (or similar), carefully, and lightly, re-create the sharp factory inner edge (See Figure 8).
- Check for leaks along boxes seams to ensure they are watertight. Use black caulk to reseal if needed.

Note: Use caution when tapping against the metal box. It may be possible to break the seal and create a leak.
