Remedy available for  
2022-2024 (WS) Jeep Wagoneer/Grand  
Wagoneer

The third row seatbelt buckles on about 104,400 of the above vehicles may have been built with buckles that are inaccessible or damaged. An inaccessible or damaged buckle may leave the occupant unable to fasten the seatbelt. If this warning is not heeded, an unfastened seatbelt may increase the risk of injury to occupants during certain types of crashes.

**SAFETY RECALL**  
NORTH AMERICA  
**Seatbelt Buckle**

Reference: A7A / NHTSA 23V-716

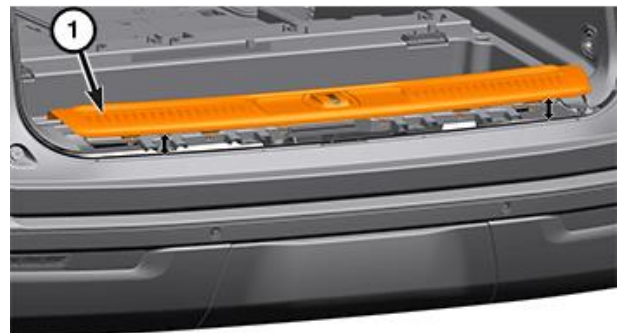
**Figure 1 – Liftgate Sill Scuff Plate**

1. Open the liftgate.
2. Using a trim stick or equivalent, release the retaining clips that secure the liftgate sill scuff plate to the rear sill and remove it from the vehicle (Figure 1).

1. Place the cargo load floor (1) into the vehicle (Figure 4).
2. Install the bolts (1) and nuts (2) that secure the cargo load floor (3) to the body and tighten the bolts to 11 N·m (8 Ft. Lbs.) and the nuts to 7 N·m (62 In. Lbs.) (Figure 3).
3. Close the cargo floor cover.
4. Long Wheelbase vehicle - Install the fasteners that secure the cargo rails to the rear floor (Figure 2).
5. Align and secure the retaining clips that secure the liftgate sill scuff plate to the rear sill (Figure 1).
6. Close the liftgate.

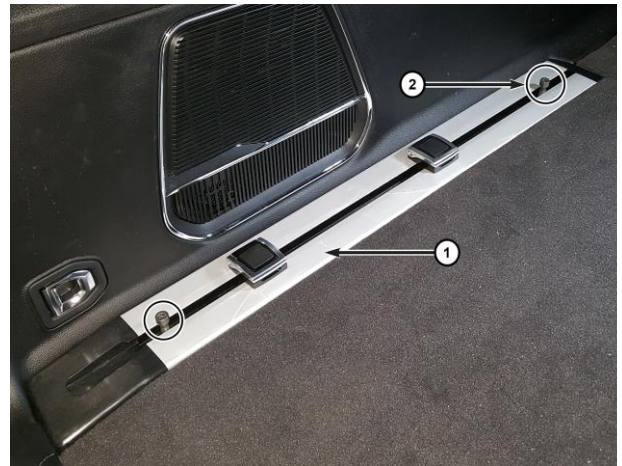
**Figure 2 – Cargo Rail Fasteners (Long Wheelbase)**

3. Long Wheelbase vehicle - Remove fasteners that secure the cargo rails to the rear floor. Remove cargo rails (Figure 2).
4. Open the cargo floor cover.

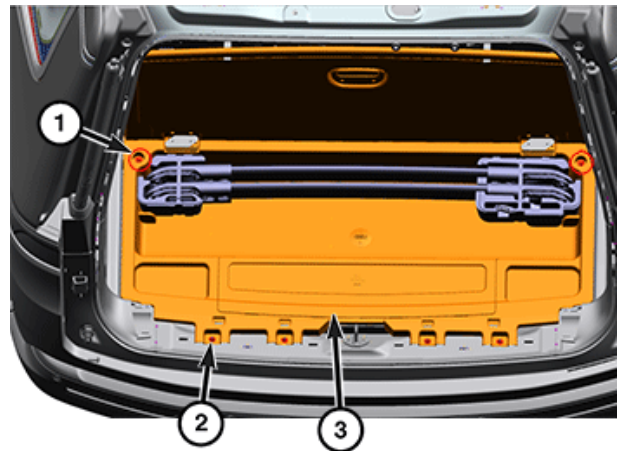
**Figure 3 – Cargo Load Floor Fasteners (Short Wheelbase Shown)**

5. Remove the bolts (1) and nuts (2) that secure the cargo load floor (3) to the body (Figure 3).

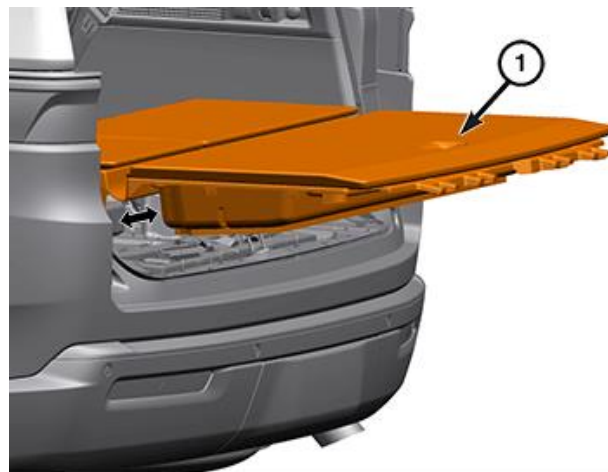
**Figure 4 – Cargo Load Floor**

6. Remove the cargo load floor (1) from the vehicle (Figure 4).

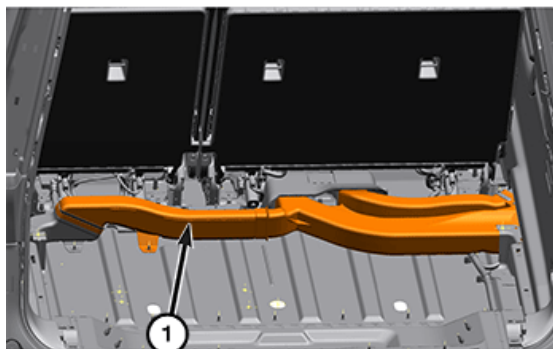
**Figure 5 – Third Row Left Outer Seat Bolts**

1. As needed, disengage the retaining tabs and remove the rear air duct (1) from the vehicle (Figure 5).

3. Roll the seat back into position on the floor.
4. Install the marriage bracket to the seats (2) (Figure 8). Install **NEW** screws (1) into the marriage bracket (3) and tighten to 28 N·m (21 Ft. Lbs.).
5. Secure the wire harness retainer (4) to the marriage bracket (3) (Figure 8).
6. Install the third row left seat to floor nuts (1) and tighten to **M10X1.50 to 50 N·m (37 Ft. Lbs.) and M12X1.75 to 70 N·m (52 Ft. Lbs.)** (Figure 7).
7. Install the **NEW** third row left seat to floor **nuts and/or bolts** (2) and tighten to 50 N·m (37 Ft. Lbs.) (Figure 6).
8. Install the seat **fastener** covers.
9. Install the rear air duct (1) to the vehicle and engage the retaining tabs (Figure 5).

1. As needed, disengage the retaining tabs and remove the rear air duct (1) from the vehicle (Figure 5).
2. Remove the third row left outer seat to floor **fastener** covers and **nuts and/or** bolts (2) from the front position. Discard the old bolts. (Figure 6).
3. Remove the third row seat to floor nuts (1) from the rear position (Figure 7).
4. Disengage the wire harness retainer (4) from the marriage bracket (3) (Figure 8).
5. Remove the screws (1) from the marriage bracket (3) and remove the bracket from the seats (2). Discard the screws (Figure 8).

8. Roll the seat back into position on the floor.
9. Install the marriage bracket to the seats (2) (Figure 8). Install **NEW** screws (1) into the marriage bracket (3) and tighten to 28 N·m (21 Ft. Lbs.).
10. Secure the wire harness retainer (4) to the marriage bracket (3) (Figure 8).
11. Install the third row seat to floor nuts (1) and tighten **M10X1.50 to 50 N·m (37 Ft. Lbs.) and M12X1.75 to 70 N·m (52 Ft. Lbs.)** (Figure 7).
12. Install the **NEW** third row right outer seat to floor bolt bolts (2) and tighten to 50 N·m (37 Ft. Lbs.) (Figure 6).
13. Install the seat **fastener** covers.
14. Install the rear air duct (1) to the vehicle and engage the retaining tabs (Figure 5).

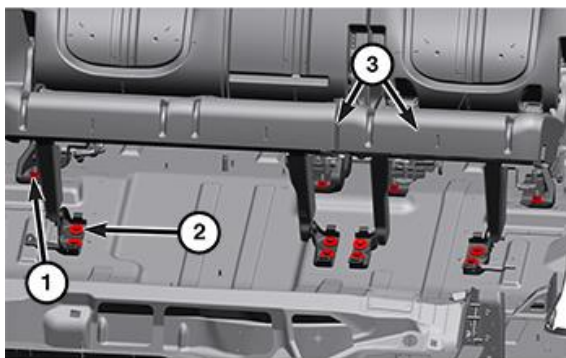
**Figure 6 – Third Row Left Outer Seat Bolts**

2. Remove the third row left outer seat to floor **fastener** covers and **nuts and/or bolts (2)** from the front position. **Discard the old bolts.** (Figure 6).

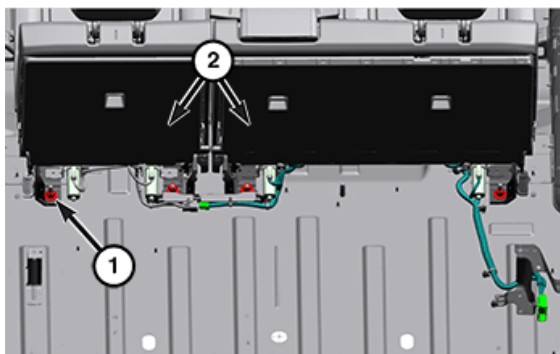
**Figure 7 – Third Row Left Outer Seat Nuts**

3. Remove the third row seat to floor nuts (1) from the rear position (Figure 7).

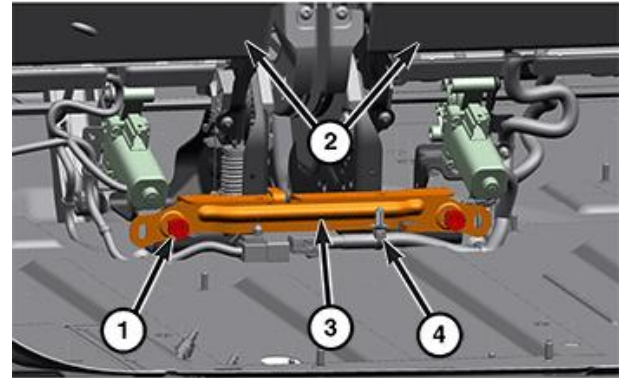
Figure 8 – Marriage Bracket Fasteners

4. Disengage the wire harness retainer (4) from the marriage bracket (3) (Figure 8).
5. Remove the screws (1) from the marriage bracket (3) and remove the bracket from the seats (2). **Discard the screws** (Figure 8).

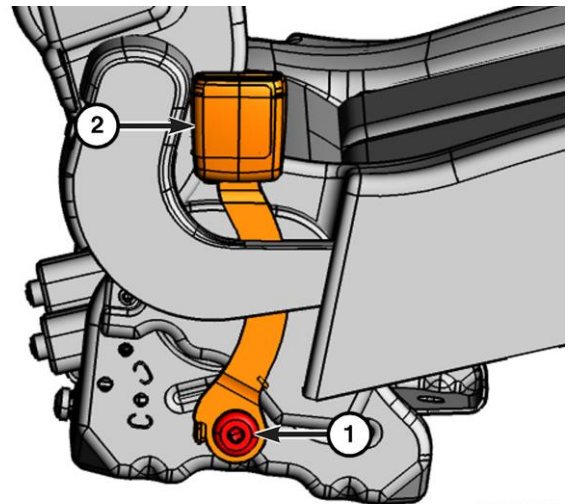
Figure 9 – Seatbelt Buckle Fasteners

6. Roll the seat forward into the footwell.
7. Remove the third row left seatbelt buckle bolt (1) from the buckle anchor (Figure 9).
8. Remove the buckle (2) from the vehicle (Figure 9).

1. Place the **NEW** seatbelt buckle into position on the seat (Figure 9).
2. Tighten the **NEW** bolt provided with the buckle to 48 N·m (35 Ft. Lbs.).

6. Roll the seat forward into the footwell.
7. Remove the third row left seatbelt buckle bolt (1) from the buckle anchor (Figure 9).
8. Remove the buckle (2) from the vehicle (Figure 9).
9. Remove the third row right seat to floor **fastener** covers and **nuts and/or** bolts (2) from the front position. Discard the bolts. (Figure 11).
10. Position the seats to the upright position.

3. Tighten the **NEW** bolt provided with the buckle to 48 N·m (35 Ft. Lbs.) (Figure 14).
4. Install the **NEW** third row right seat to floor **nuts and/or** bolts (2) and tighten to 50 N·m (37 Ft. Lbs.) (Figure 11).
5. Install the seat **fastener** covers.
6. Place the **NEW** third row left seat seatbelt buckle into position on the seat (Figure 9).
7. Tighten the **NEW** bolt provided with the buckle to 48 N·m (35 Ft. Lbs.).

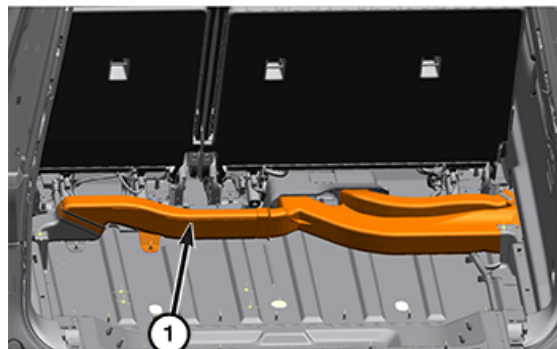
**Figure 10 – Third Row Left Outer Seat Bolts**

1. As needed, disengage the retaining tabs and remove the rear air duct (1) from the vehicle (Figure 10).

3. Roll the seat forward into the footwell.
4. Tighten the **NEW** bolt provided with the buckle to 48 N·m (35 Ft. Lbs.) (Figure 14).
5. Roll the seat back onto the floor.
6. Install the marriage bracket to the seats (2) (Figure 13). Install **NEW** screws (1) into the marriage bracket (3) and tighten to 28 N·m (21 Ft. Lbs.).
7. Secure the wire harness retainer (4) to the marriage bracket (3) (Figure 13).
8. Install the third row left seat to floor nuts (1) and tighten to **M10X1.50 to 50 N·m (37 Ft. Lbs.) and M12X1.75 to 70 N·m (52 Ft. Lbs.)** (Figure 12).
9. Install the **NEW** third row right seat to floor **nuts and/or bolts** (2) and tighten to 50 N·m (37 Ft. Lbs.) (Figure 11).
10. Install the seat **fastener** covers.
11. Install the rear air duct (1) to the vehicle and engage the retaining tabs (Figure 10).

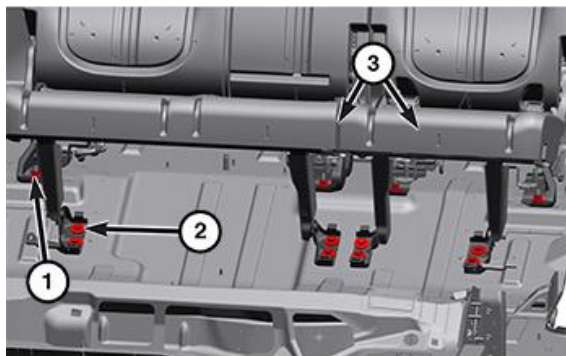
**Figure 11 – Third Row Right Outer Seat Bolts**

2. Remove the third row right outer seat to floor **fastener covers** and **nuts and/or bolts (2)** from the front position. **Discard the bolts.** (Figure 11).
3. Position the seats to the upright position.

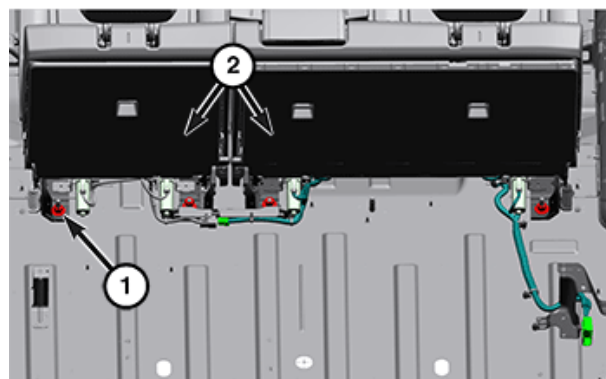
**Figure 12 – Right Outer Seat Nuts**

4. Remove the third row seat to floor nuts (1) from the rear position (Figure 12).

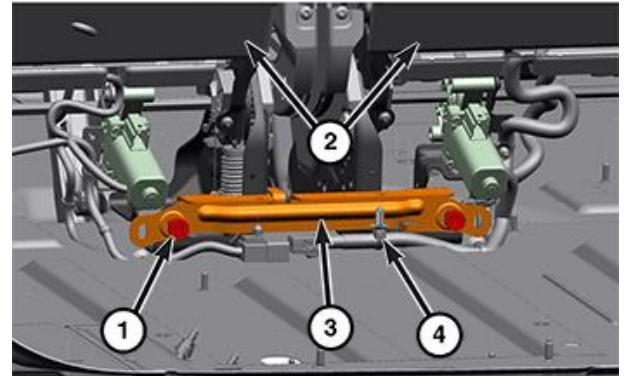
Figure 13 – Marriage Bracket Fasteners

5. Disengage the wire harness retainer (4) from the marriage bracket (3) (Figure 13).
6. Remove the screws (1) from the marriage bracket (3) and remove the bracket from the seats (2). **Discard the screws** (Figure 13).

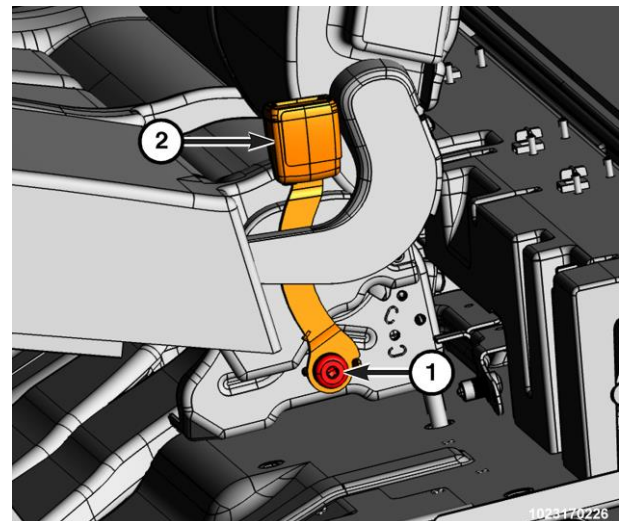
Figure 14 – Seatbelt Buckle Fastener

7. Roll the seat forward into the footwell.
8. Remove the third row center seatbelt buckle bolt (1) from the buckle anchor (Figure 14).
9. Roll the seat back onto the floor.
10. Raise the lower seat cushion.
11. Remove the buckle (2) from the seat (Figure 14).

1. Place the **NEW** seatbelt buckle into position on the seat (Figure 14).
2. Lower the seat cushion.

11. Remove the third row **center** seatbelt buckle bolt (1) from the buckle anchor (Figure 14).
12. Raise the lower seat cushion.

13. Remove the buckle (2) from the seat (Figure 14).

1. Place the **NEW center** seatbelt buckle into position on the third row right seat (Figure 14).
2. Lower the seat cushion.

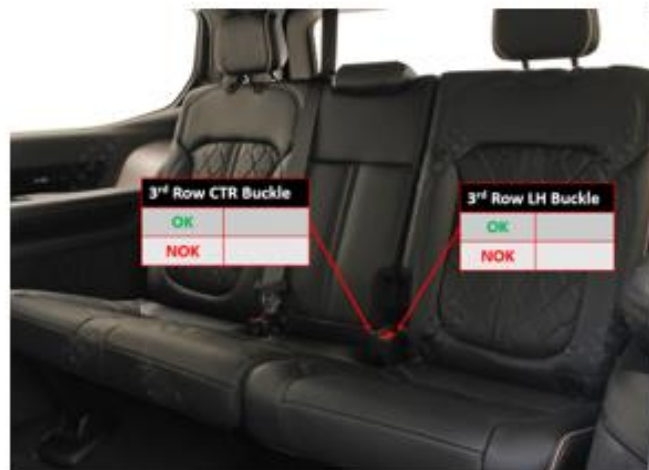
Your dealership has inspected the seatbelt buckles in accordance with the Safety Recall A7A Inspection Procedure. We would like to notify you that one or more of the seat belts has failed the inspection.

**Drivers can continue to safely operate this vehicle, provided no occupants are positioned in the 3<sup>rd</sup> row seat(s) indicated below as "NOK".**

**The parts to correct this condition were not immediately available.** We are making every effort to send the required parts as quickly as possible and will service your vehicle free of charge (parts and labor).
