Remedy available for
 2022-2024 (WS) Jeep Wagoneer/Grand
 Wagoneer

Revision	Edition	Detail
2	April 2025	LOP number for "Inspect and Replace Left 3rd Row Seatbelt Buckle " updated.

Seatbelt Buckle

Reference: A7A / NHTSA 23V-716

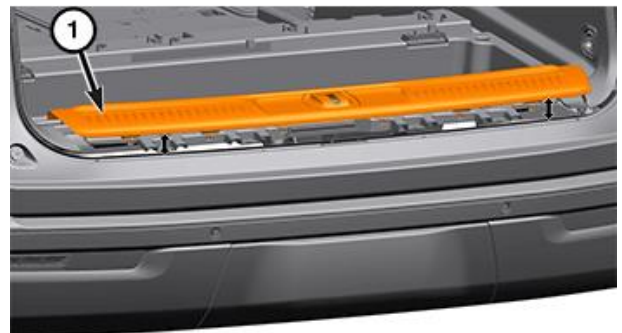
Figure 1 – Liftgate Sill Scuff Plate

1. Open the liftgate.
2. Using a trim stick or equivalent, release the retaining clips that secure the liftgate sill scuff plate to the rear sill and remove it from the vehicle (Figure 1).

1. Place the cargo load floor (1) into the vehicle (Figure 4).
2. Install the bolts (1) and nuts (2) that secure the cargo load floor (3) to the body and tighten the bolts to 11 N·m (8 Ft. Lbs.) and the nuts to 7 N·m (62 In. Lbs.) (Figure 3).
3. Close the cargo floor cover.
4. Long Wheelbase vehicle - Install the fasteners that secure the cargo rails to the rear floor (Figure 2).
5. Align and secure the retaining clips that secure the liftgate sill scuff plate to the rear sill (Figure 1).
6. Close the liftgate.

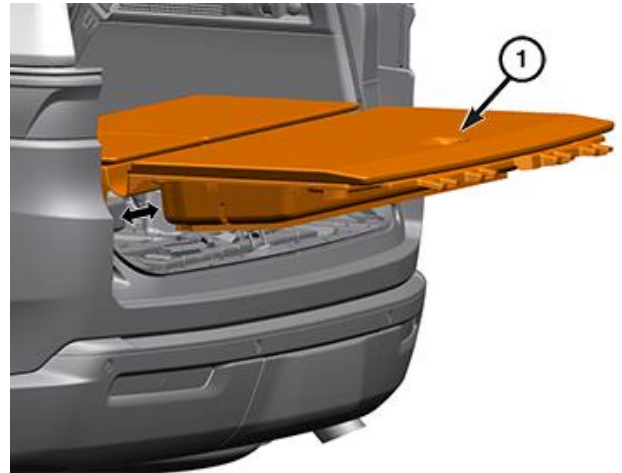
Figure 4 – Cargo Load Floor

6. Remove the cargo load floor (1) from the vehicle (Figure 4).

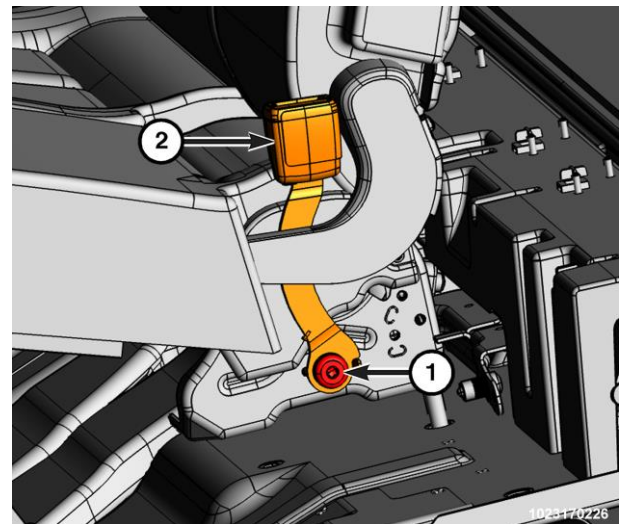
Figure 14 – Seatbelt Buckle Fastener

7. Roll the seat forward into the footwell.
8. Remove the third row center seatbelt buckle bolt (1) from the buckle anchor (Figure 14).
9. Roll the seat back onto the floor.
10. Raise the lower seat cushion.
11. Remove the buckle (2) from the seat (Figure 14).

1. Place the **NEW** seatbelt buckle into position on the seat (Figure 14).
2. Lower the seat cushion.

3. Roll the seat forward into the footwell.
4. Tighten the **NEW** bolt provided with the buckle to 48 N·m (35 Ft. Lbs.) (Figure 14).
5. Roll the seat back onto the floor.
6. Install the marriage bracket to the seats (2) (Figure 13). Install **NEW** screws (1) into the marriage bracket (3) and tighten to 28 N·m (21 Ft. Lbs.).
7. Secure the wire harness retainer (4) to the marriage bracket (3) (Figure 13).
8. Install the third row left seat to floor nuts (1) and tighten to M10X1.50 to 50 N·m (37 Ft. Lbs.) and M12X1.75 to 70 N·m (52 Ft. Lbs.) (Figure 12).
9. Install the **NEW** third row right seat to floor nuts and/or bolts (2) and tighten to 50 N·m (37 Ft. Lbs.) (Figure 11).
10. Install the seat fastener covers.
11. Install the rear air duct (1) to the vehicle and engage the retaining tabs (Figure 10).

11. Remove the third row center seatbelt buckle bolt (1) from the buckle anchor (Figure 14).
12. Raise the lower seat cushion.

13. Remove the buckle (2) from the seat (Figure 14).

1. Place the **NEW** center seatbelt buckle into position on the third row right seat (Figure 14).
2. Lower the seat cushion.

3. Tighten the **NEW** bolt provided with the buckle to 48 N·m (35 Ft. Lbs.) (Figure 14).
4. Install the **NEW** third row right seat to floor nuts and/or bolts (2) and tighten to 50 N·m (37 Ft. Lbs.) (Figure 11).
5. Install the seat fastener covers.
6. Place the **NEW** third row left seat seatbelt buckle into position on the seat (Figure 9).
7. Tighten the **NEW** bolt provided with the buckle to 48 N·m (35 Ft. Lbs.).
