TECHNICAL INSTRUCTIONS

SAFETY RECALL 23TA12

Front Lower Bumper Cover Assembly May Detach While Driving

CERTAIN 2020-2023 MODEL YEAR HIGHLANDER AND HIGHLANDER HV

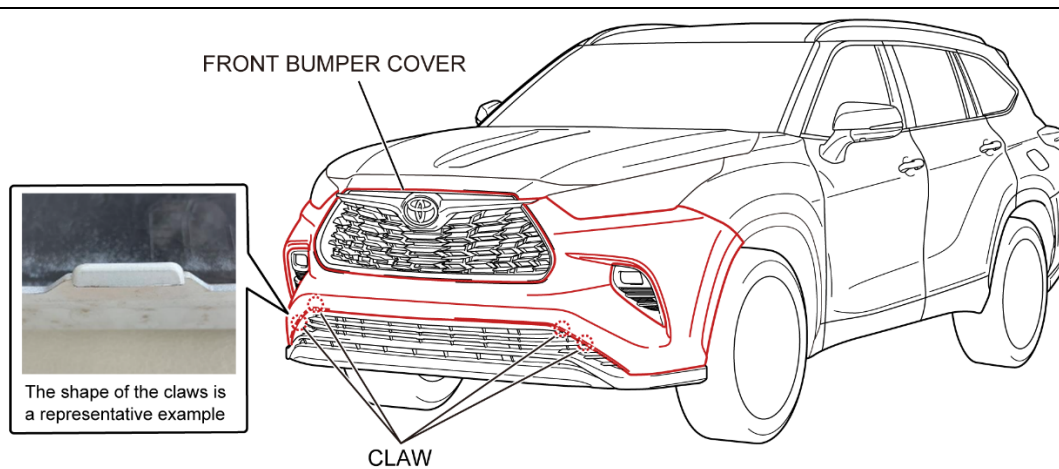
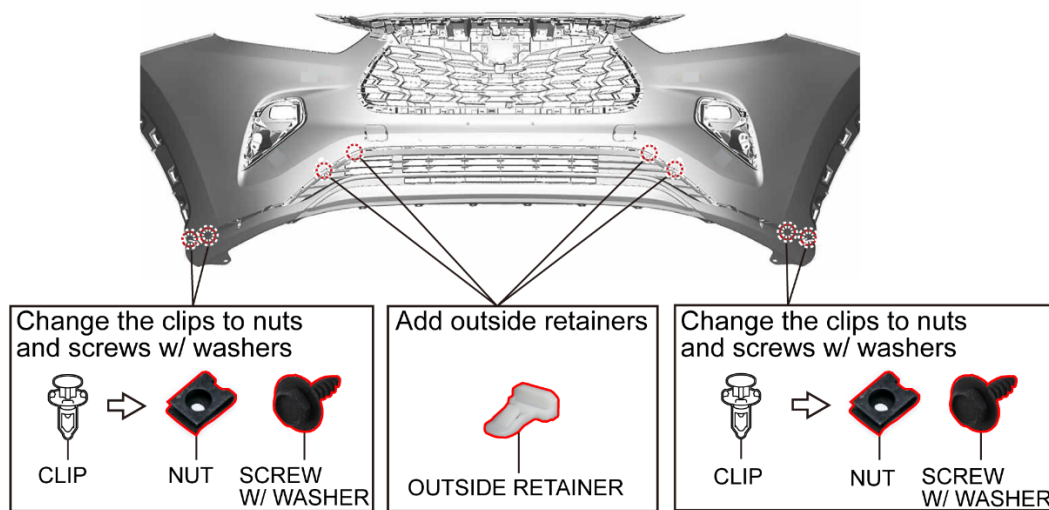
A090186J01001aS

Add fasteners to the front bumper cover

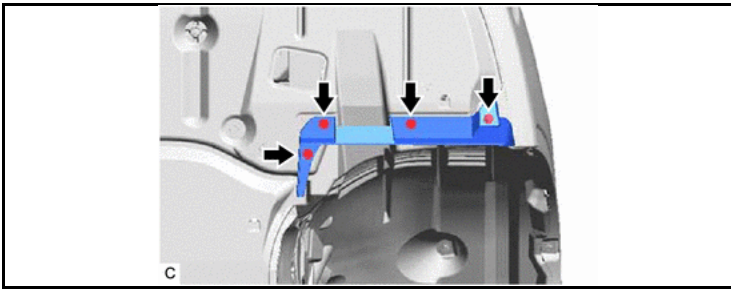
1. REMOVE THE FRONT WHEEL OPENING EXTENSION PAD LH

- a) Remove the 4 screws and front wheel opening extension pad LH.

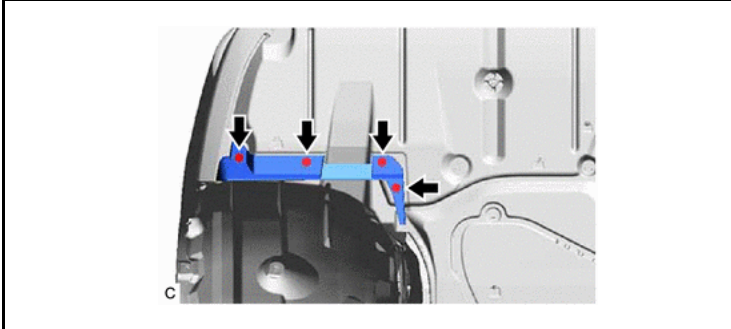
2. REMOVE THE FRONT WHEEL OPENING EXTENSION PAD RH

- a) Remove the 4 screws and front wheel opening extension pad RH.

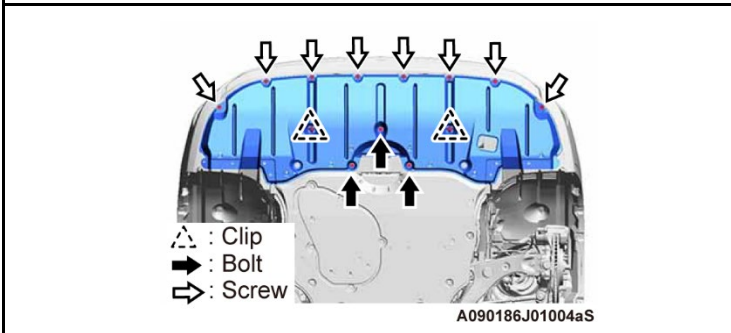
3. REMOVE NO. 1 ENGINE UNDER COVER

- a) Remove the 3 bolts, 8 screws, 2 clips and No. 1 engine under cover.

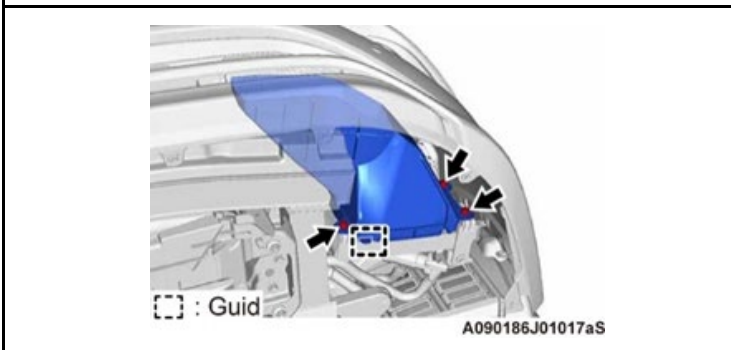
4. UNBOLT THE TRANSMISSION OIL COOLER AIR DUCT (IF APPLICABLE)

- a) Remove the 3 bolts from the transmission oil cooler duct located on the driver's side front bumper.

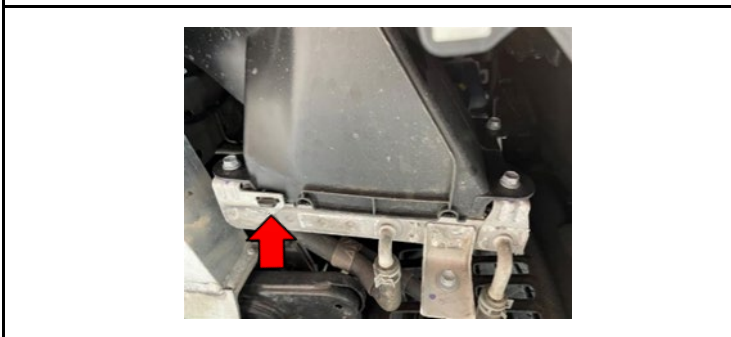
- b) Disengage the guide to remove the transmission oil cooler air duct from the oil cooler assembly.

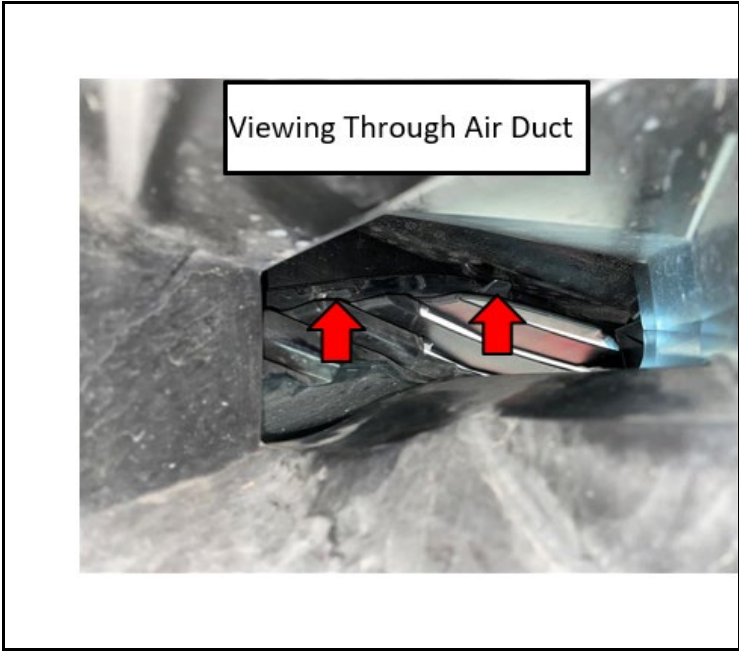
- c) Turn the air duct so that the upper driver's side bumper cover claws can be viewed by peering through the tube with a flashlight.

5. INSPECT FRONT BUMPER COVER CLAWS

a) Check for damage on the 4 claws (shown in the picture) and check that all the claws are engaged.

b) If disengaged claws were found in step “a”, properly engage them.

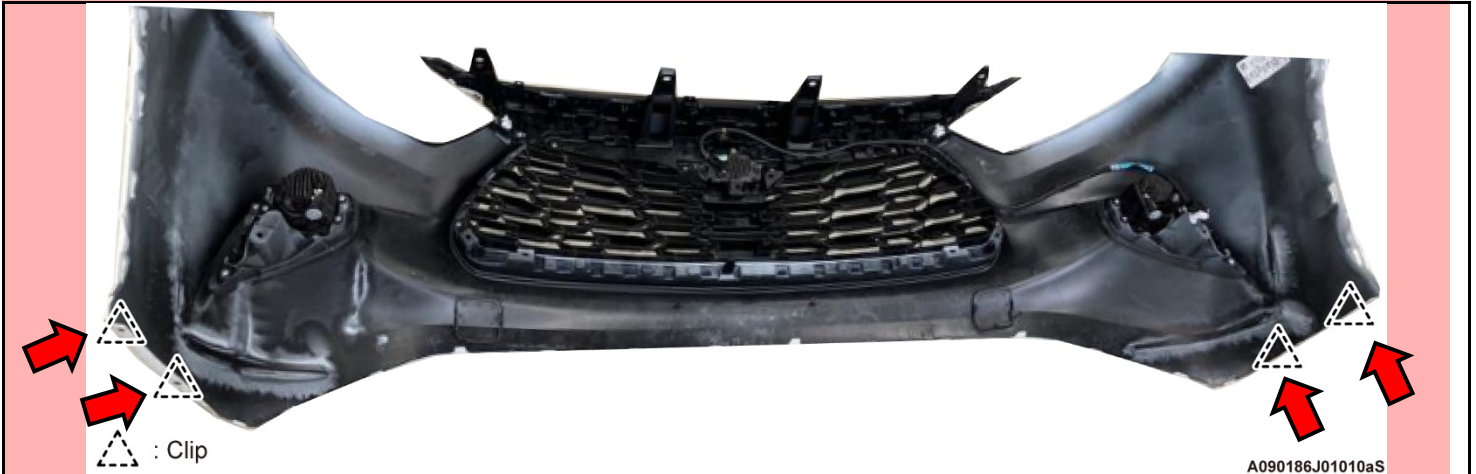
- a) Remove the 4 clips.

- b) Mark or destroy the removed 4 clips and store them in a separate container to prevent accidental reuse.
- c) Install the 4 **NEW** nuts.

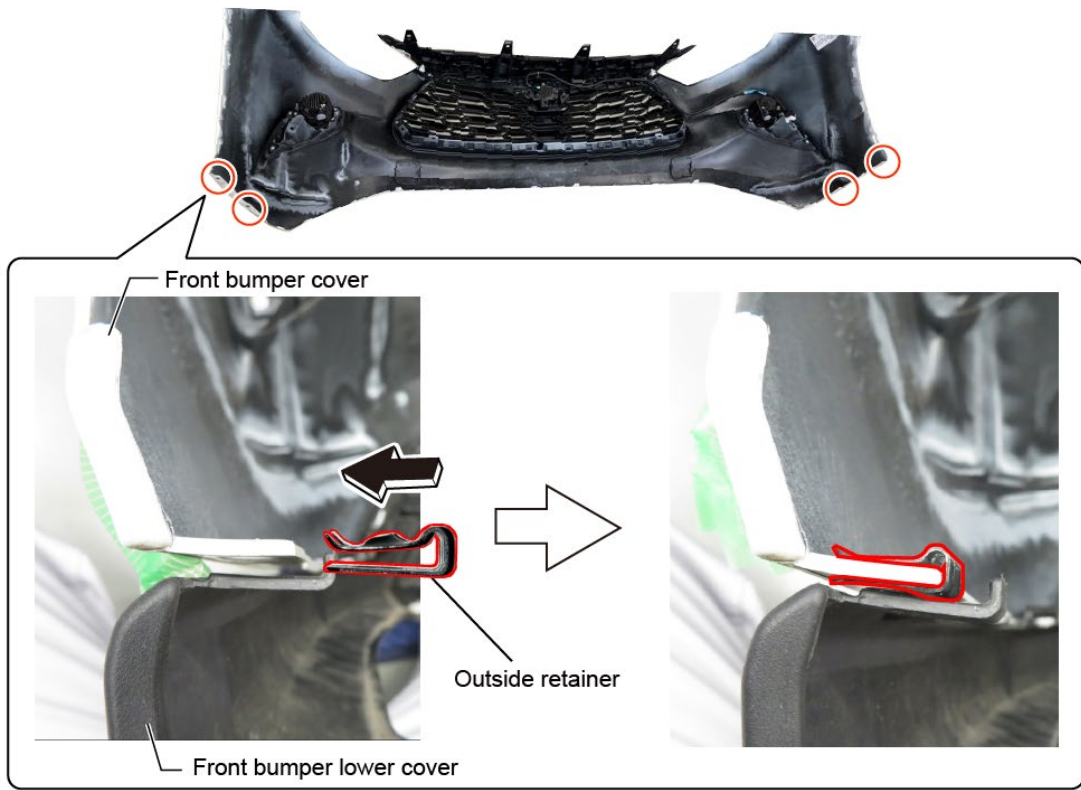
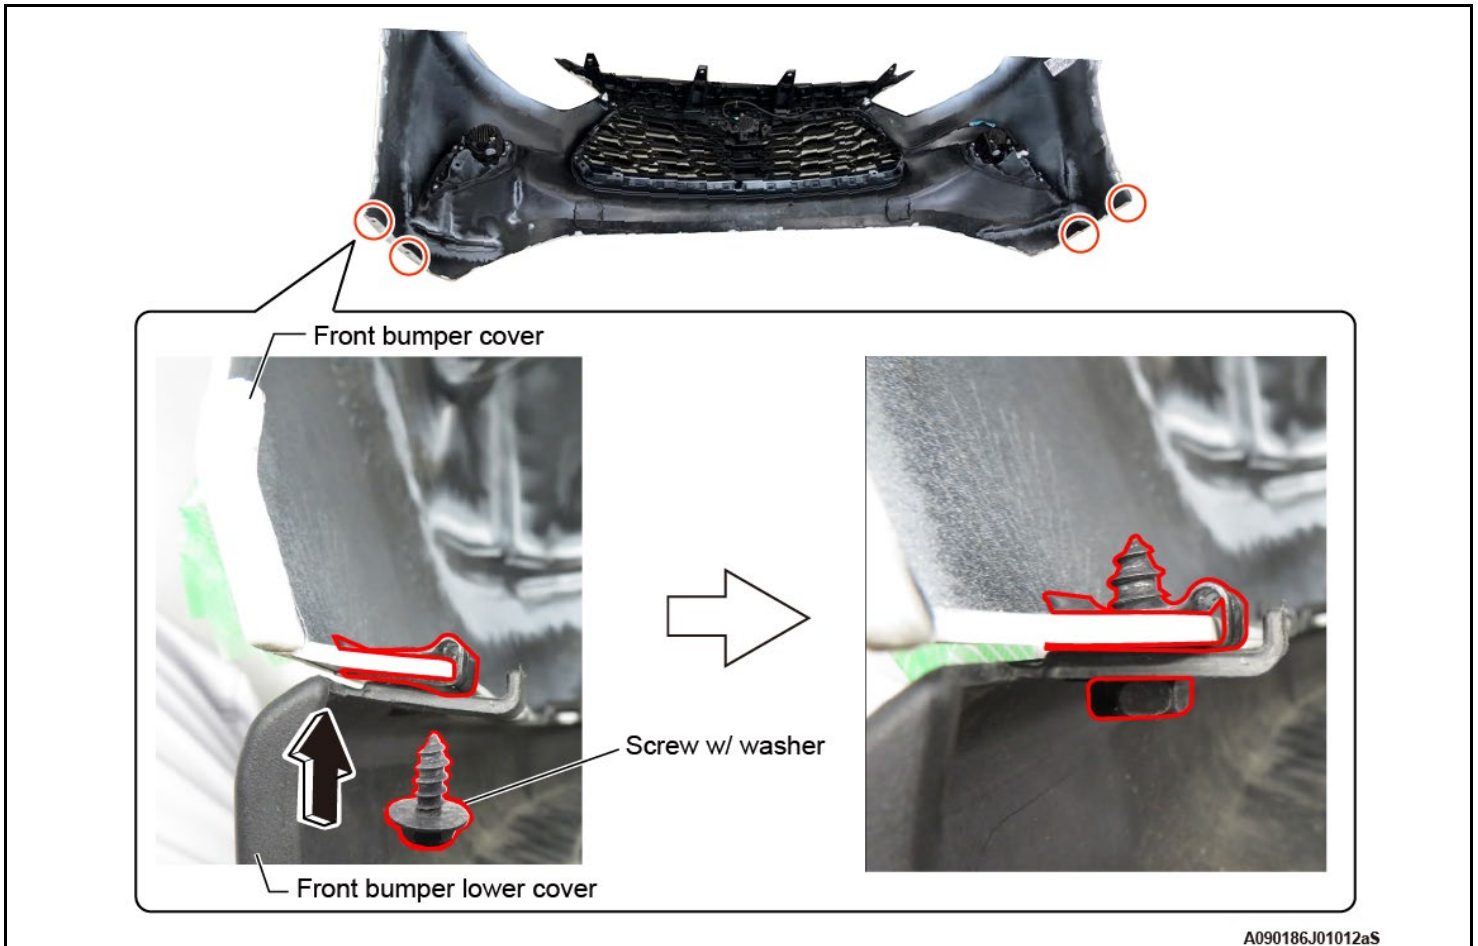
A090186J01011aS

- d) Install the 4 **NEW** screws and washers.
- e) Confirm the alignment of the bumper and fender when fastening.

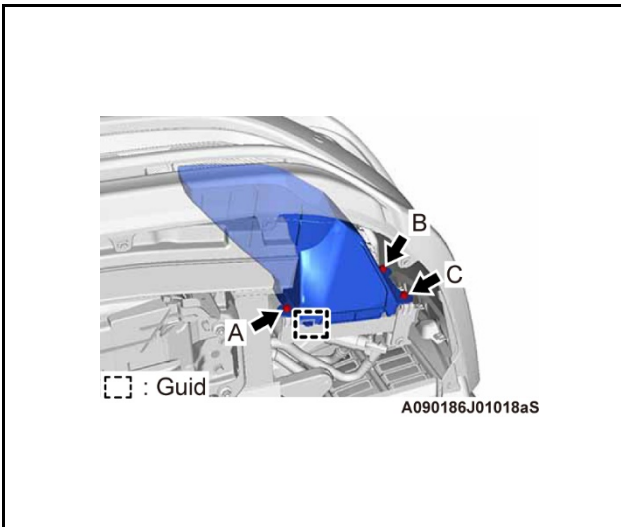
1. REINSTALL TRANSMISSION OIL COOLER AIR DUCT

- Re-engage the guide to temporarily reinstall the transmission oil cooler air duct to the oil cooler assembly.
- Reinstall the transmission oil cooler air duct to the oil cooler assembly with the 3 bolts.

Torque:

6.0 N*m (61 kgf*cm, 53 in.*lbf)

Tightening order: Bolt (A) → Bolt (B) → Bolt (C)

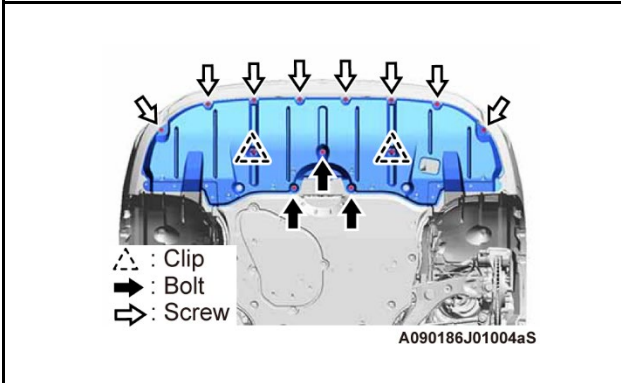
2. REINSTALL NO. 1 ENGINE UNDER COVER

- Reinstall the No. 1 engine under cover with the 3 bolts, 8 screws and 2 clips.

Bolt: 7.5 N*m (76 kgf*cm, 66 in.*lbf)

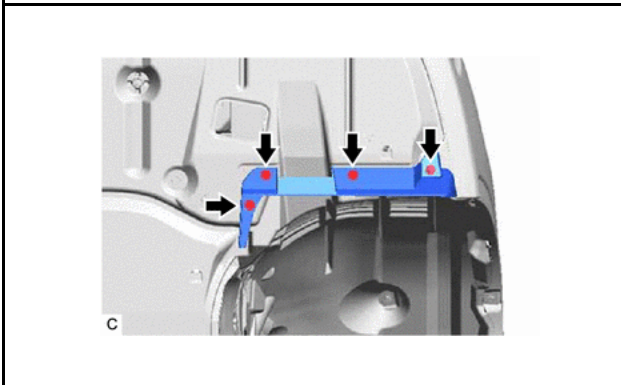
3. REINSTALL FRONT WHEEL OPENING EXTENSION PAD LH

- Reinstall the front wheel opening extension pad LH with the 4 screws.

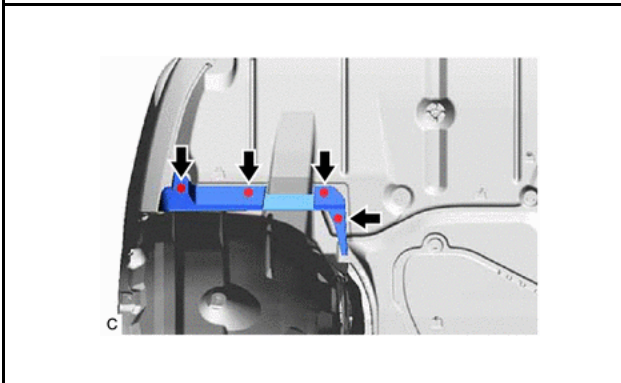
4. REINSTALL FRONT WHEEL OPENING EXTENSION PAD RH

- Reinstall the front wheel opening extension pad RH with the 4 screws.

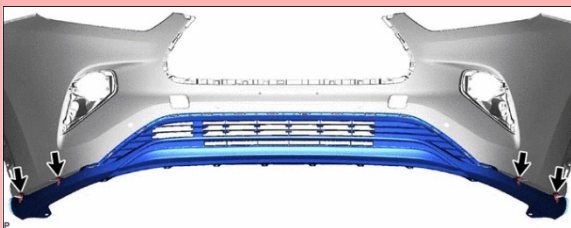
(A)

- a) for **Type A**: Remove the 4 clips.

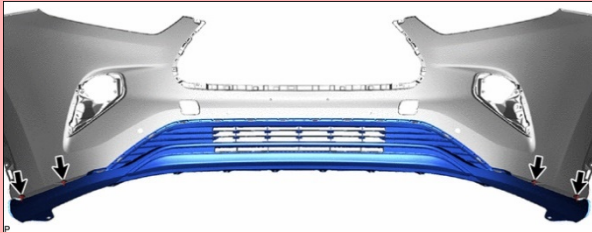
(B)

b) for **Type B**: Remove the 4 screws.

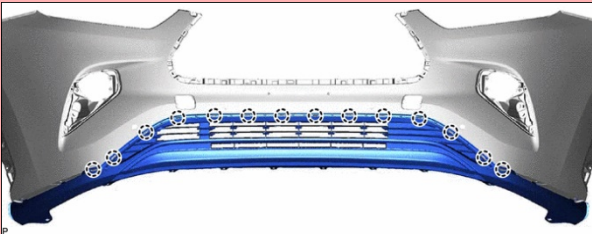
5. DISENGAGE THE CLAWS

a) Disengage 14 claws to remove the front bumper lower cover from the front bumper cover.

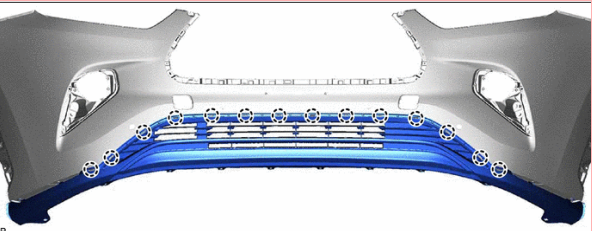
1. INSTALL FRONT BUMPER LOWER COVER

a) Engage the 14 claws.
