TECHNICAL INSTRUCTIONS

SAFETY RECALL 23TA13

Potential Vehicle Fire related to 12-volt battery

CERTAIN 2013 - 2018 RAV4 VEHICLES

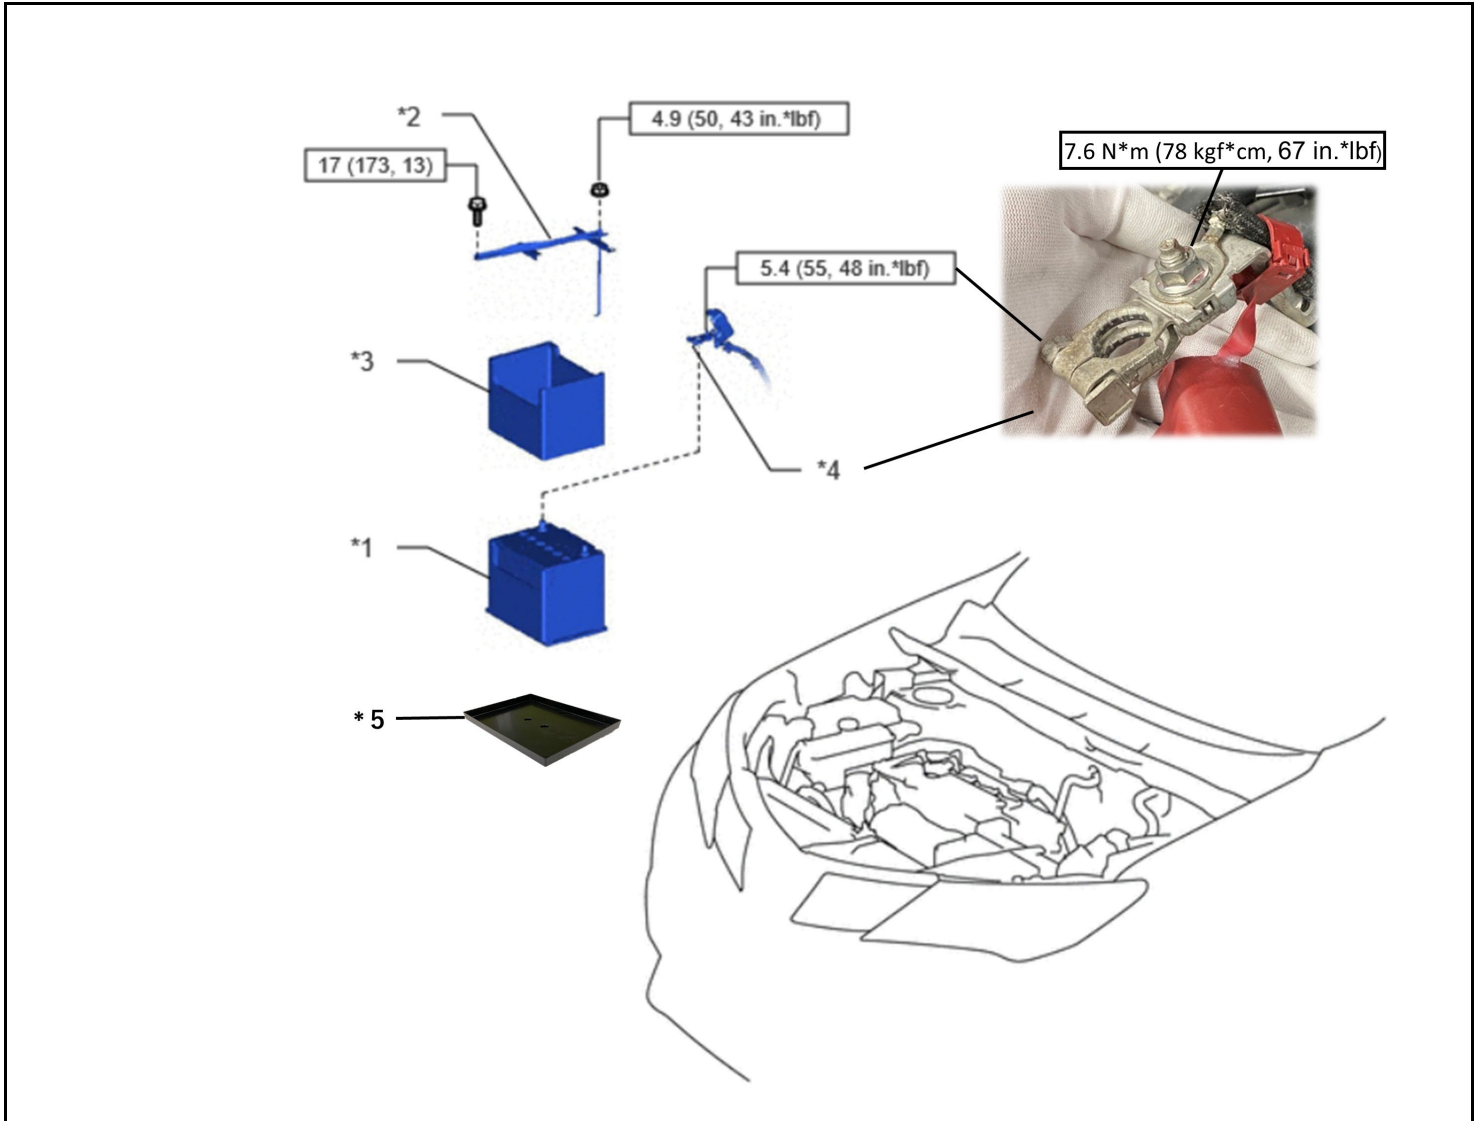
V. COMPONENTS

*1	BATTERY	*2	BATTERY CLAMP SUB-ASSEMBLY
*3	BATTERY INSULATOR	*4	POSITIVE BATTERY TERMINAL
*5	BATTERY TRAY		Specified torque: N*m (kgf*cm, in.*lbf)

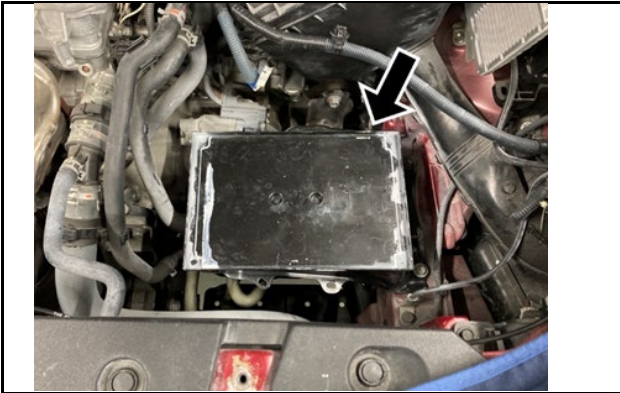
1. REMOVE BATTERY TRAY.

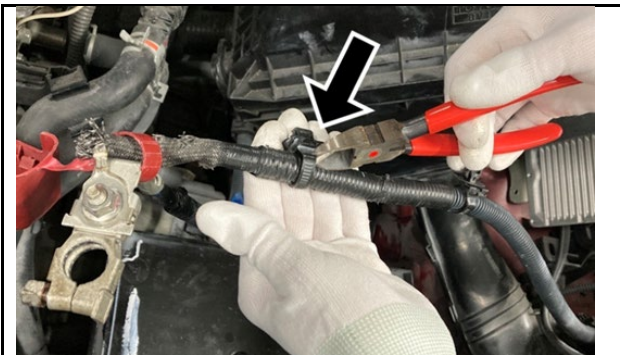
2. CUT FRONT WIRE HARNESS CLAMP.

Be careful not to damage the harness.

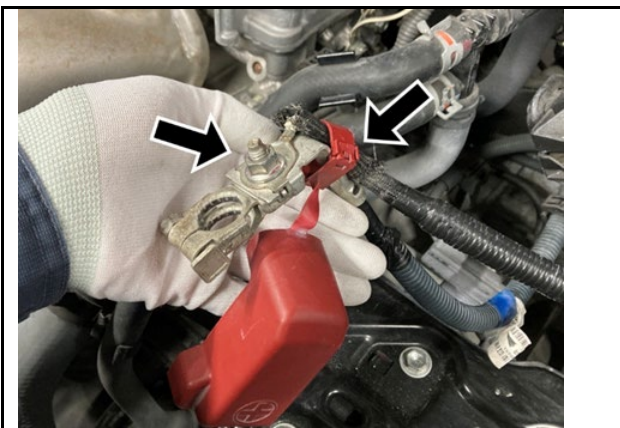
3. REMOVE HEAD OF POSITIVE (+) BATTERY TERMINAL AND BATTERY CONNECTOR COVER.

- a) Remove the nut and the head of the positive (+) battery terminal.
- b) Remove the battery connector cover.

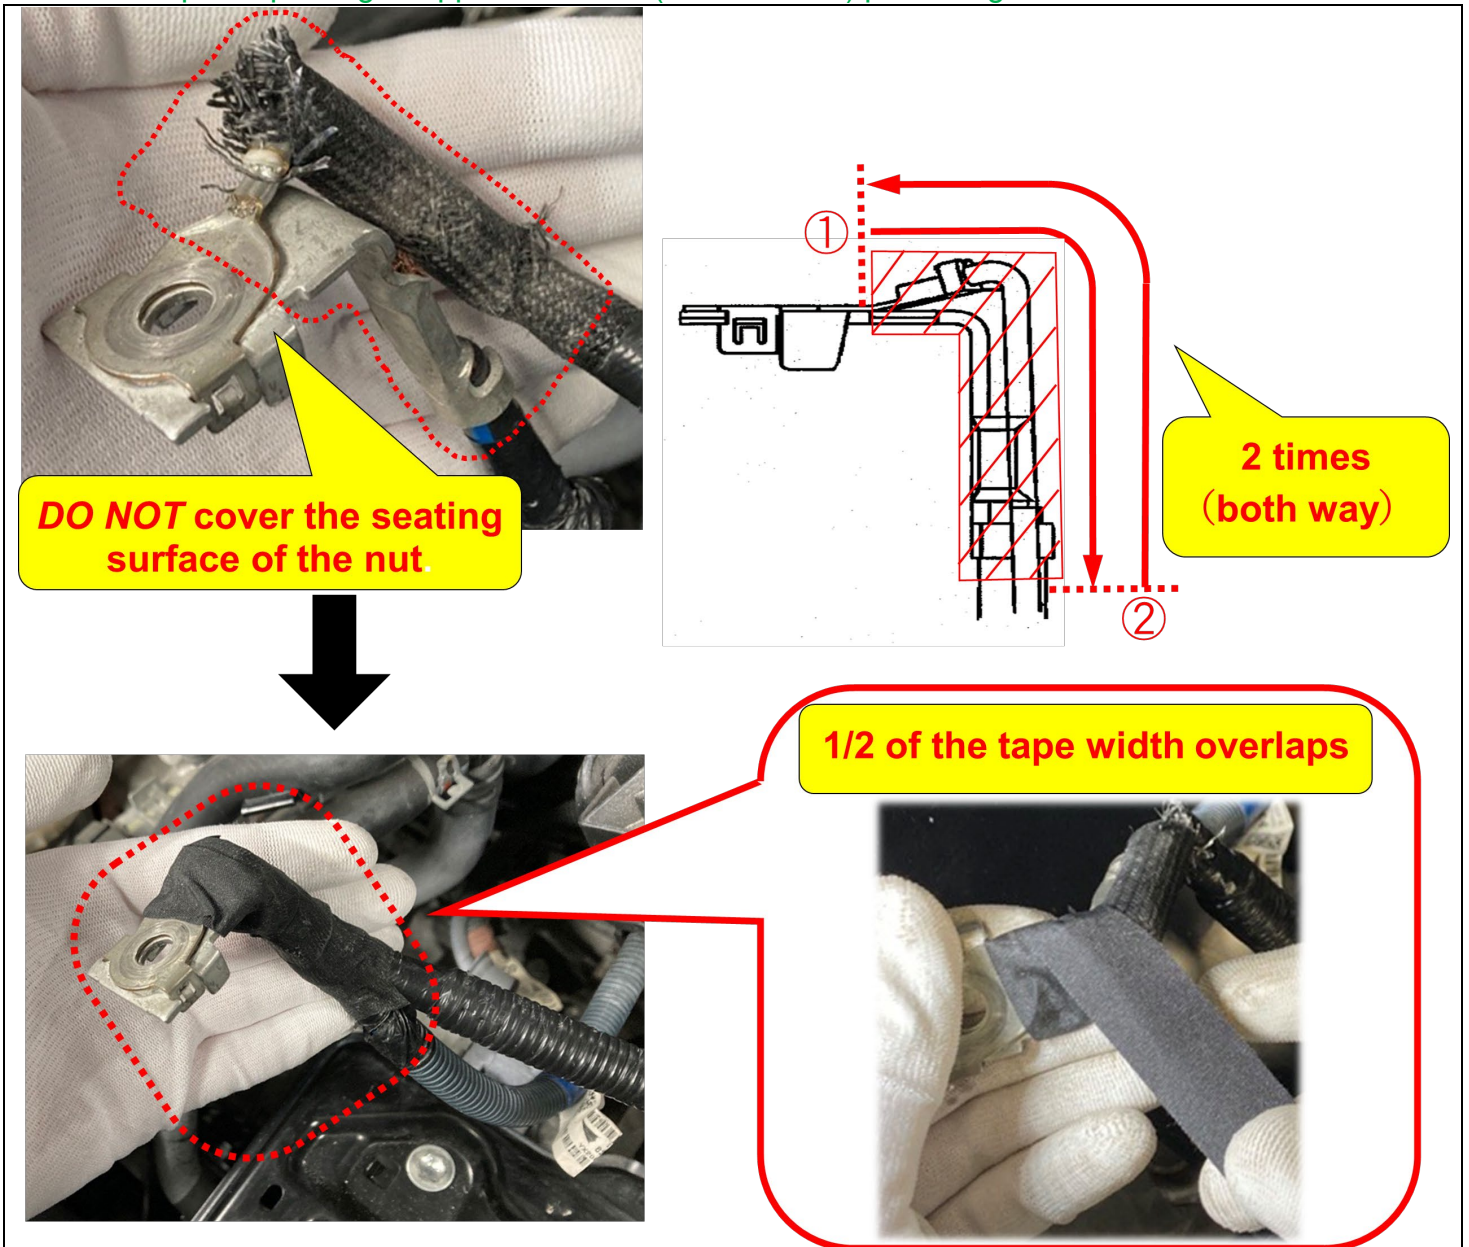
4. WRAP REPAIR TAPE (Tessa Tape).

a) Wrap the terminal area (metal area) spirally as shown in the illustration with repair tape.

- Ensure that the terminal area (metal area) is completely covered by repair tape.
- Wrap the tape spirally with 1/2 of the tape width overlaps as shown in the illustration and wrap the tape another time in the opposite direction.
- **DO NOT** cover the seating surface of the nut.

Repair tape length: approx. 400mm (15.75 inches) per a single rework.

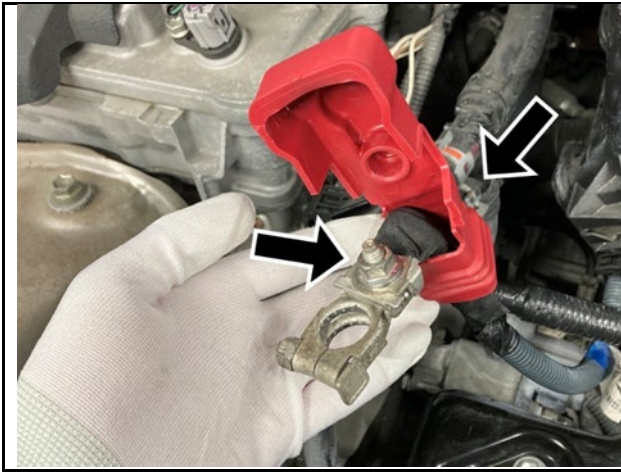
5. INSTALL HEAD OF POSITIVE (+) TERMINAL AND **NEW** CONNECTOR COVER.

- a) Install a **New** battery connector cover.
- b) Install the head of the positive (+) battery terminal and tighten the nut.

7.6 N*m (78 kgf*cm, 67 in.*lbf)

Route the positive battery cable on the bracket between the j-hook and air cleaner

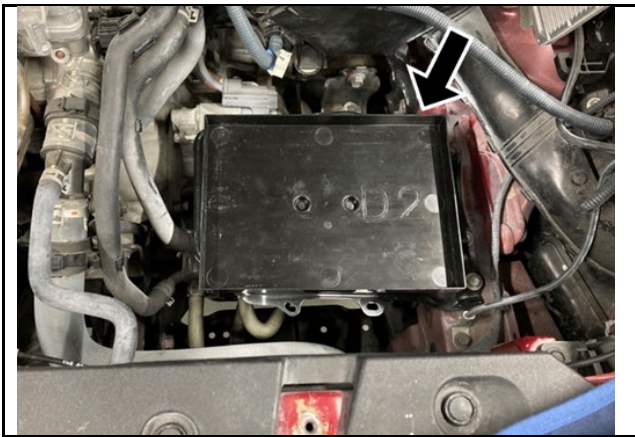
6. INSTALL **NEW** BATTERY TRAY.

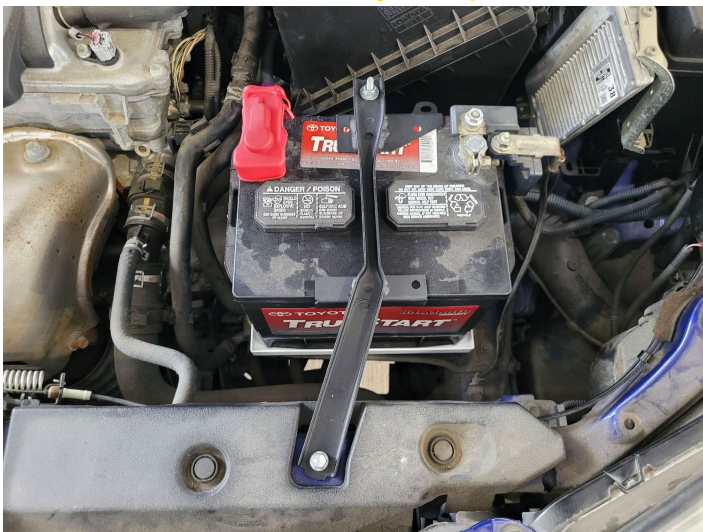
- when installing the battery, attaching the front wire harness only is necessary.
- Install a **NEW** battery clamp and a **NEW** J-hook.

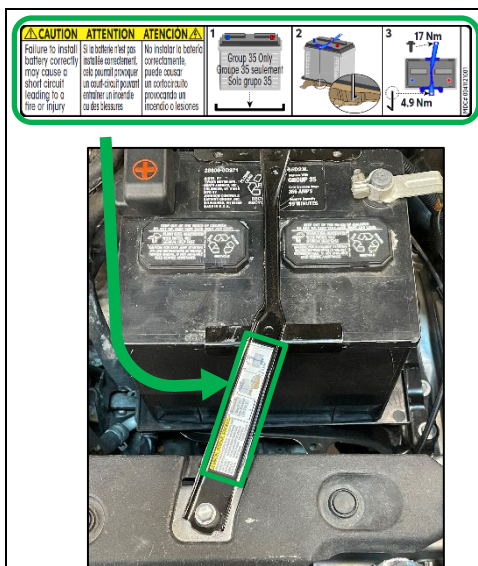
ADHERE CAUTION LABEL TO BATTERY HOLD-DOWN CLAMP

- a. Check to see if label is installed already.
- b. If not installed, adhere new caution label to the battery hold-down clamp.

- Ensure battery hold-down clamp is clean and free of moisture or dirt so the label can properly adhere.
- Labels may be ordered from the MDC.
