# **TECHNICAL INSTRUCTIONS**

## **SAFETY RECALL 23TA13**

**Potential Vehicle Fire related to 12-volt battery**

### **CERTAIN 2013 - 2018 RAV4 VEHICLES**

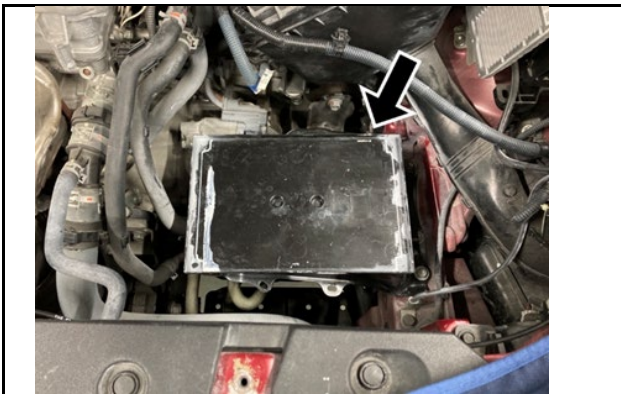
1. REMOVE BATTERY TRAY.

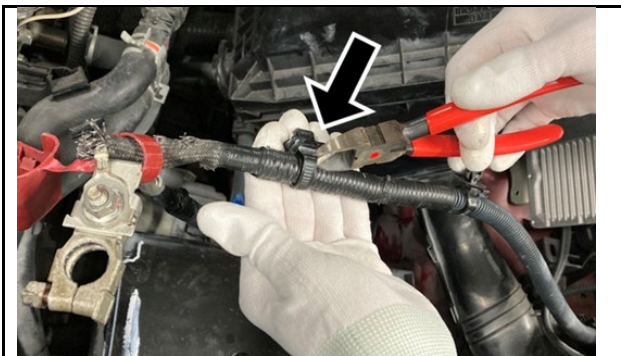
2. CUT FRONT WIRE HARNESS CLAMP.

**NOTICE:**

Be careful not to damage the harness.

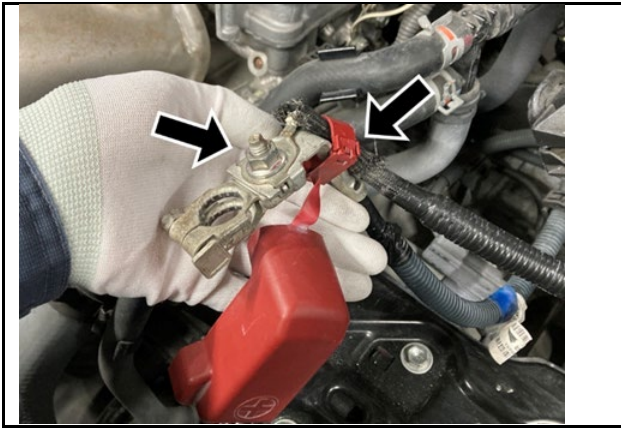
**3. REMOVE HEAD OF POSITIVE (+) BATTERY TERMINAL AND BATTERY CONNECTOR COVER.**

- a) Remove the nut and the head of the positive (+) battery terminal.
- b) Remove the battery connector cover.

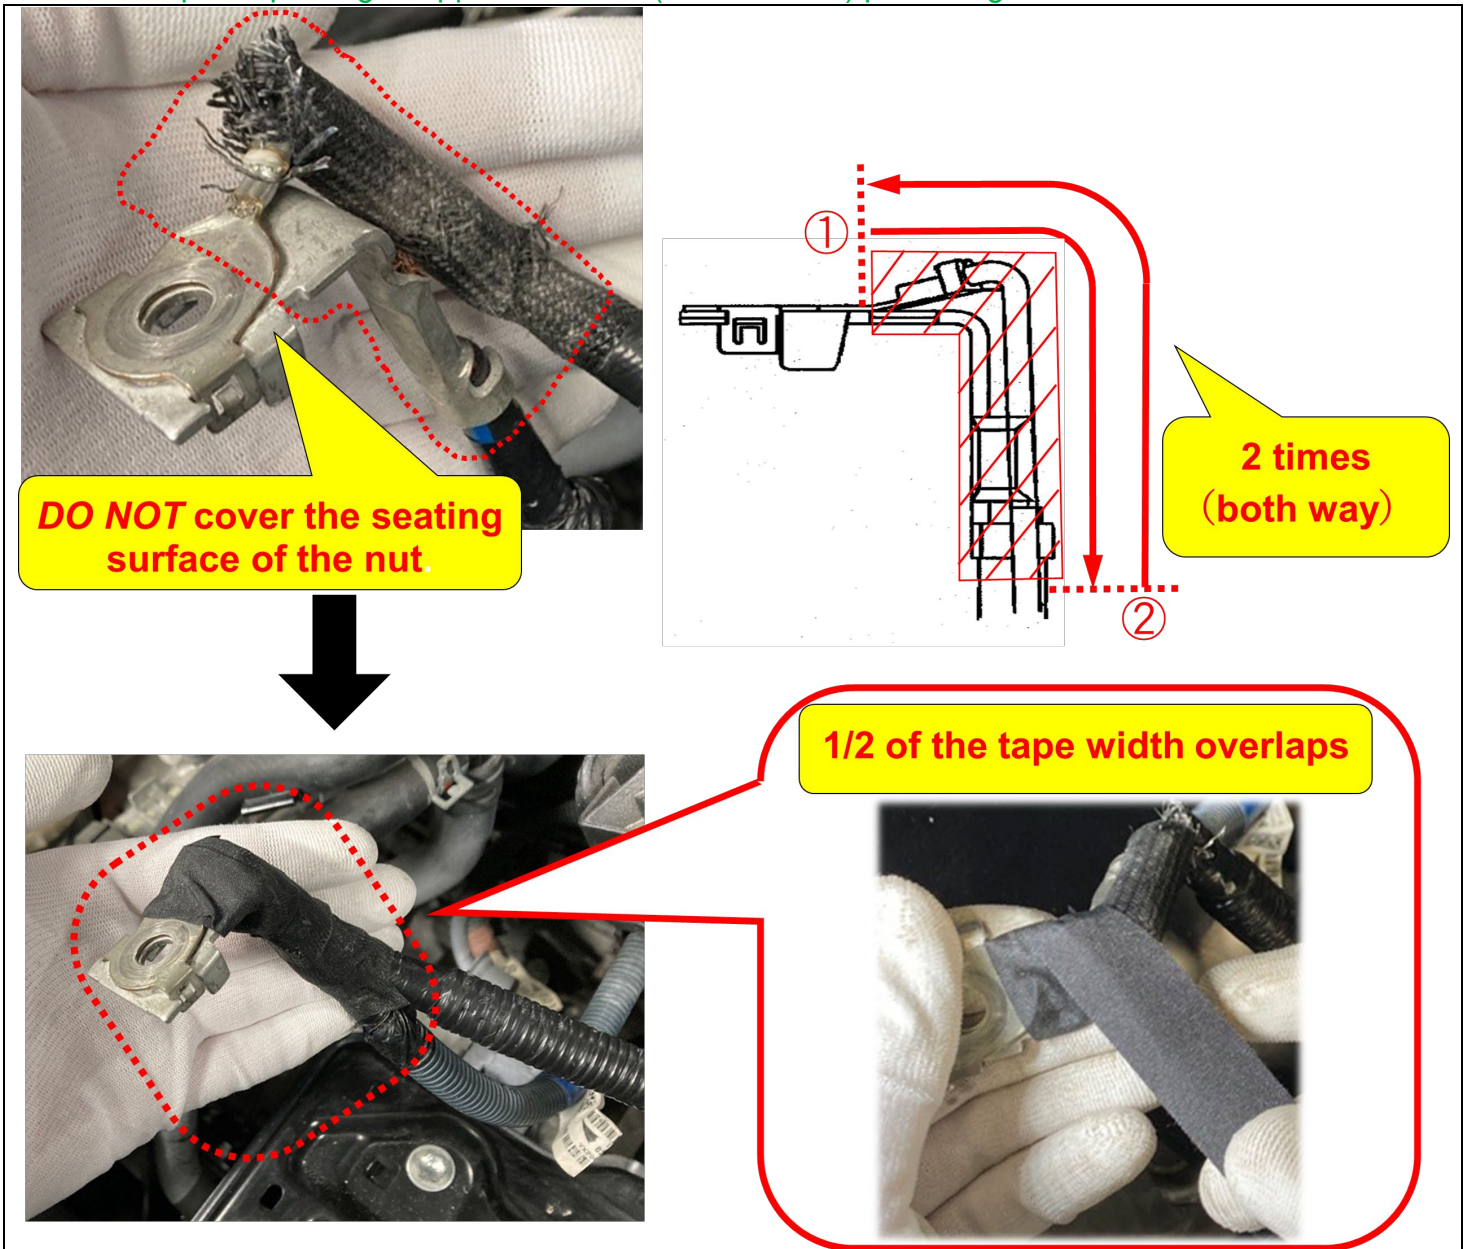
#### 4. WRAP REPAIR TAPE (Tessa Tape).

a) Wrap the terminal area (metal area) spirally as shown in the illustration with repair tape.

- Ensure that the terminal area (metal area) is completely covered by repair tape.
- Wrap the tape spirally with 1/2 of the tape width overlaps as shown in the illustration and wrap the tape another time in the opposite direction.
- **DO NOT** cover the seating surface of the nut.

Repair tape length: approx. 400mm (15.75 inches) per a single rework.

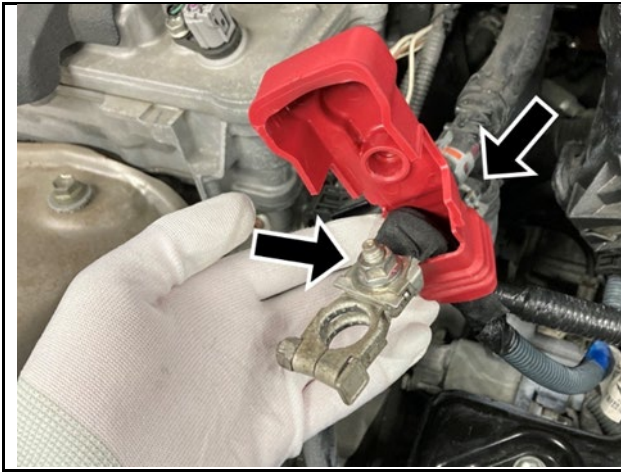
**5. INSTALL HEAD OF POSITIVE (+) TERMINAL AND *NEW* CONNECTOR COVER.**

- a) Install a *New* battery connector cover.
- b) Install the head of the positive (+) battery terminal and tighten the nut.

Torque:

7.6 N\*m (78 kgf\*cm, 67 in.\*lbf)

**NOTE:**

Route the positive battery cable on the bracket between the j-hook and air cleaner

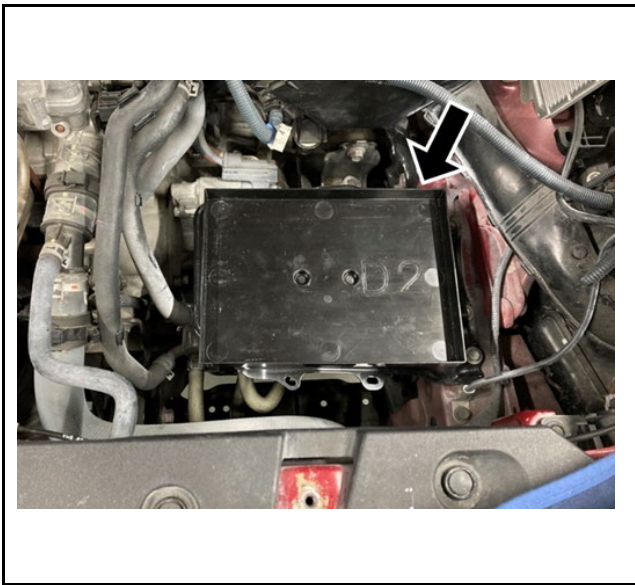
**6. INSTALL *NEW* BATTERY TRAY.**

**NOTICE:** If the correct group 35 battery is not installed, ensure the battery tray fits properly. Properly fitted means the battery can sit within the tray and does not rest on the raised edges. If the battery does sit on the raised edges, the battery hold down cannot be properly torqued. In this case, use the original tray in the vehicle and provide the tray from the recall repair kit to the customer. Document any discrepancies on the Disclosure form if applicable.

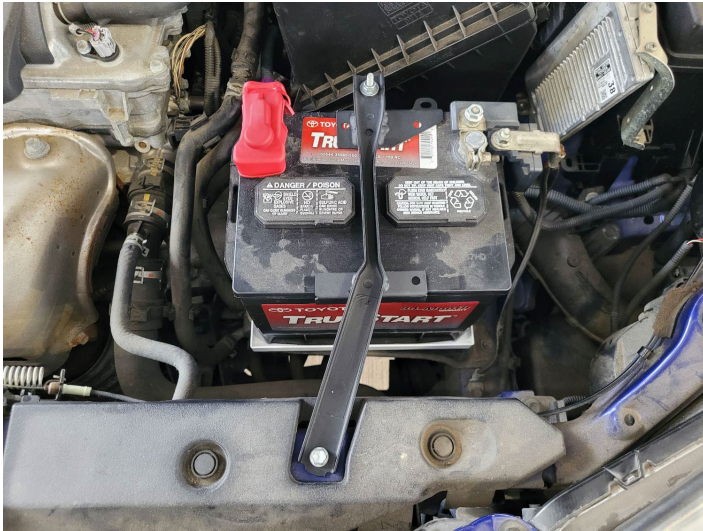
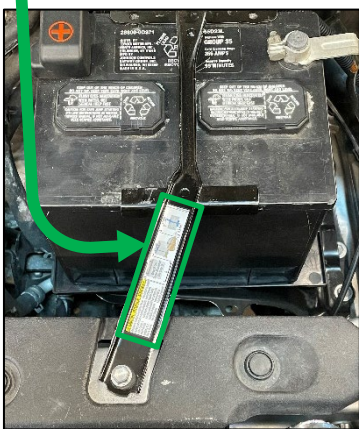
### ADHERE CAUTION LABEL TO BATTERY HOLD-DOWN CLAMP

- a. Check to see if label is installed already.
- b. If not installed, adhere new caution label to the battery hold-down clamp.

- Ensure battery hold-down clamp is clean and free of moisture or dirt so the label can properly adhere.
- Labels may be ordered from the MDC.
