# Compliance Recall

## Code: 60G3

**Subject: Compliance Recall 60G3 - Panoramic Glass Roof Interior Sunshade**

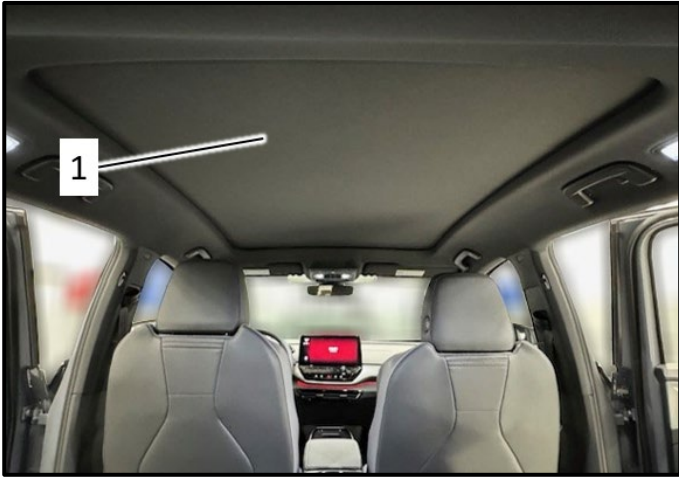
- Ensure that the sunshade <1> is completely closed.

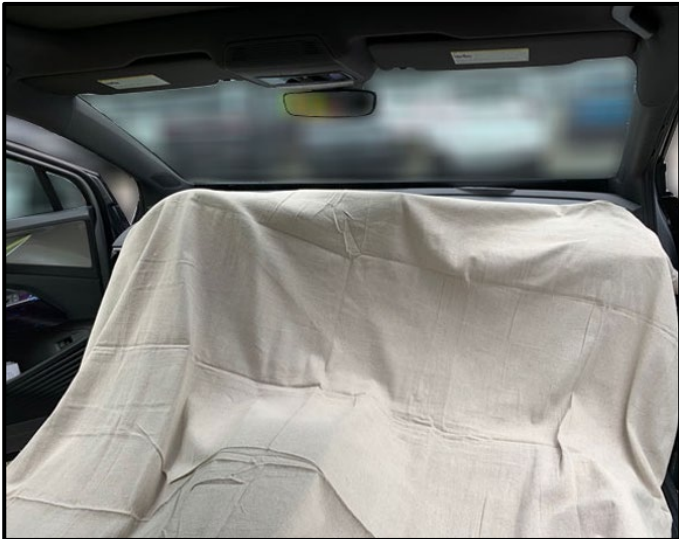
- Cover the interior to protect it from overspray.

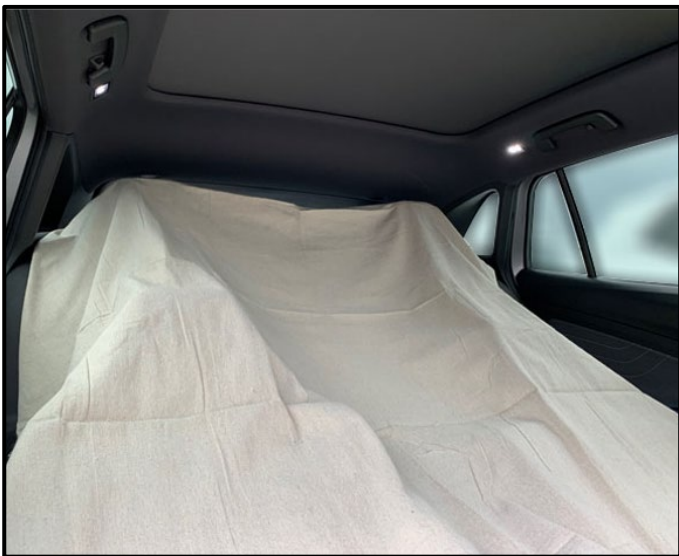
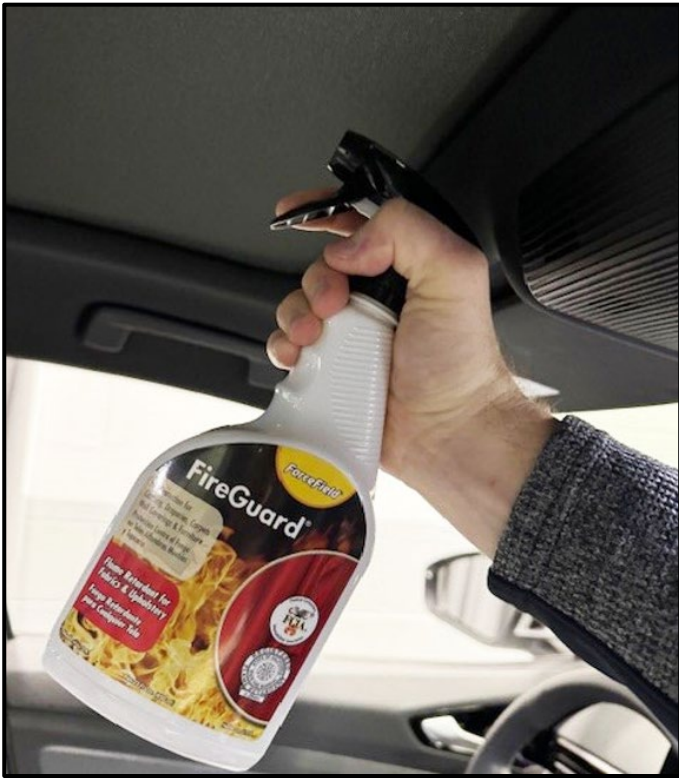
- Apply the flame retardant spray per the instructions on the bottle to the entire sunshade.

- After application, allow the vehicle to sit for one hour with all of the doors and rear lid opened to allow the product to dry.
