Compliance Recall

Code: 60G3

Subject Panoramic Glass Roof Interior Sunshade

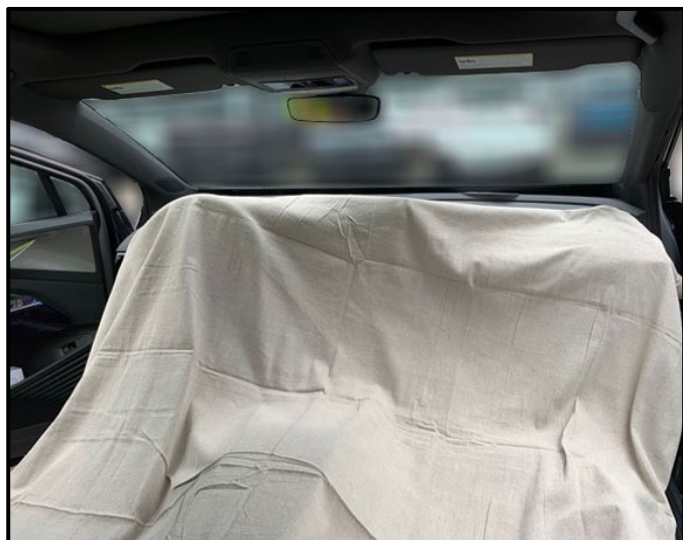
- Cover the interior to protect it from overspray.

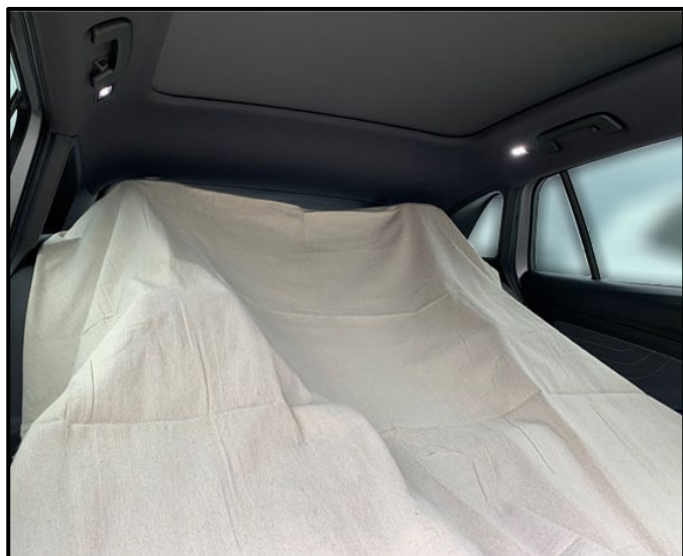
- Apply the flame retardant spray per the instructions on the bottle to the entire sunshade.

- After application, allow the vehicle to sit for one hour with all of the doors and rear lid opened to allow the product to dry.

Read the product instructions for information about interactions with other chemicals and safety precautions.
