Service Bulletin

24-001

March 1, 2024 Version 5

Safety Recall: 2016–20 MDX Connecting Rod Bearing

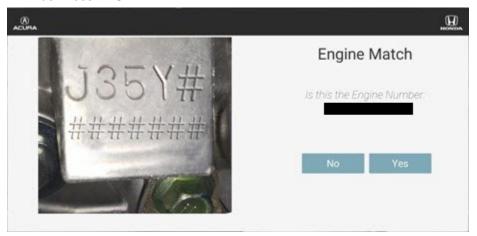
- 8. Does the engine number from the vehicle match the engine number on file?
 - Yes-Press YES.

No-Manually enter the 12-digit engine number into the application.
 NOTE: Blank or incorrect numbers will not be accepted and rejected during the inquiry call.

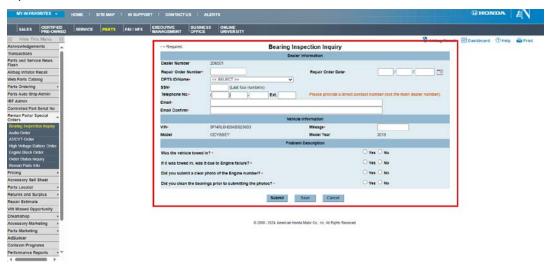
5. Input all vehicle information to create a case.

6. A 7-digit case reference number will be generated.

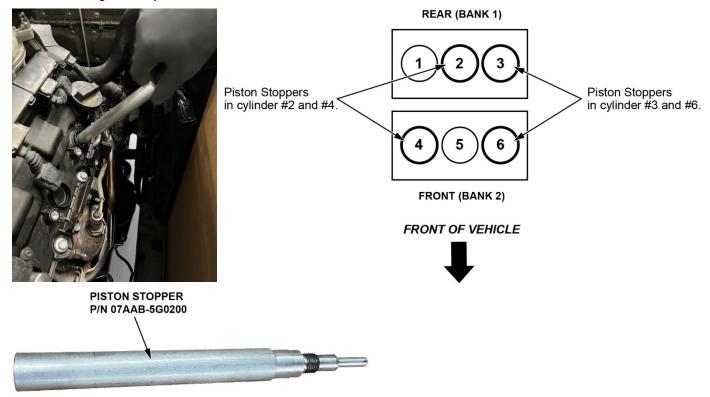
10. Install the piston stoppers in cylinders 2,3,4, & 6.

NOTE: Hand tighten only.

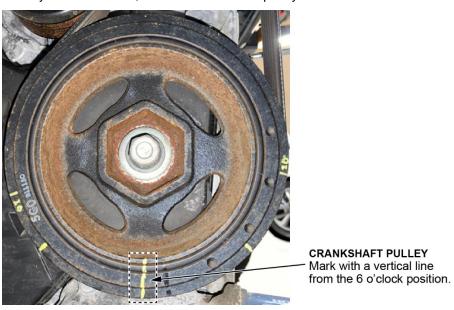
18. With cylinder 1 at TDC, mark the crankshaft pulley with a vertical line at the 6 o'clock position.

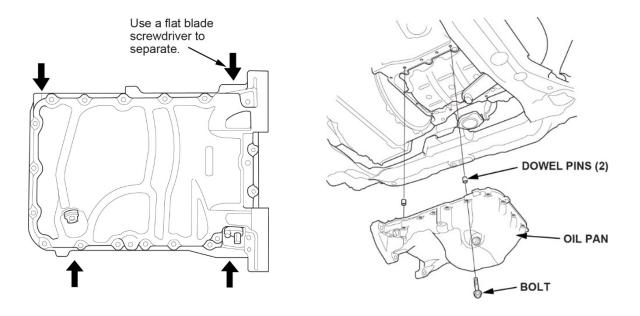
- Remove the bolts securing the oil pan.
- Use a flat blade screwdriver to separate the oil pan from the engine block.

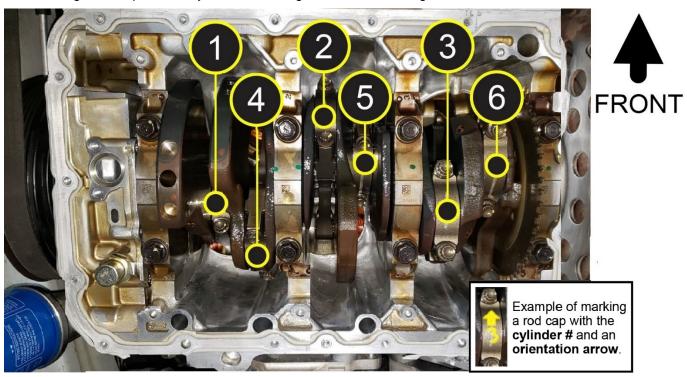
28. Clean and label each connecting rod cap with a paint marker (or otherwise suitable marking instrument) prior to removal. Make sure each rod cap has both the **cylinder #** and an **orientation arrow** pointing to the front of the vehicle.

- Do not confuse the existing marking on the side of the connecting rod and rod cap with the cylinder number. These are manufacturing marks referring to the size of the rod.
- Installing a rod cap incorrectly will result in engine knock and/or engine failure.

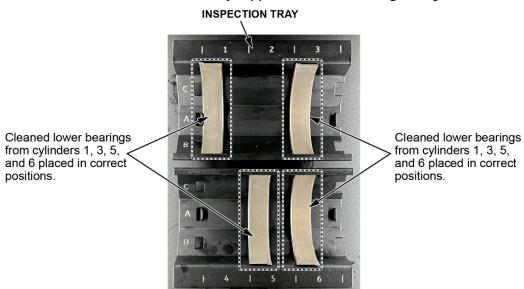
- Thoroughly clean the bearings with a clean shop towel prior to placing the bearing in the inspection tray. No oil should be present. Do not use any solvents.
- Place the removed bearings into the inspection tray at the correct position. For example, the cylinder 1 bearings should be in the #1 slot in the tray. Upper and lower bearing arrangement in the tray does not matter.

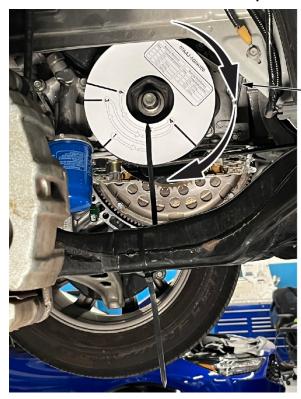
33. Rotate the crankshaft clockwise to the #2 position (TDC +45°).

Rotate the crank clockwise to the #2 position.

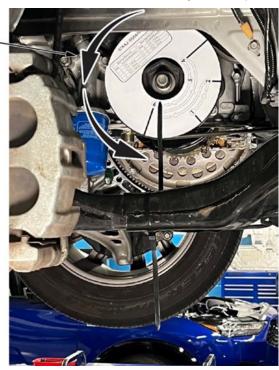
38. Rotate the crankshaft counterclockwise to the #3 position (TDC -45°).

Rotate the crank counterclockwise to the #3 position.

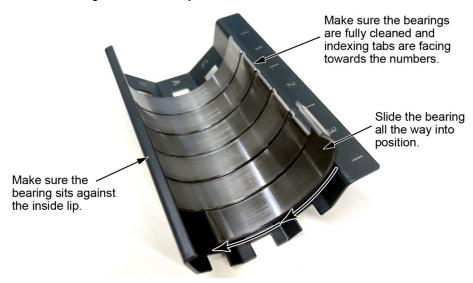
- 47. Make sure the bearings are fully seated and level with the edge of the inspection tray.
 - The bearing's indexing tab should be lined up at the numbers.
 - The flat edge of the bearing should be inside the lip.
 - All bearings should be fully seated.

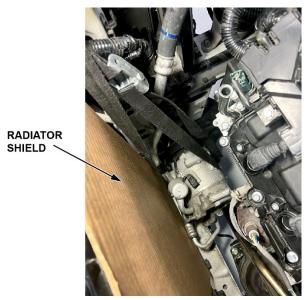
- A suitable radiator shield could be as simplle as a clean piece of carddboard.
- Make sure the shield covers the entire radiator surface that was exposed with the fan removed.

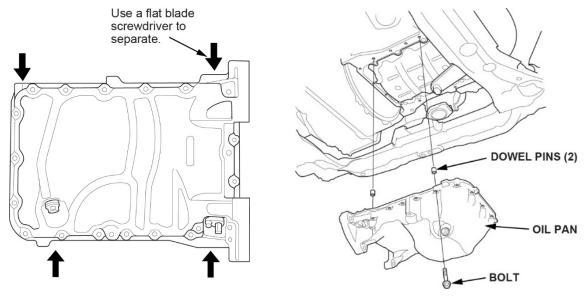
- Remove the bolts securing the oil pan.
- Use a flat blade screwdriver to separate the oil pan from the engine block.
- 37. Using a flat blade screwdriver, separate the oil pan from the engine block in the places shown.

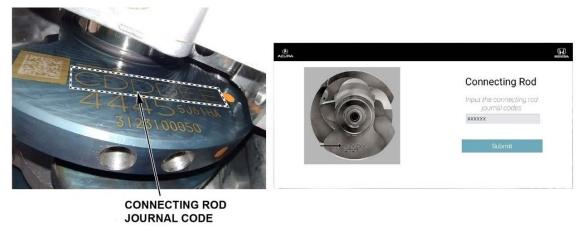
- 40. Login to V-SMART application.
- 41. Enter the connecting rod journal codes.

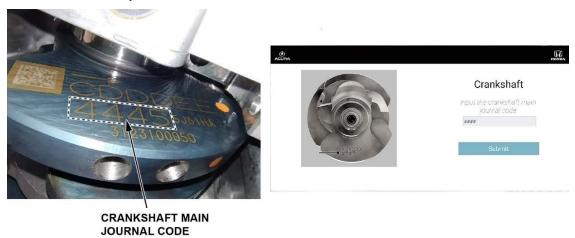
42. Enter the crankshaft journal codes.

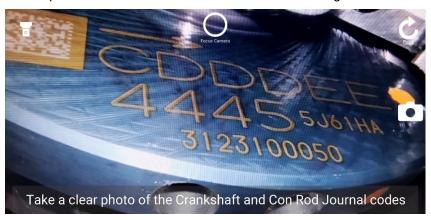
43. Take a picture of the code on the crankshaft counterweight with the V-SMART tool.

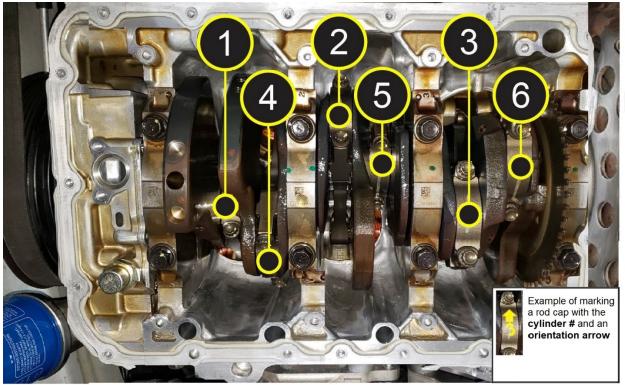
- Do not confuse the existing marking on the side of the connecting rod and rod cap with the cylinder number. These are manufacturing marks referring to the size of the rod.
- Installing a rod cap incorrectly will result in engine knock and/or engine failure.

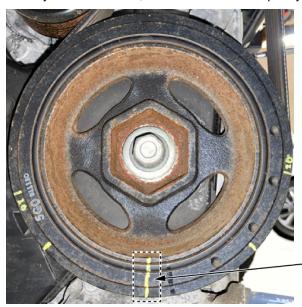
50. With cylinder 1 at TDC, mark the crankshaft pulley with a vertical line at the 6 o'clock position.

CRANKSHAFT PULLEY
Mark with a vertical line
from the 6 o'clock position.

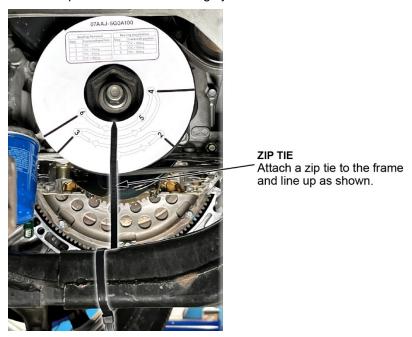
- Make sure it is pointing up at the 6 o'clock position on the pulley.
- The zip tie should extend roughly 8" to 12" over the subframe.

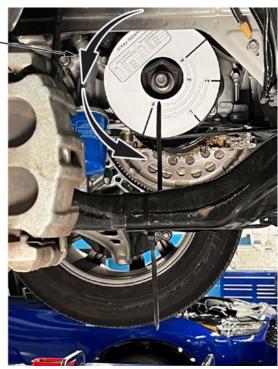
62. Rotate the crankshaft counterclockwise to the #3 position (TDC -45°).

Rotate the crank counterclockwise to the #3 position.

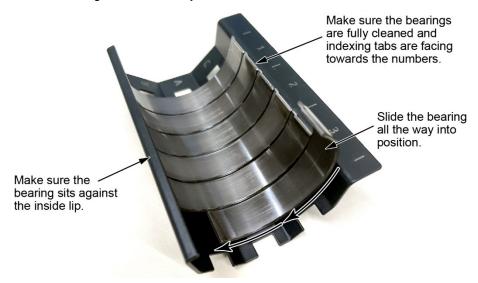
- 71. Make sure the bearings are fully seated and level with the edge of the inspection tray.
 - The bearing's indexing tab should be lined up at the numbers.
 - The flat edge of the bearing should be inside the lip.
 - All bearings should be fully seated.

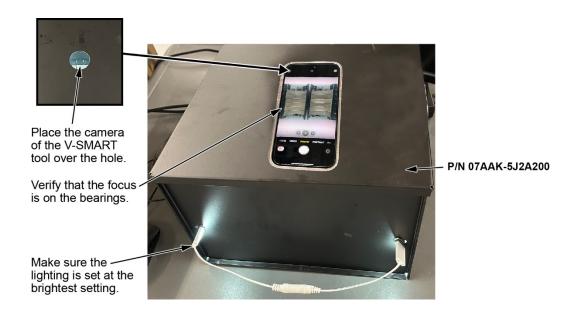
- Use the camera tap focus for a clear image.
- · Any unclear images will not be accepted.
- Follow the V-SMART tool prompts after photo submission.

When taking the photos:
