**November 29, 2023**

Version 2

## Safety Recall: 2023–24 Accord Front Seat Belt Pretensioner Inspection

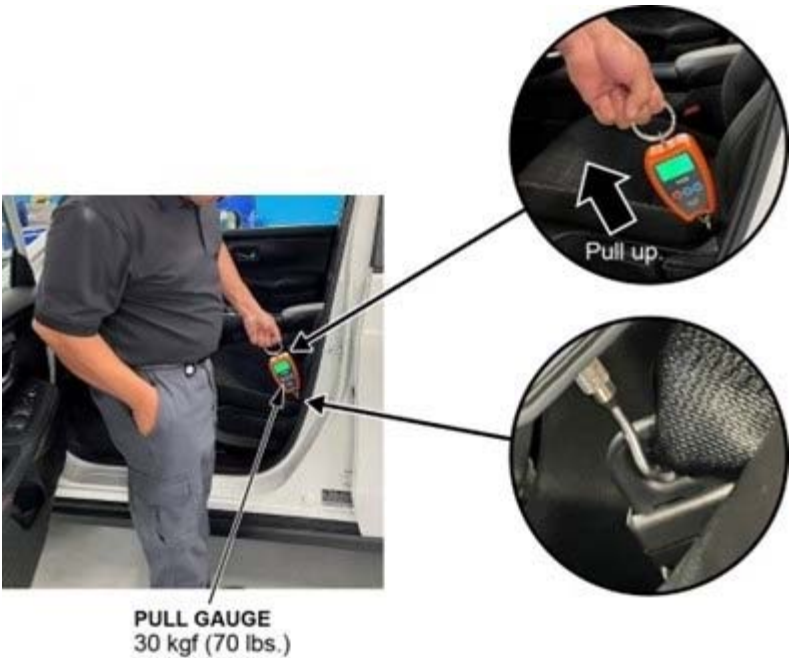
1. Insert the S-hook of the pull force gauge into the seat belt pretensioner loop to inspect the driver's side.

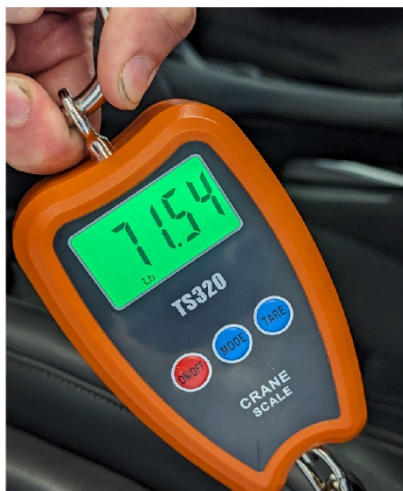
**GOOD**

2. While wearing eye protection, carefully pull up and apply a load of **30kgf (70 lbs)**
  - If the pretensioner quick connector remains intact and **DOES NOT** separate from the pretensioner assembly, no further action is required.
  - If the pretensioner quick connector separates from the pretensioner assembly, go to the REPAIR PROCEDURE.

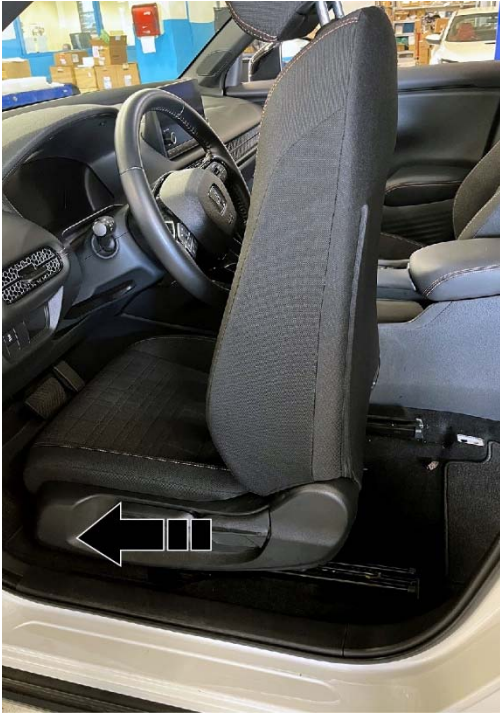
2. Move the driver's front seat to the forwardmost position and remove the rearmost seat bolts.

3. Slide the seat forward.

NOTE: Do not remove the seat.

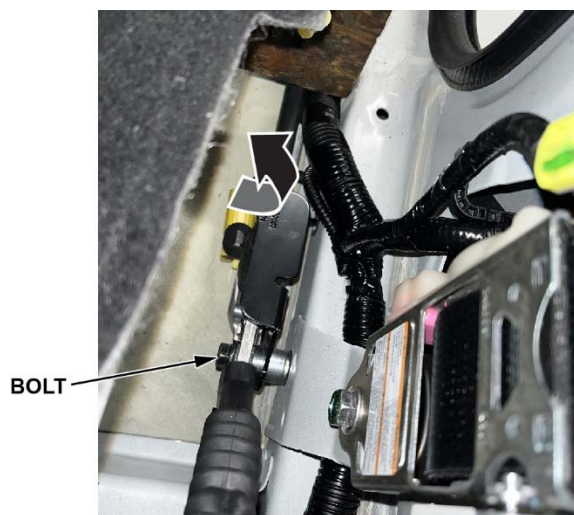
6. Pull back on the carpet as needed to gain access to the seat belt pretensioner bolt.
