Safety Recall: 2023–24 Accord Front Seat Belt Pretensioner InspectionSupersedes 23-098, dated November 29, 2023, to revise the information highlighted in **yellow**.**AFFECTED VEHICLES**

Year	Model	Trim Level	VIN Range
2023–24	Accord	ALL	Check the VIN status for eligibility.

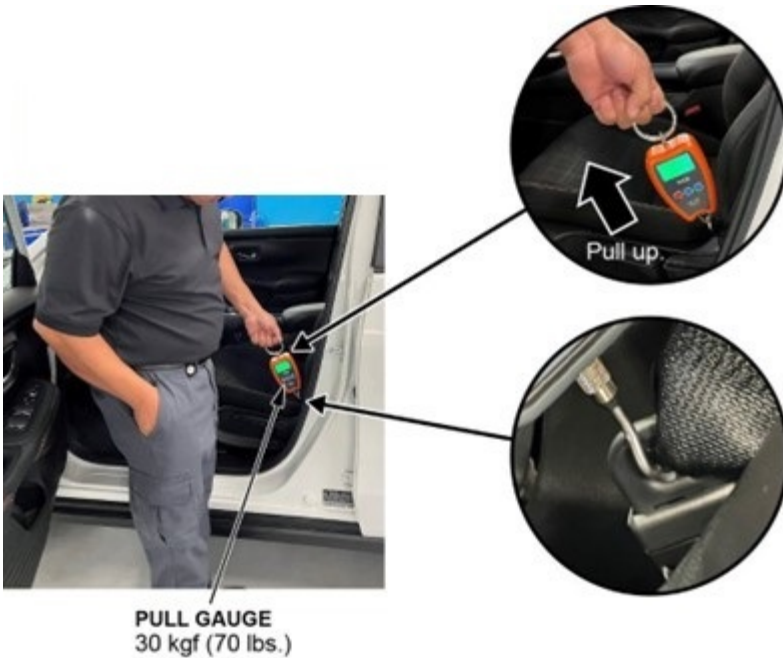
1. Insert the S-hook of the pull force gauge into the seat belt pretensioner loop to inspect the driver's side.

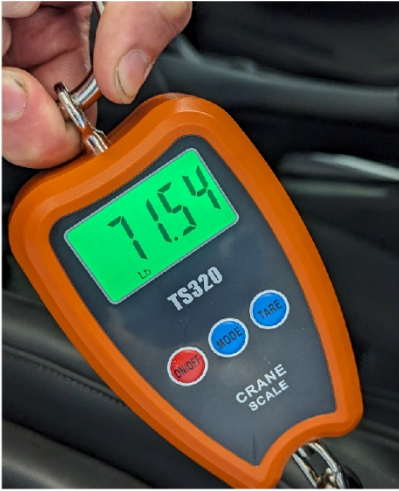
GOOD

2. While wearing eye protection, carefully pull up and apply a load of **30kgf (70 lbs)**
 - If the pretensioner quick connector remains intact and **DOES NOT** separate from the pretensioner assembly, no further action is required.
 - If the pretensioner quick connector separates from the pretensioner assembly, go to the REPAIR PROCEDURE.
