**PLEASE READ ALL WARNINGS IN THIS DOCUMENT. THIS RECALL IS A RE-INSPECTION CHECK TO MAKE SURE RECALL 1817L OR 2318A WAS REPAIRED PROPERLY.**

# 2004-2006 B-SERIES – MIS-INSTALLED AIR BAG AFTER TAKATA RECALL

## PASSENGER AIRBAG INFLATOR INSPECTION

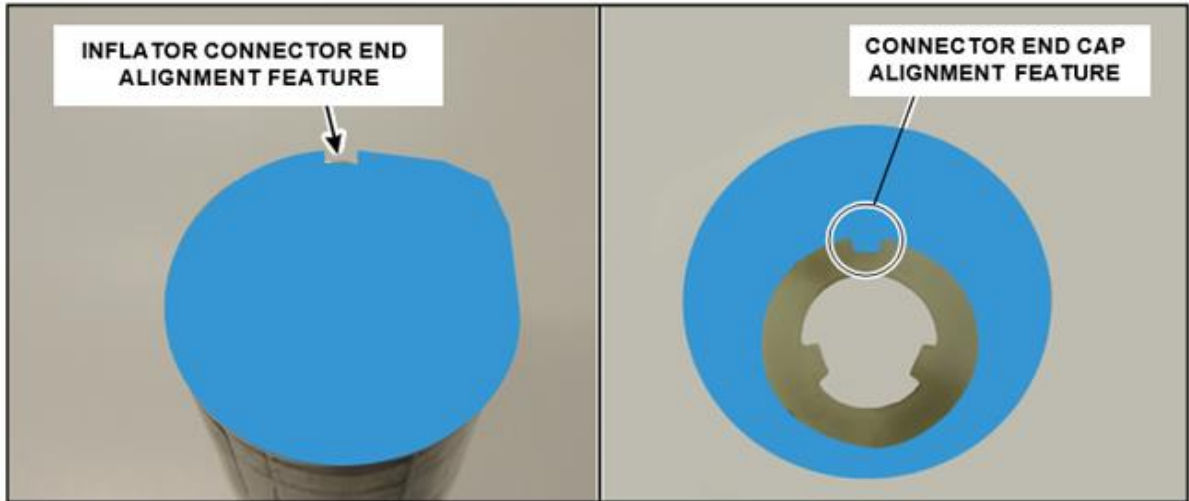
12. Align and install both inflator end caps.

**NOTE 1:** *Both inflator connector end caps must be installed with the tab features aligned and fully seated. The end caps are specific to each end of the Inflator.*

**NOTE 2:** *The tail end cap does not have an alignment tab.*
