ATTENTION ALL DEALERS:

2004-2006 B-SERIES – MIS-INSTALLED AIR BAG AFTER TAKATA RECALL

PASSENGER AIRBAG INFLATOR INSPECTION

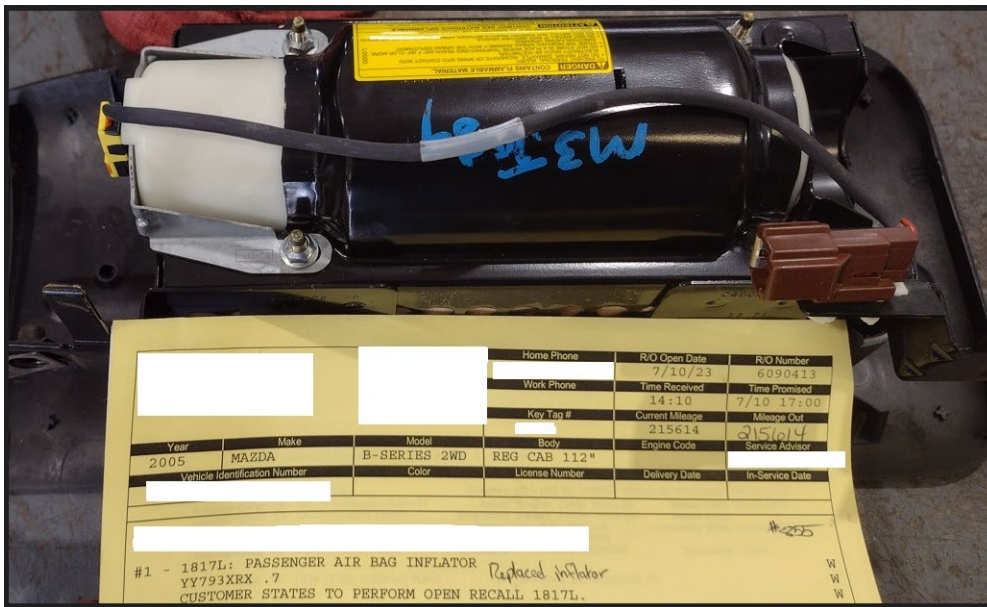
FIGURE 3 – REQUIRED PHOTO #2 – CORRECT INSTALLATION

6. Take Required Photo example showing correct wiring: Please leave VIN and customer information on the RO in the photo. DO NOT clear out the customer information and VIN. We have blanked out the VIN & customer information for privacy, as an example only.

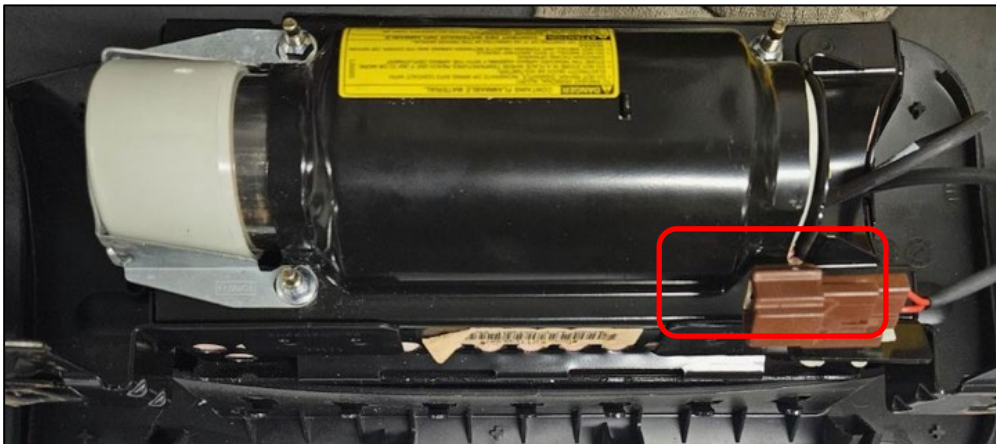
9. After taking the photo, disconnect the wires from the brown connector (**incorrectly installed air bag inflator shown**) – **NOTE INCORRECT INFLATOR CAP AND BUNDLED WIRE AT CONNECTOR**

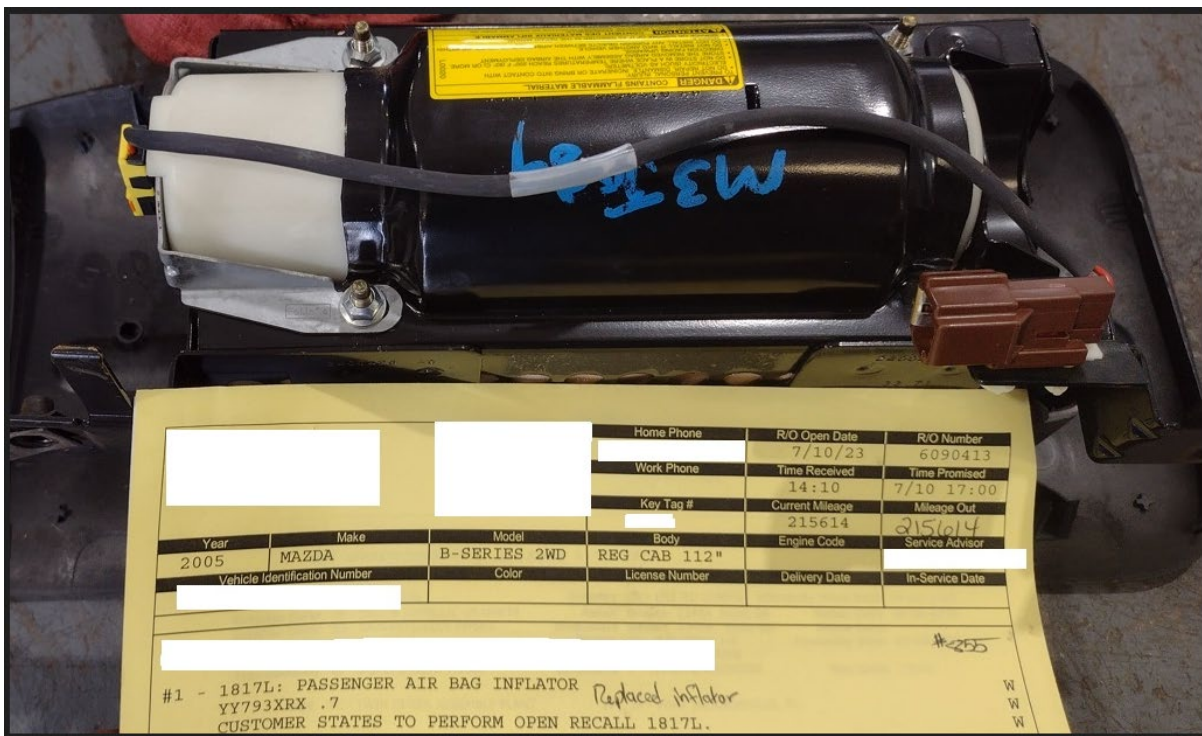
FIGURE 3 – REQUIRED PHOTO #2

Required Photo #2 example showing correct wiring: Please leave VIN and customer information on the RO in the photo. **DO NOT** clear out the customer information and VIN. We have blanked out the VIN & customer information for privacy, as an example only.
