Compliance Recall

Code: 69GA

Subject: Compliance Recall 69GA - Driver Seat Side Airbag

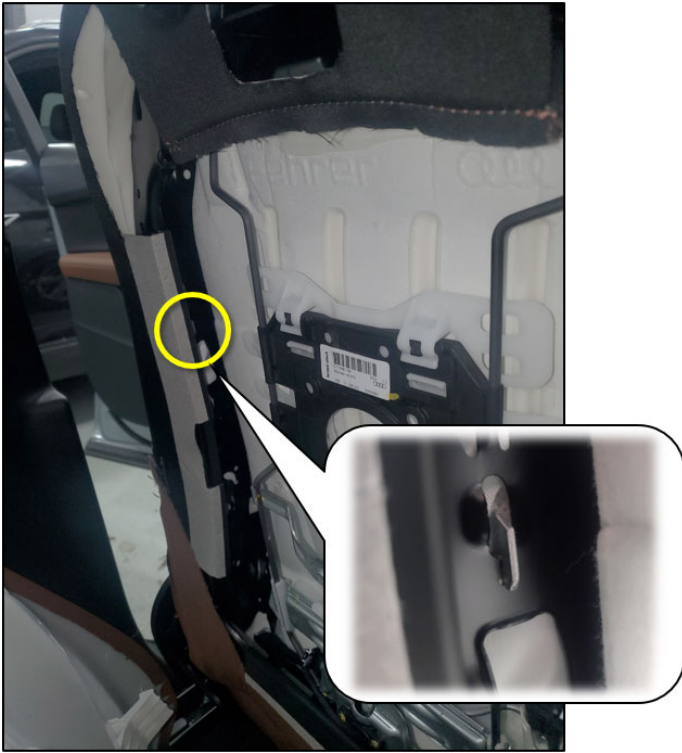
Repair Overview

- Inspect installation of driver front thorax airbag.
- Correct installation, if necessary.

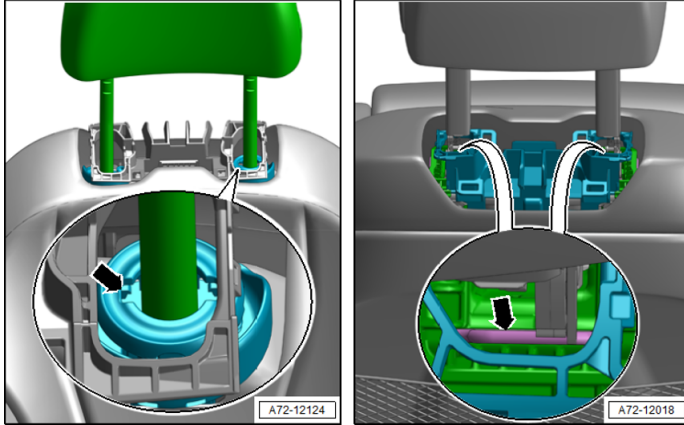
Remove headrest (if equipped):

The headrest must be removed in order to remove the backrest cover.

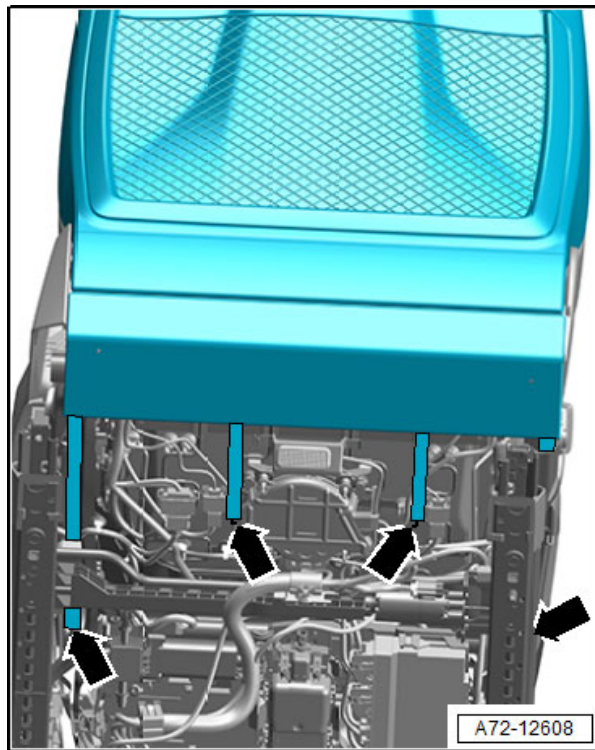
Remove backrest cover:

Standard/Sport seats:

- Move the front seat all the way forward and up.
- Disengage the tension straps <arrows> on the bottom of the seat pan.

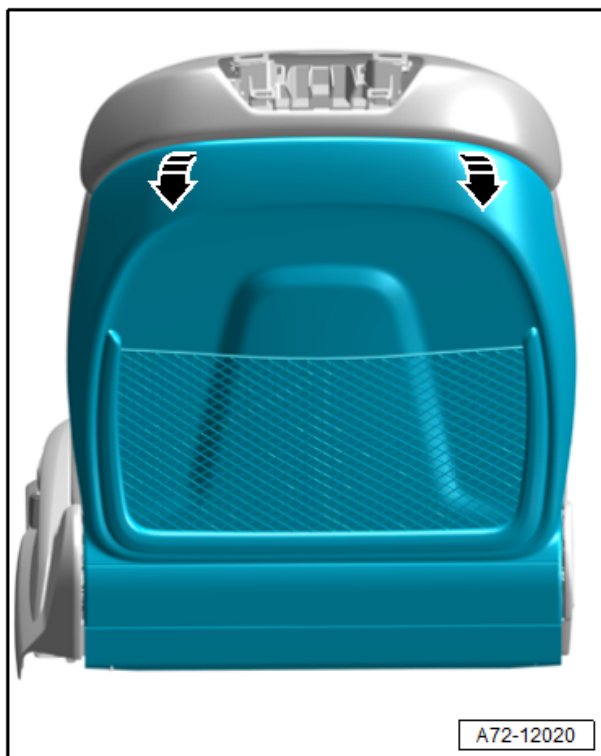
- Grab the backrest cover at the upper edge and pull toward the rear out of the retainer <arrows>.

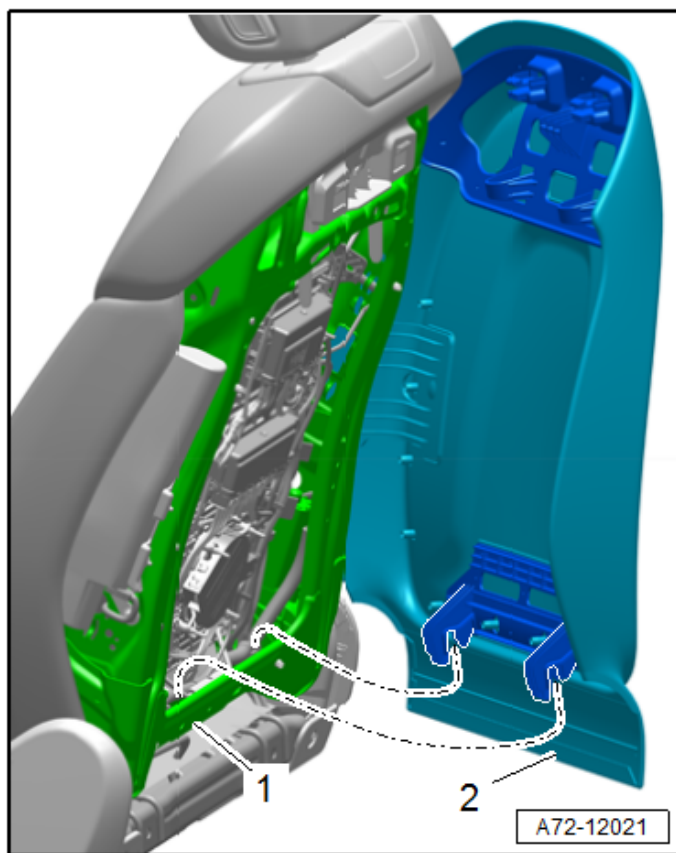
- Disengage the lower backrest cover hooks <2> from the backrest <1> and remove the backrest cover.

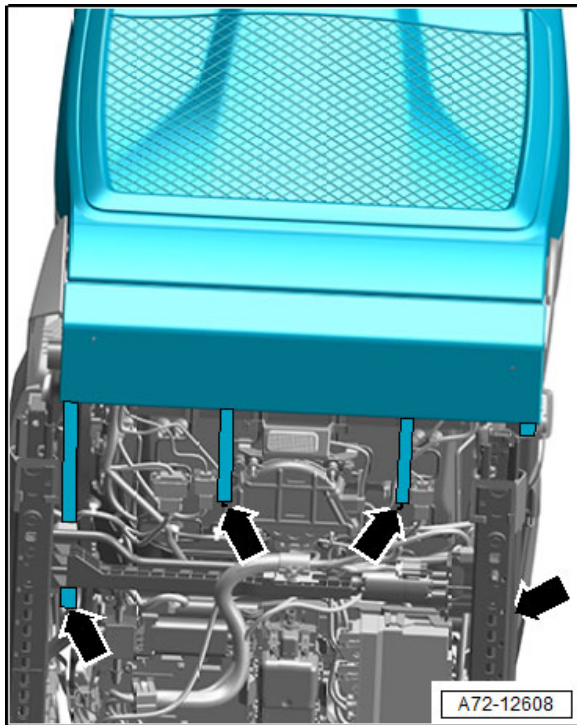
Remove backrest cover:

Super Sport Seat:

- Move the front seat all the way forward and up.
- Disengage the tension straps <arrows> on the bottom of the seat pan.

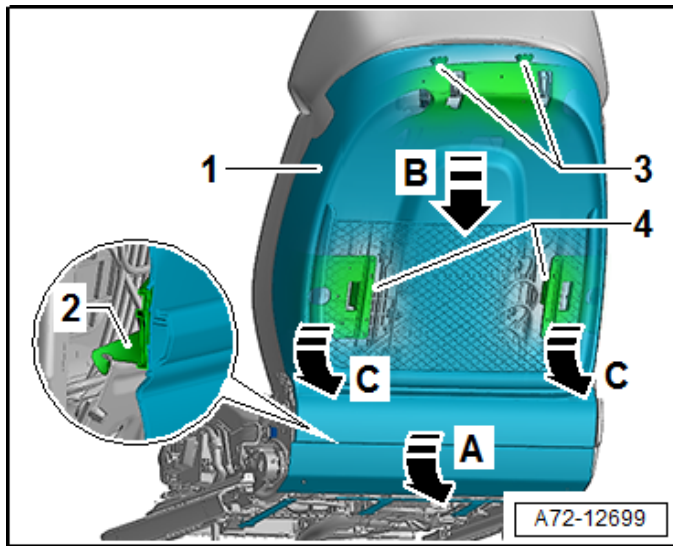
- Remove the hook for the lower backrest cover <2> from the backrest cover <direction of arrow A>.
- Secure the backrest cover <1> over the upper edge and release the catches <3> (see below for details on releasing the catches <3>).
- Check if the hook on the lower backrest cover <2> is loosened from the backrest frame.
- Remove the side hook <4> for the backrest cover <1> from the backrest frame in the <direction of arrow C>.

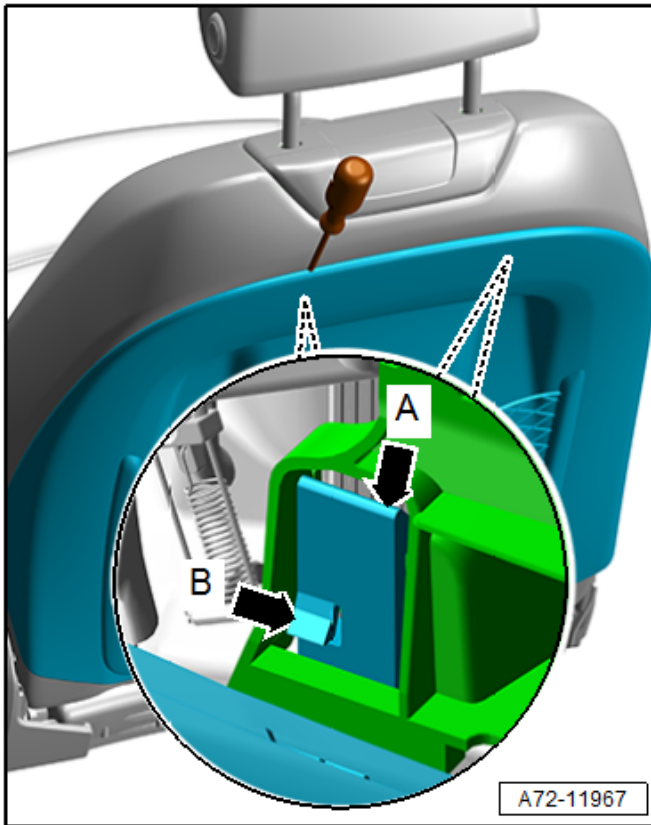
Releasing the upper catches:

- Insert the Wedge 02 from the Removal Wedge Set -VAS895015- between the cushion and the cover.
- Insert the outer edge of the wedge from the inside of the seat along the seat seam. Begin by only slightly inserting the wedge.
- Push the cushion to the side and release the hook <arrow A> and the catch <arrow B> using the Wedge 02. At the same time, pull the backrest cover downward out of the catch.
- Repeat the procedure for the hook on the opposite side.

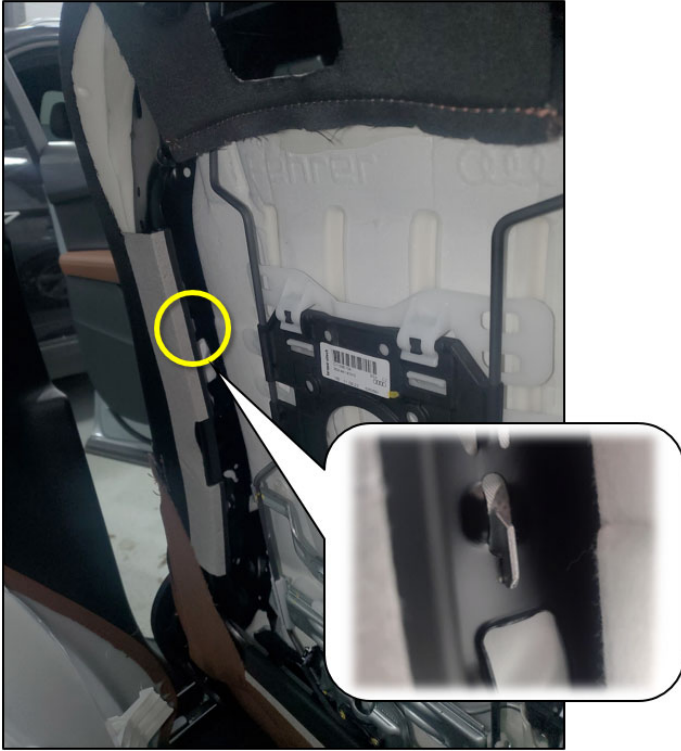
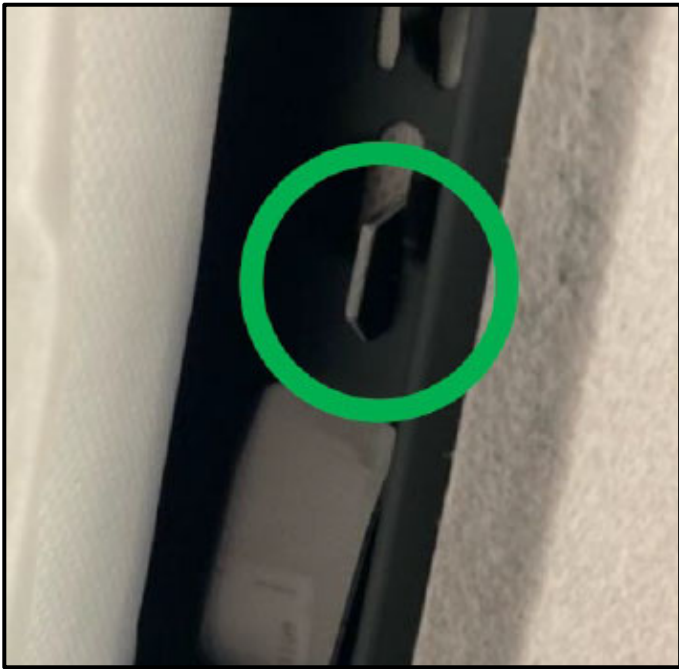
Inspect thorax airbag installation:

- Check if the airbag securing hook <circle> in engaged correctly.

- If the securing hook on the thorax airbag is engaged in the seat frame:
 - The airbag is installed correctly.
 - Reassemble the seat in the opposite order of disassembly.
 - Proceed to Section C.

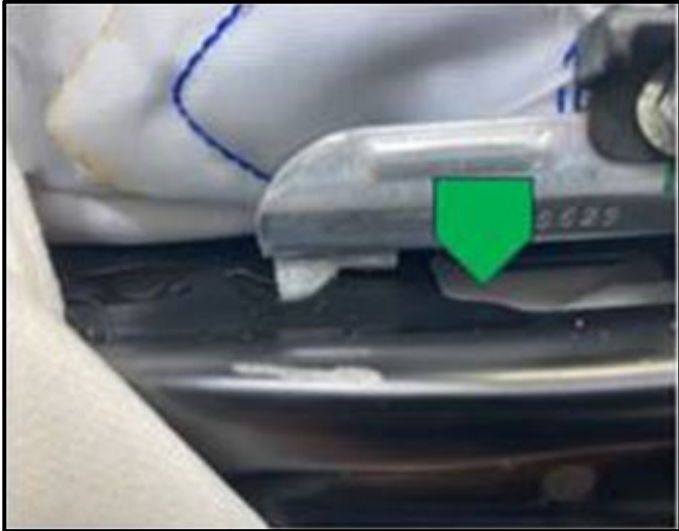
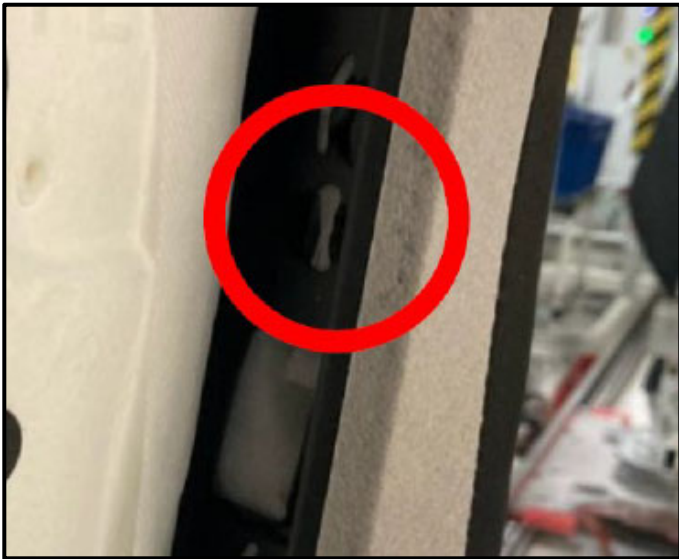
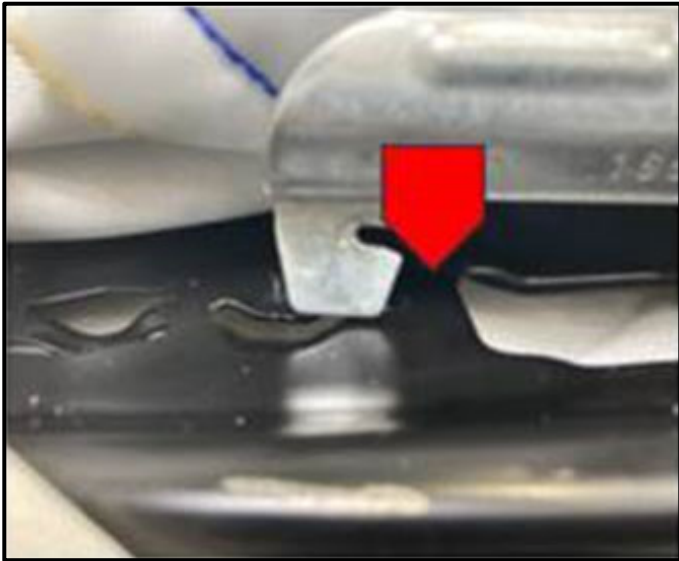
- If the securing hook on the thorax airbag is NOT engaged in the seat frame:
 - The airbag is not installed correctly.
 - Remove backrest padding in area of side airbag (sill side) only until side airbag is easily accessible.
 - Unbolt the airbag and reinstall it so the hook is engaged in the seat frame.
 - Replace the securing bolt for the airbag.
 - Refer to the ELSA Repair Manual for the proper torque specification. Refer to: *Repair manual > Body > Body 69 Passenger Protection, Airbags, Seat Belts Thorax Airbags Overview - Front Thorax Airbag*
 - Reassemble the seat in the opposite order of disassembly.
 - Proceed to Section C.
