## SIB 63 02 24 RECALL 23V-884: R 18 Headlight

**OL31 - R 18 B****63 12 091 Replacing the headlight**

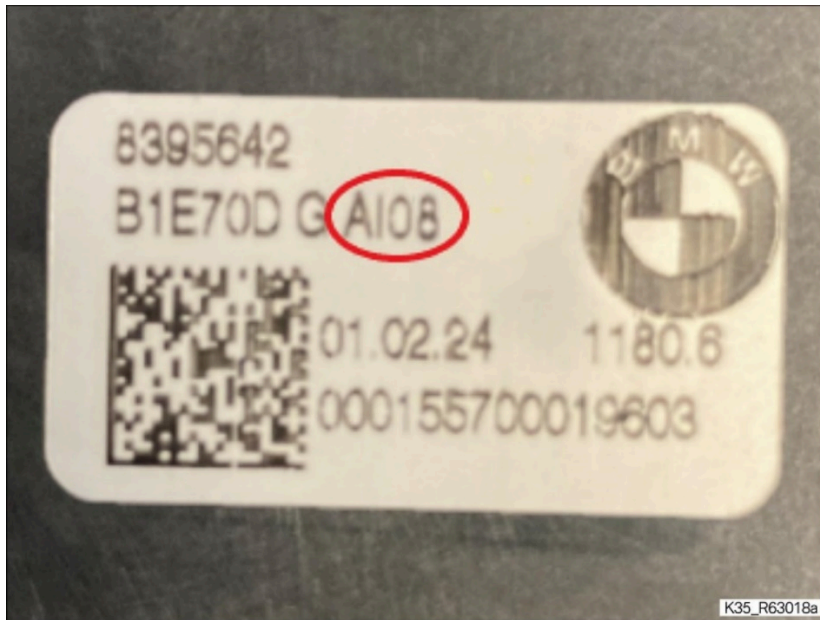
It is **CRUCIAL** to ensure and double check that only a new headlight **with the correct revision index (AI)** is used. This can be determined by the corresponding identification. Any other revision index that is not listed

below is not a new headlight.

Part number	Part description	Revision Index	Version
63 12 8 395 642	LED Headlight Pro	AI07 or higher	New
63 12 8 395 649	LED Headlight Pro black	AI03	New
63 12 8 395 641	LED Headlight Basic	AI07	New

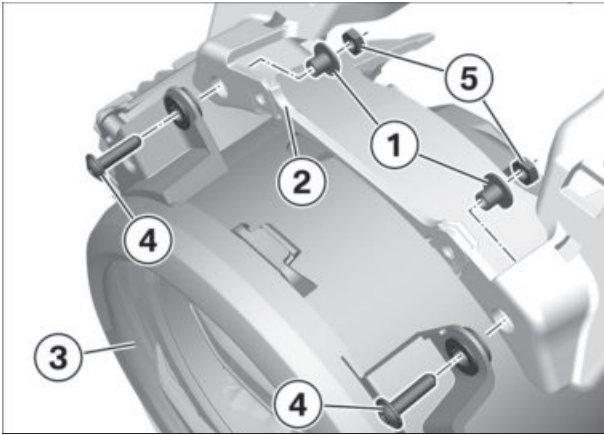
- Install collar bushes **(1)** article number 5 B5B 781 on left and right of windscreen holder **(2)**.
- Install headlight **(3)** with new longer bolts **(4)** article number 8 534 939 and with hexagon nuts **(5)** article number 9 904 475 on the left and right.
