# SAFETY RECALL

# SR24-81

## WHEELCHAIR LIFT SYSTEM – THRESHOLD WARNING SENSOR LIGHT REPLACEMENT

9700 (B13R)

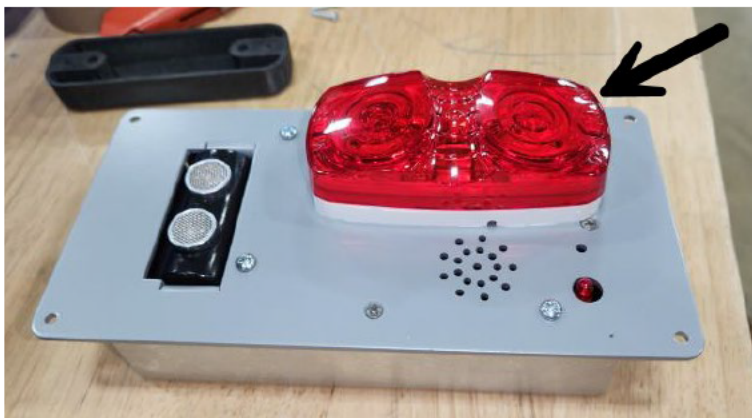
Figure 1 : Red lens cover to be removed

1. Cut the electrical power to the wheelchair lift system using the dashboard WCL switch.
2. Use a small prybar to remove red lens from TWS light, and discard. Figure 1.

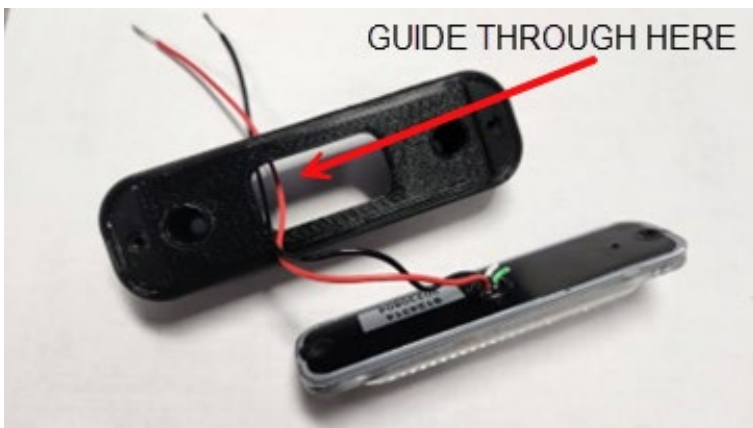
Figure 7: Red and black wires guided through the TWS light adapter

8. Guide red and black wires from light unit through the opening of the TWS light adapter. Figure 7.

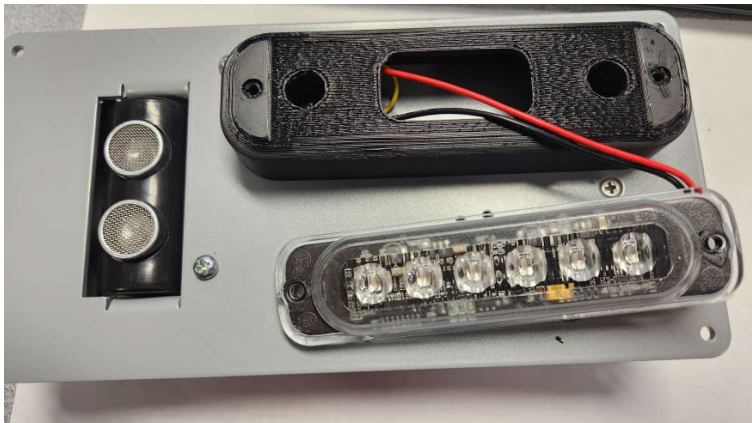
*Figure 11: TWS adapter placed and installed to faceplate*

11. Place the TWS light adapter on the faceplate aligned with the same hole locations from Step 4. Use previously removed screws from Step 4 to screw the adapter to the faceplate. Conceal both wires inside the TWS light adapter. Figure 11.

**BE CAREFUL WITH THE PLASTIC PART. DO NOT USE A POWER SCREWDRIVER**
