**RECREATIONAL VEHICLE  
SAFETY RECALL NOTICE**

Safety Recall: 23V-822

**IMPORTANT SAFETY RECALL – 3rd Notice**

Keystone RV Company has decided that a defect which relates to motor vehicle safety exists in certain model 2021-2022 Coleman Travel Trailers. As a result, Keystone RV is conducting a safety recall. We apologize for any inconvenience this action may cause you; however your safety and continued satisfaction are of the utmost importance to us.

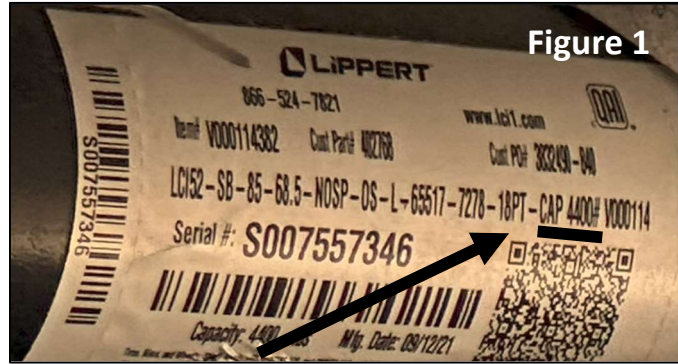
**Figure 1**

It has been decided that the vehicles in the recall population may have axle springs rated at 4400 pounds rather than the 5100 pound axle rating as specified on Federal Identification Tag. The axles installed had the wrong size springs. Under certain conditions during travel, undersized axle springs can be overloaded leading to an increased risk of axle spring failure and increasing the risk of a crash.

You may choose to self-inspect the axle's tags. If the tag reads as CAP 4400#, as shown in Figure 1, as soon as possible, please make an appointment to have your RV serviced by your dealership. Customers should unload all cargo and empty holding tanks (fresh water, grey water, black water, and water heater) and take their unit to an authorized dealer for remedy of the incorrectly installed axles springs. The labor

Keystone representatives have been in contact with the staff at your selling dealership regarding this situation. The remedy is to replace under rated 4400 LB springs with the correct size 5100 LB springs. This would require both 2200 LB springs be replaced. The service and parts required for this corrective action will be provided at no charge to you.
