February 17, 2023

Safety Recall: 2023 CR-V Front Passenger Seat Frame

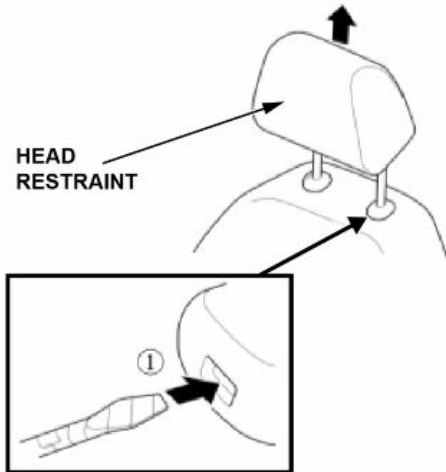
1. Remove the head restraint from the front passenger's seat and set it aside.

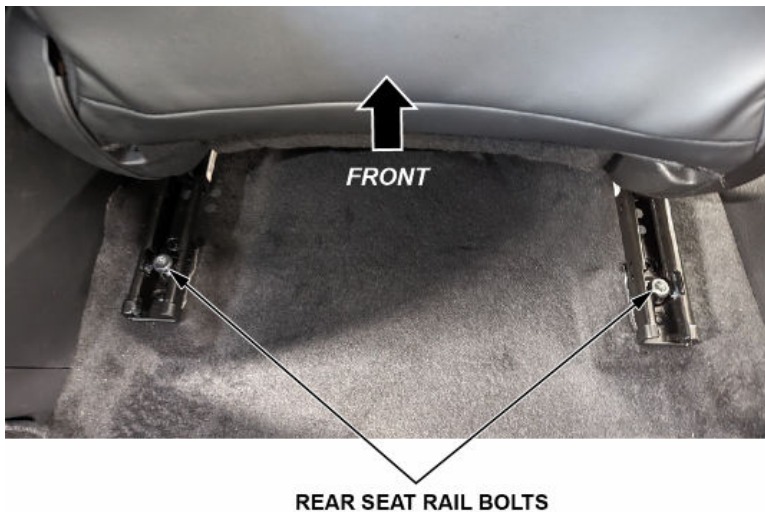
2. Adjust the front passenger's seat to the most forward position until the rail bolts are fully visible, then remove the bolts.

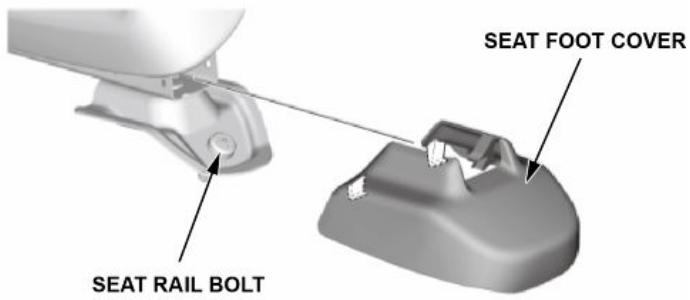
- Adjust the front passenger's seat to the most rear position and carefully remove the seat foot cover.

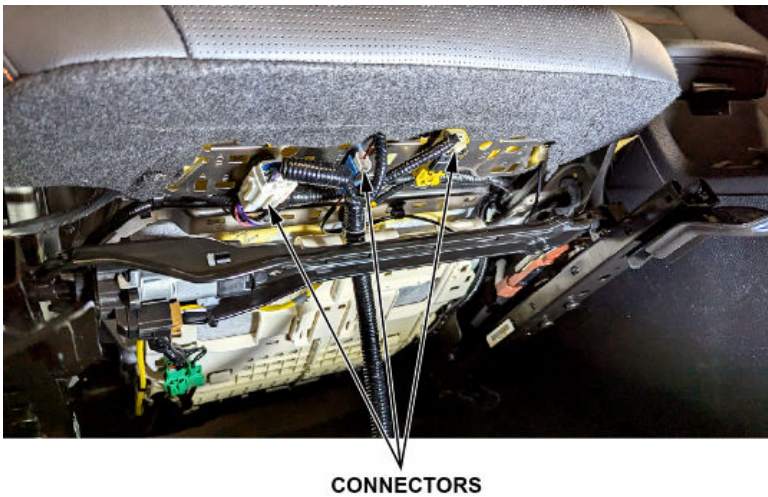
- Disconnect the 12V battery's negative terminal.
NOTE: Wait at least **3 minutes** before proceeding to the next steps.
- Remove the front seat rail bolts.
- Carefully and slowly tilt back the seat assembly to expose the harness and connectors.

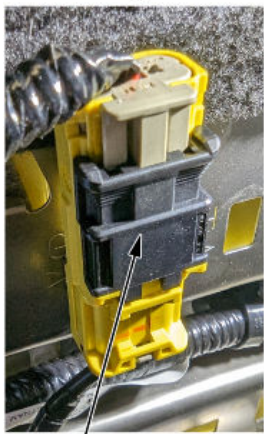
Slide Locking Connector

SLIDE LOCK

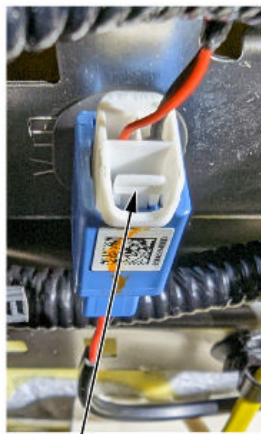
Tab Release Connector

TAB RELEASE

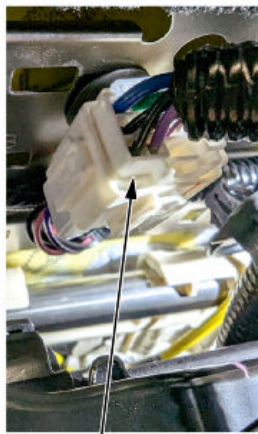
Tab Release Connector

TAB RELEASE

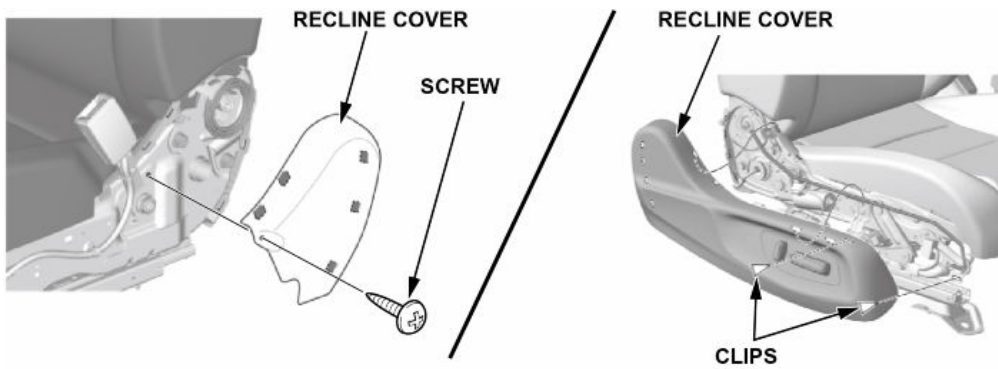
9. Remove the screw and carefully remove the cover without damaging the locking tabs.

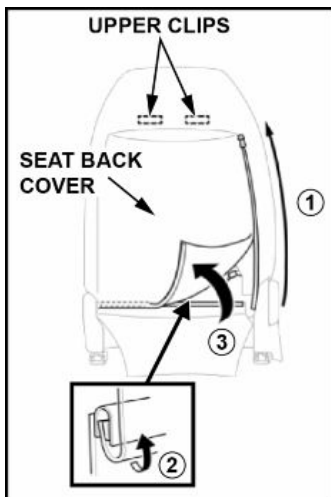
(1) Unhook the seat bottom cover to expose the (2) zippers. Unzip both zippers.

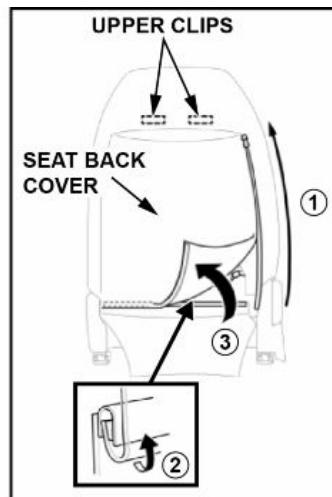
(2) Unhook (2) upper clips from underneath the seat cover.

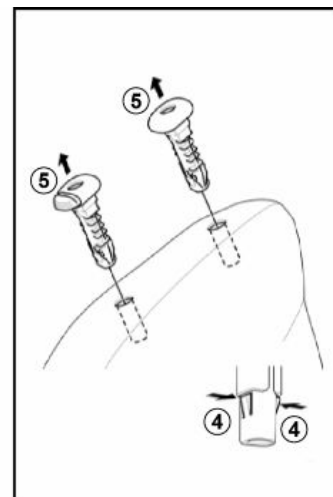
(3) Remove (2) head restraint lock guides by squeezing both locking tabs while pressing up.

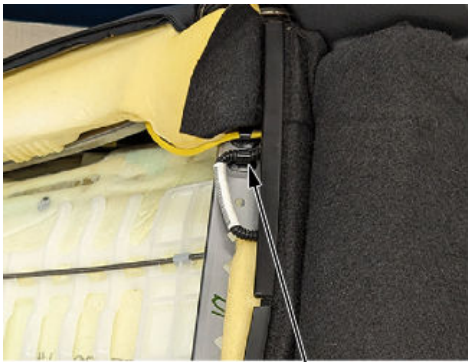
SEAT BACK CLIP

12. Disconnect the seat heater harness clip from the seat-back and seat bottom.

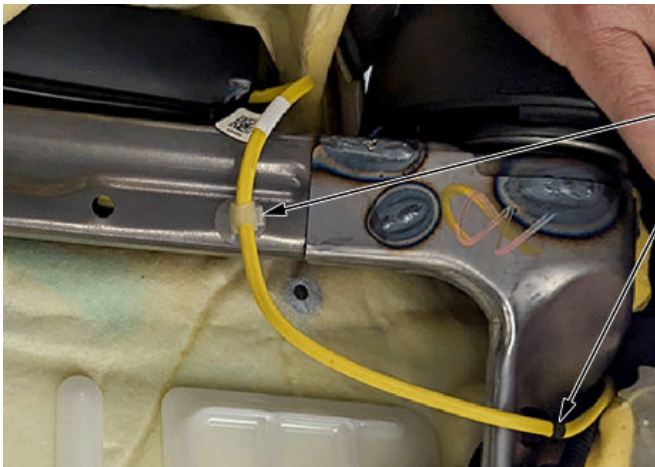
SRS HARNESS CLIPS

13. Remove the following SRS harness clips.

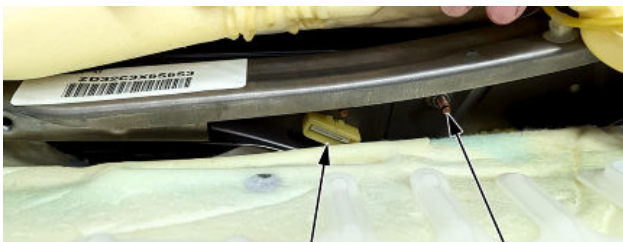
14. Disconnect the side airbag from the seat-back frame.

CONNECTOR
Disconnect.

SIDE AIRBAG
Disconnect.

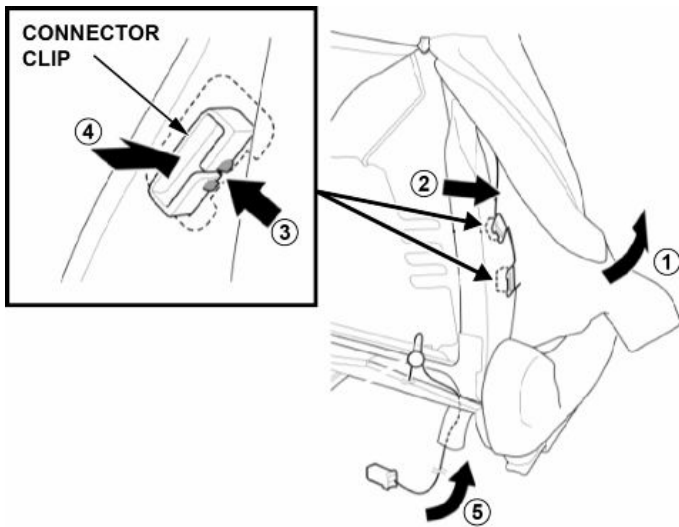
15. Disconnect the seat heater connector clips as shown below.

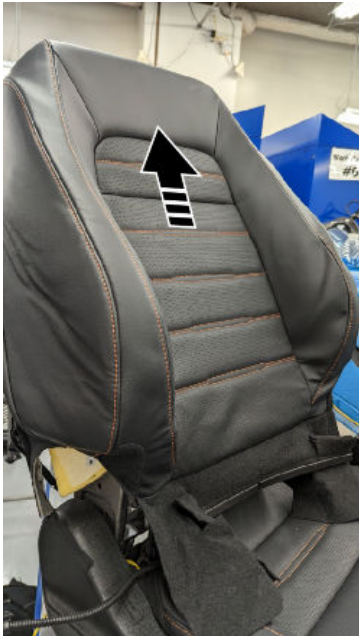
16. Remove the seat cushion and cover.

- 16.1. Starting at the sides of the seat-back base, gently pull away any seat cushion that are interfering with the seat frame.
- 16.2. Slowly slide the cushion and cover up (together) and over the seat frame until fully removed.
- 16.3. Set it aside on a clean work area.

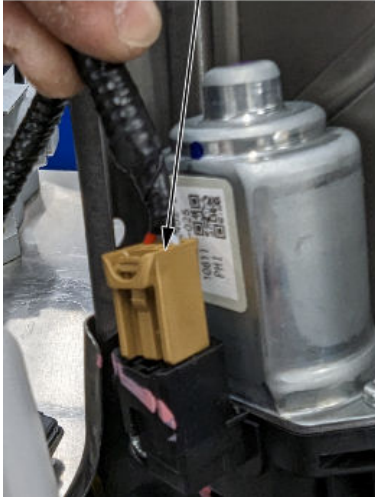
MOTOR CONNECTOR

17. Disconnect the reclining motor connector and harness clip.

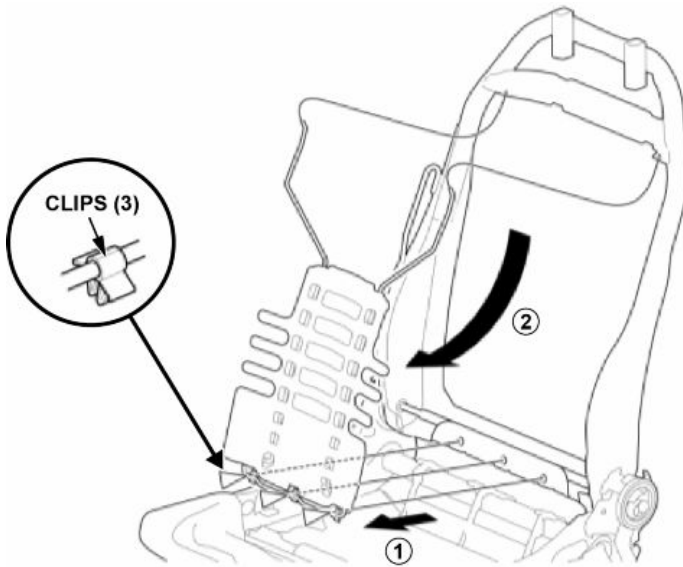
18. Remove the lumbar support mat.

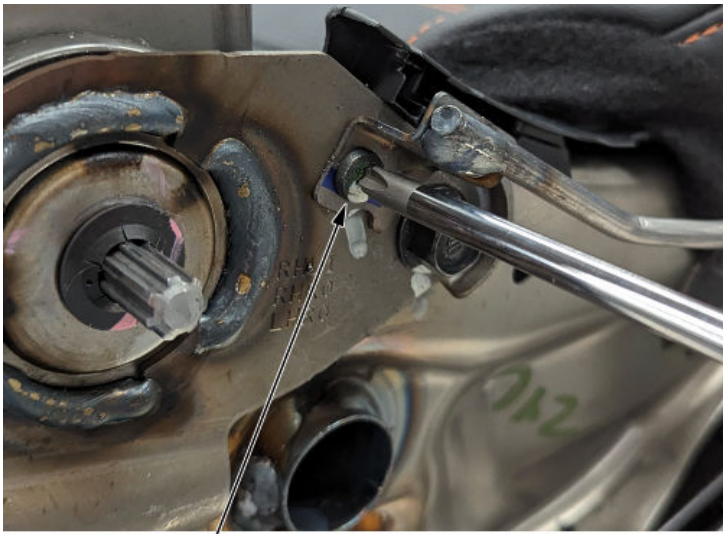
SEAT OUTER RAIL

19. Remove the seat rear outer-rail screw.

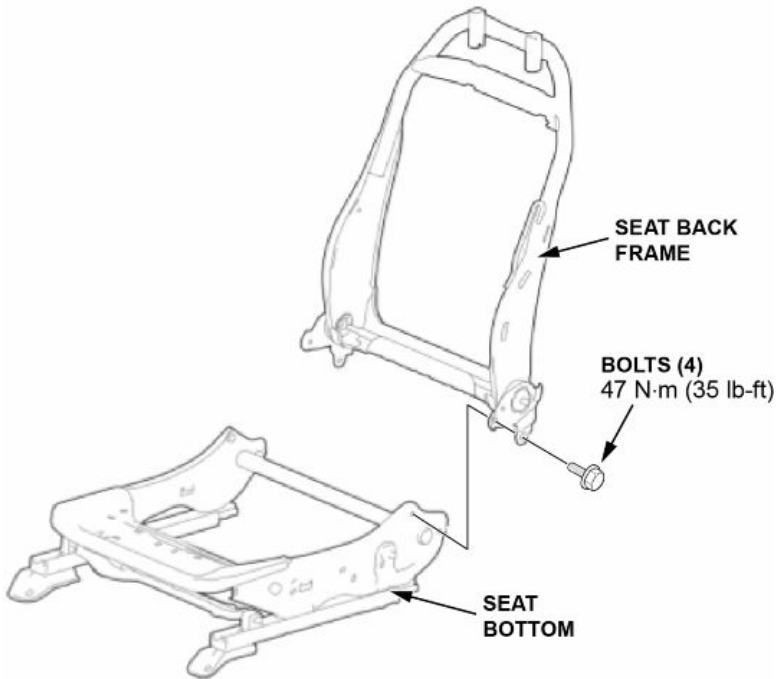
20. Remove the four seat bolts (two on each side) that connect the seat-back and bottom.

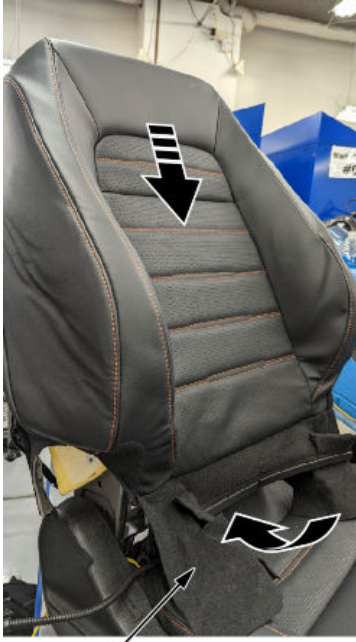
SEAT COVER
Tuck bottom of cover under to cover seat frame.

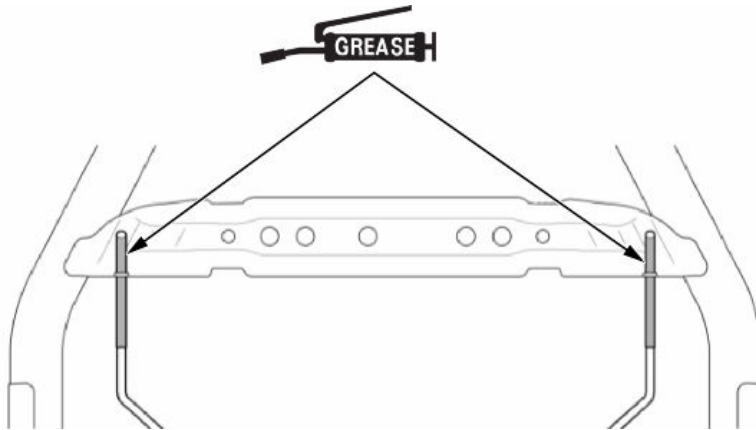
22.4. During the lumbar mat reinstall process, apply multipurpose grease before installing the wire.
