Safety Recall: 2018–19 Accord Driver’s Seat Belt Buckle Replacement

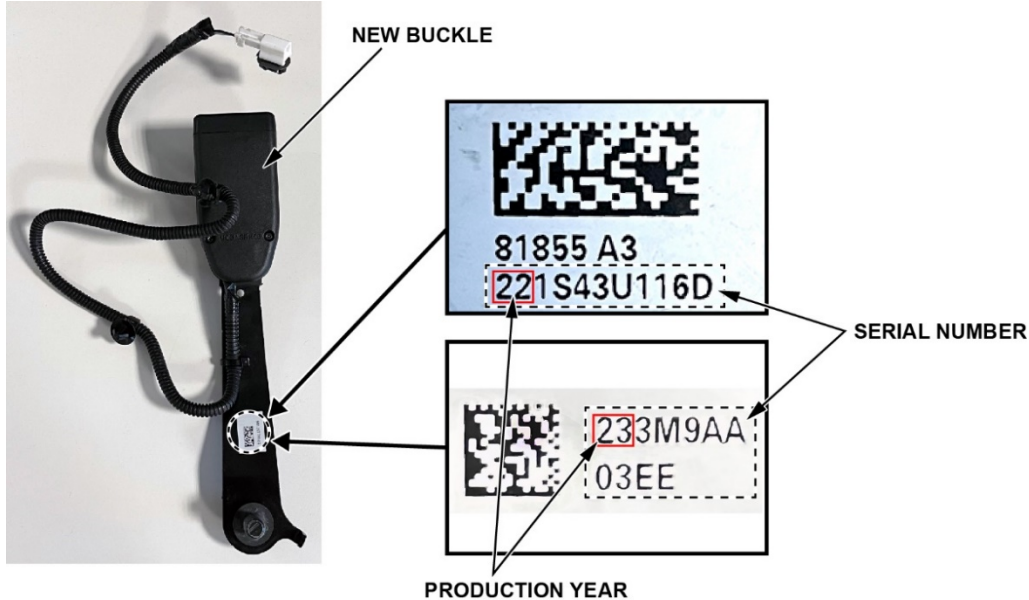
1. Before installing the new buckle, write the 11-digit serial number of the new buckle on the repair order. The serial number is a required field on the warranty claim and must be provided to your Warranty Administrator to ensure the claim is not rejected.

NOTE: The first two digits of the serial number indicate the year of production and should begin with "19" or greater. If the serial number begins with "18", **DO NOT INSTALL** the buckle. The buckle should be returned to American Honda.
