PREVOST

SAFETY RECALL

SR23-13

DATE :	May 2023	SECTION :	06 ELECTRICAL
SUBJECT:	Power Cable Unsuitable Grommet

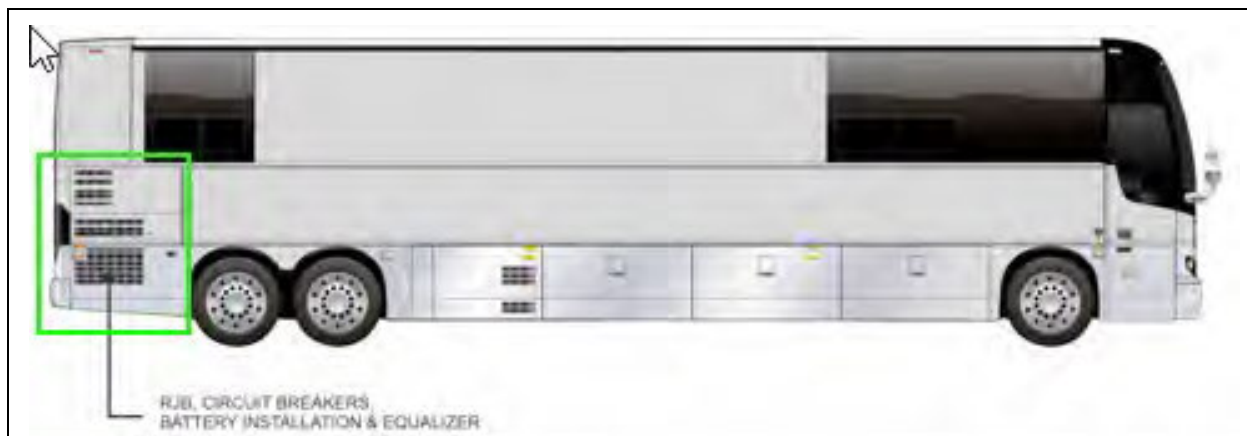
1. Locate the grommet location in the rear electrical compartment.

- Open the vehicle curb side engine door.
- Open the rear electrical compartment (next to the batteries).
- In the compartment, the two part grommet is installed in the cable pass through hole located at the top right corner of the compartment (hidden behind the battery equalizer).

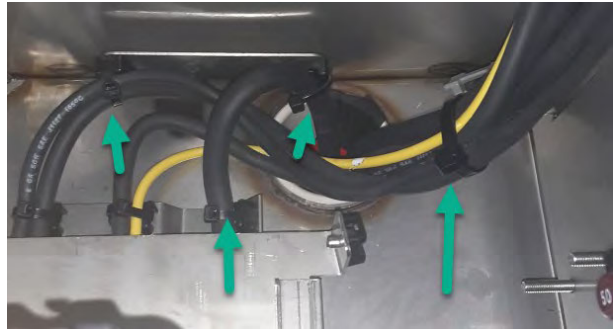
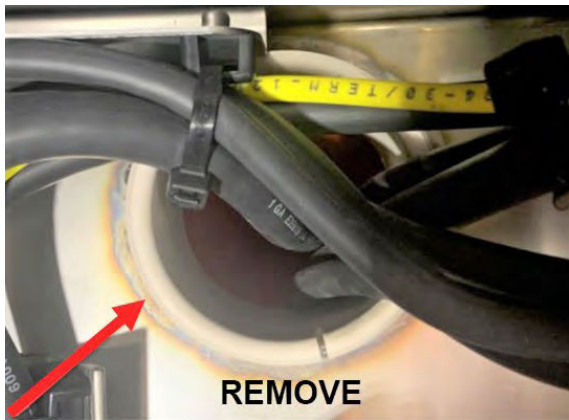
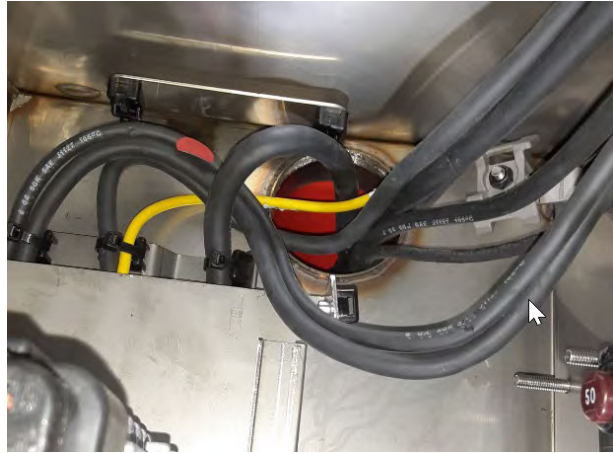
On vehicles affected by this recall, electrical power distribution cables routed through a metallic panel are not protected by a suitable grommet (grommet was cut in half and both parts were glued to the panel). If one of the halves fell off, the wiring conductor insulation could become damaged by chafing on the edges of the panel, potentially causing a short-circuit.

2. Cut all the cable ties holding the power cables passing through the hole.
3. Remove both halves of the grommet.
 - Discard the grommet halves.
 - Remove residual adhesive on the panel as required.
