# SOP10110

## Inspection Recall for QAAR10243R1

### W24RTB Ratcheting Bed Stay

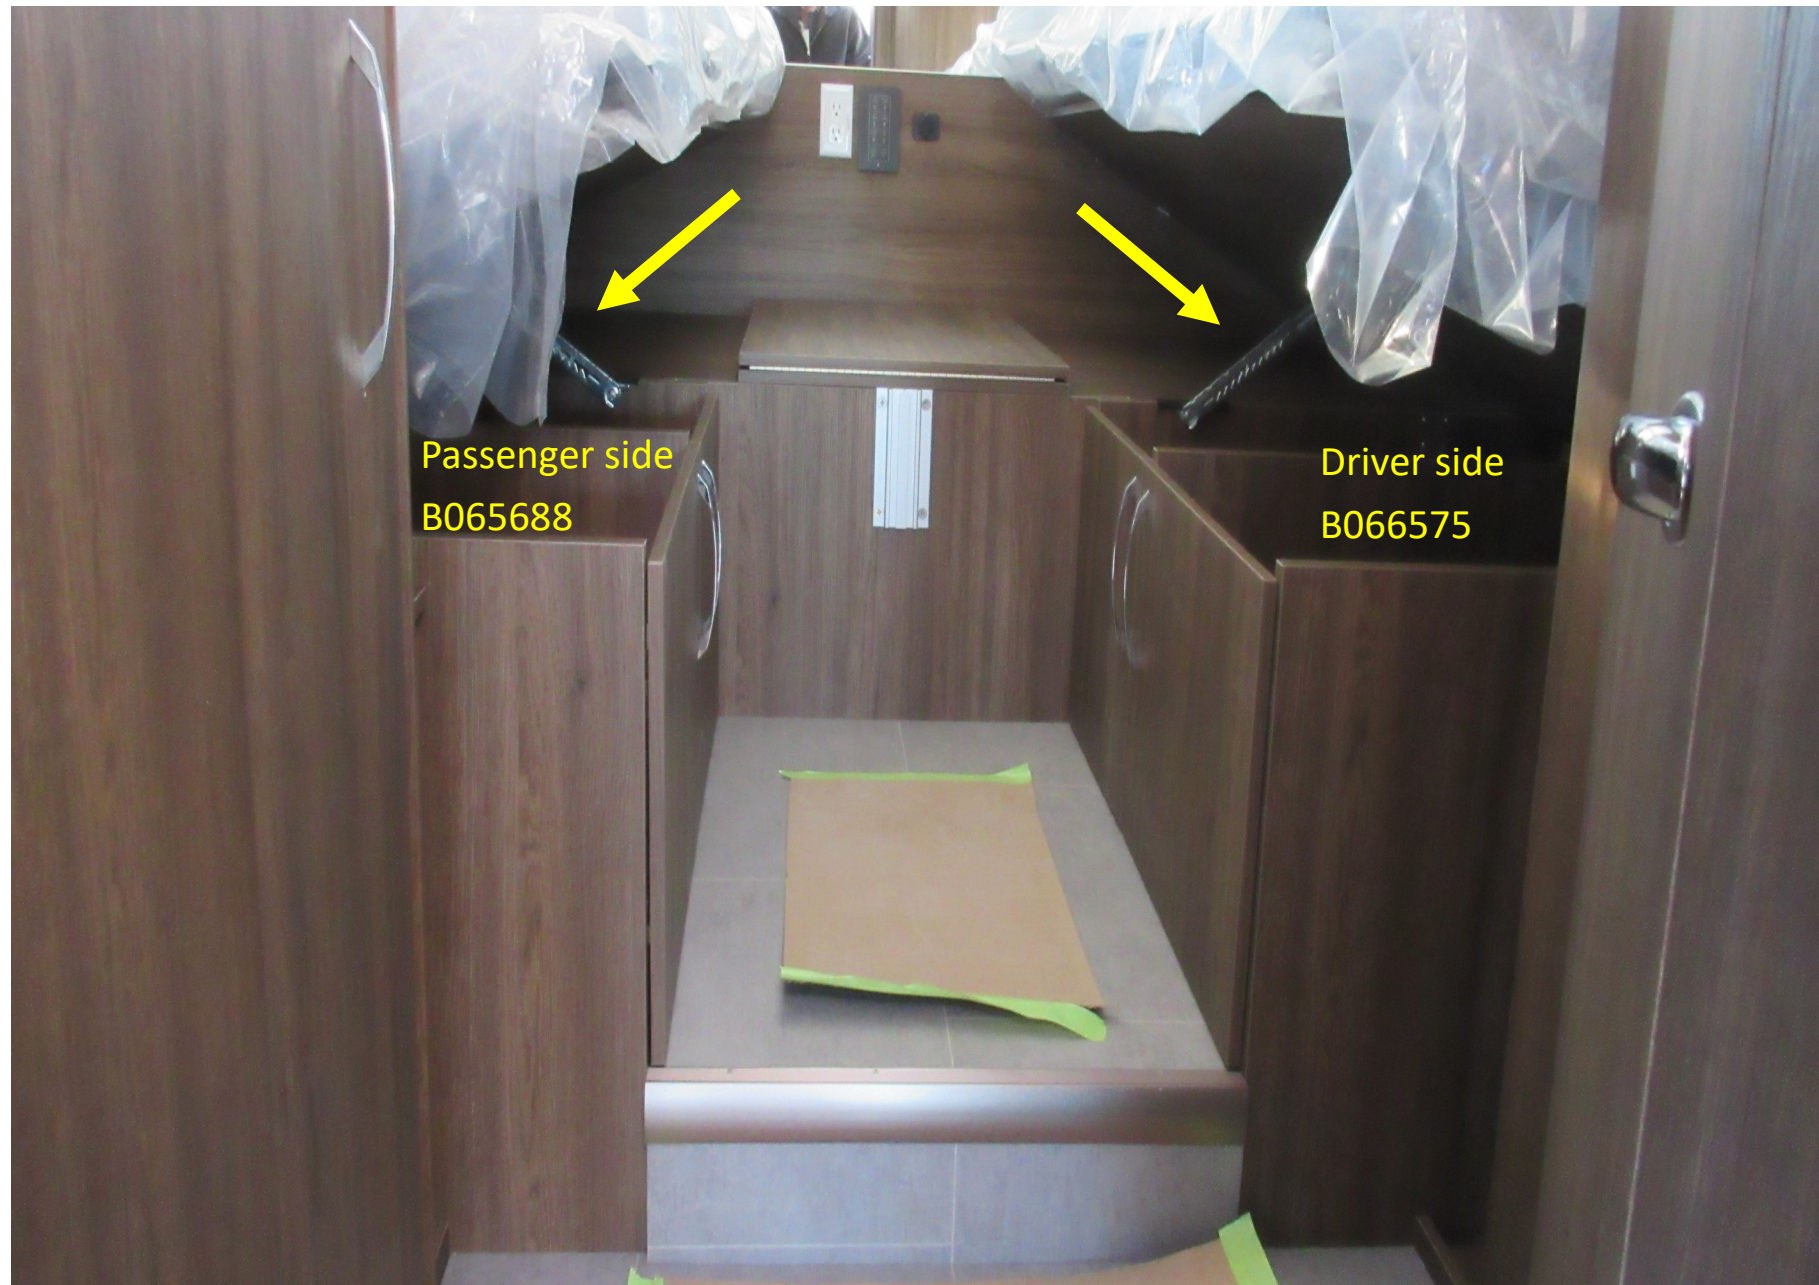
1

Open both bed lids to locate the ratcheting bed stay and inspect the bed stay focusing on the ratcheting mechanism.

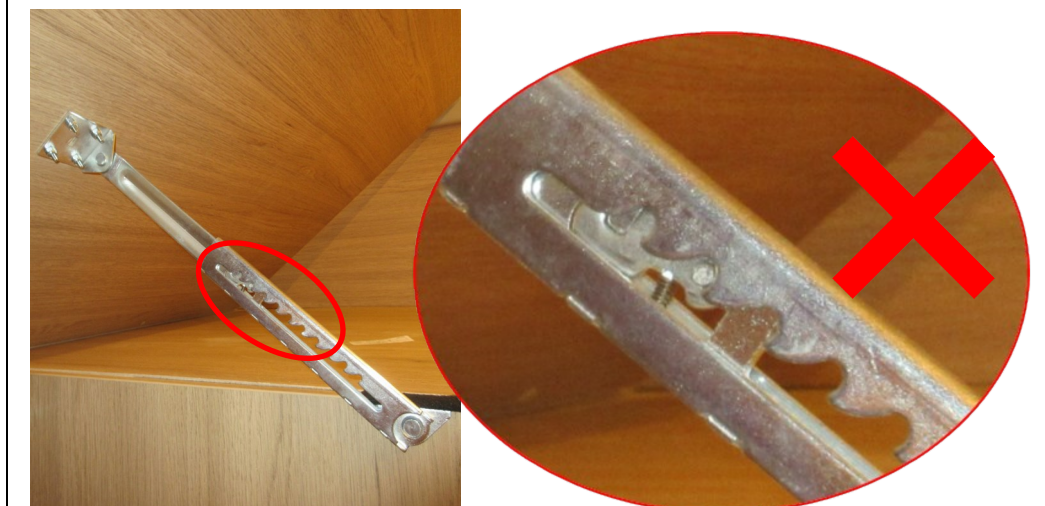
3

If notch is on the top with the teeth pointing down a corrective action is required.

Contact Leisure Travel Vans Customer Service/Warranty for further instructions: 1-877-992-9906 or recalls@tripleerv.com
