IMPORTANT SAFETY RECALL NOTICE

Ref: Safety Recall - (NHTSA Recall No. 24V296)

Technical Bulletin TB1816, Rev A

Hopper Rear Door Pin Replacement

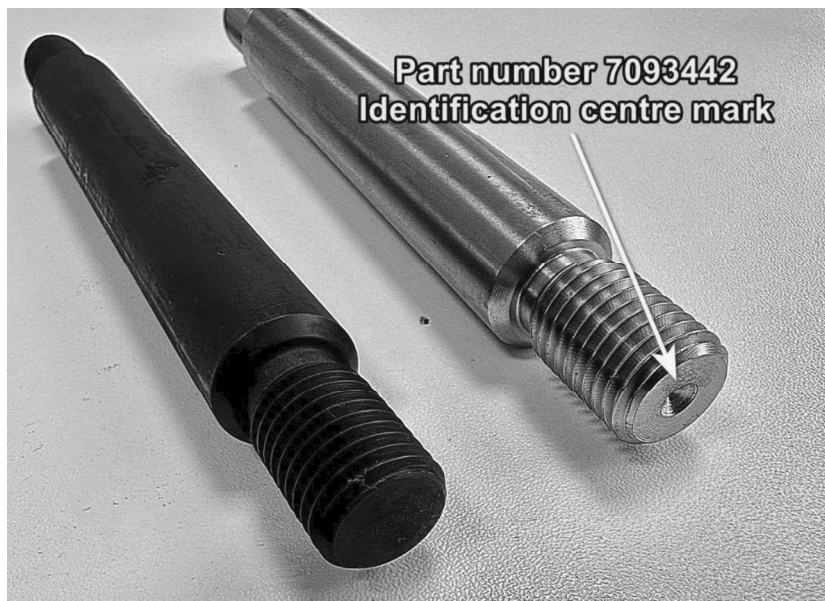
Fig 1 Pin – Hydraulic cylinder pivot

A replacement pin has been designed from a high strength, high hardness, corrosion resistant stainless steel to eliminate the potential for corrosion to affect the pin integrity over time. The new pin is from polished and ground stainless steel and silver in colour whereas the old pins had a black finish. There is also an indent machined into one end of the new pin so it can be distinguished from the original even when installed see Fig 1.

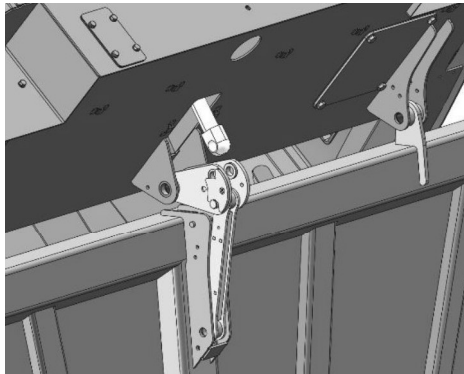
Fig 2

4. Remove the retainer and pin from the rod end of the door cylinder see Fig 2. Please retain the pin to be re-inserted.

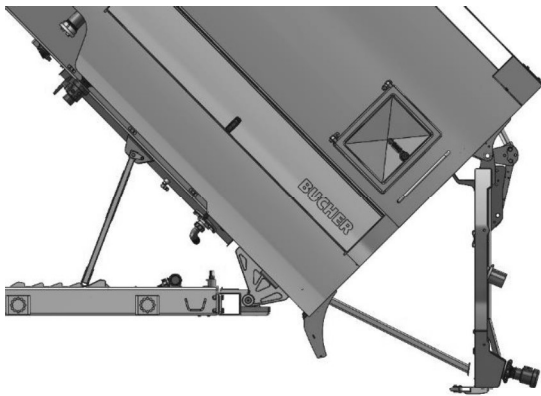
1. With the vehicle on firm level ground, raise the hopper to the fully tipped position and support on the hopper safety prop. see Fig 3
2. Open the hopper door so that it hangs vertically, with no load on the door cylinder. See Fig 3
3. Remove meshes from the hopper. If mesh shakers are fitted, the air pipes will need to be disconnected.

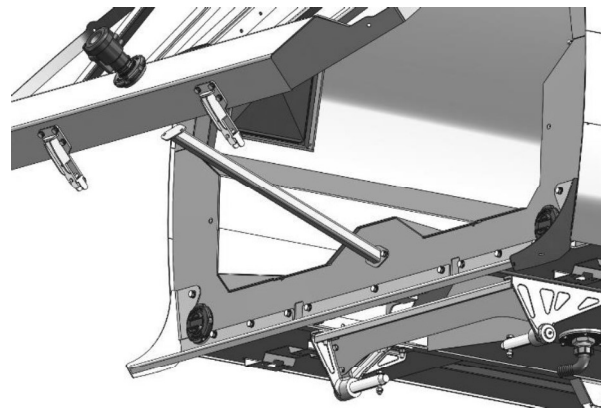
Fig 4

5. Fit stay to support the rear door using the existing fixings by bolting it to the recirc access port in the centre of the hopper. If the recirc water option is fitted the stub pipe will need to be removed to allow the stay to be fitted Fig 4.

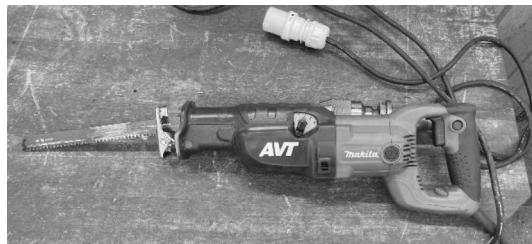
- a. If the pin is free to move, it can be drifted out using a suitable drift.
- b. If the pin is seized, then there are several options for removing it:
 1. Using a reciprocating saw on a slow setting, ideally with around 30mm of stroke, cut the pin either side of the cylinder block from the top of the machine. The saw requires a carbide tipped 300mm long blade but it will need to be cooled with cutting fluid or water during the cutting process. (The body will need to be accessed from a suitable platform at the rear of the machine) This method is not possible with a VT801 machine as the saw will not reach.

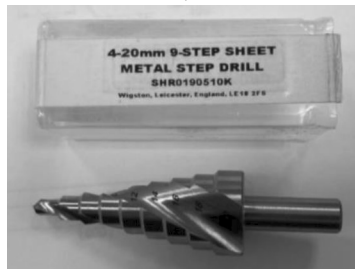
2. Alternatively, from inside the hopper cut each end of the pin off using a cutting disk on a grinder so that the pin is cut off flush with the bosses in the body. Centre pop the centre of the pin each end and using a high-speed drill, drill pilot holes $\text{\O}6\text{mm}$ to a depth of 22mm. Gradually open the hole up to 20mm using increasing size drill bits to release the cylinder. A step drill may be used to open the hole to as close to 20mm as possible.

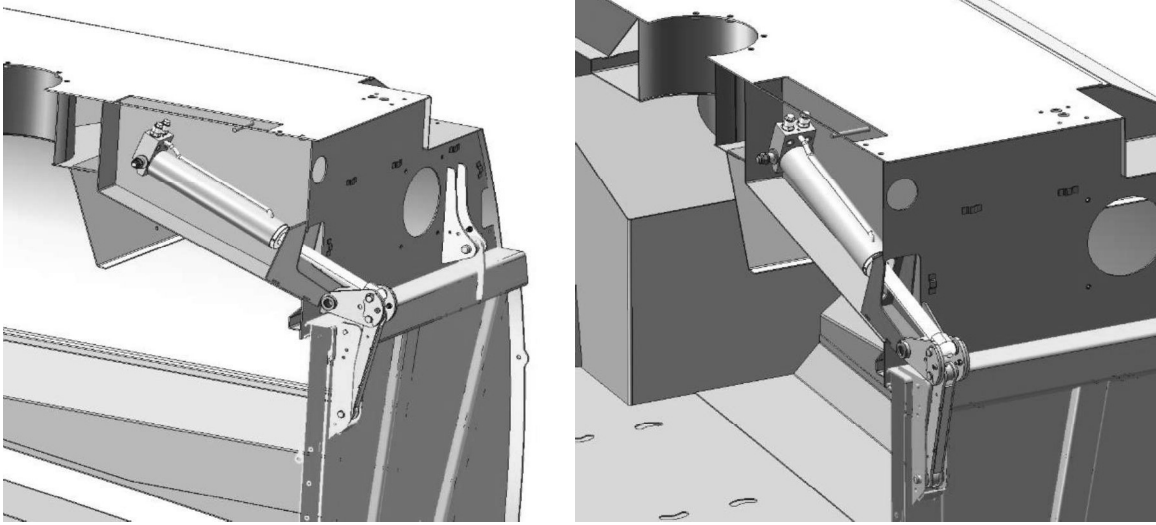
Figure 1 – Location of Retaining Bracket installed.

7. Switch vehicle ignition off and remove key from ignition.
8. By hand, raise the cylinder rod upwards to allow the retaining bracket to be inserted over the cylinder rod. Locate the retaining bracket into the hopper aperture with the circular cut outs against the linkage pivot – See Figure 1.

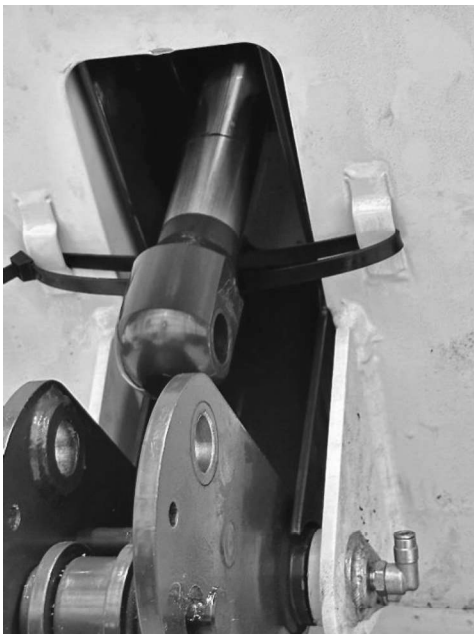
Figure 2 – Temporary support for cylinder rod end.

10. Switch vehicle ignition off and remove key from ignition.
11. Elevate cylinder rod end and use a tie wrap across cleats to temporarily support the rod end - See Figure 2.

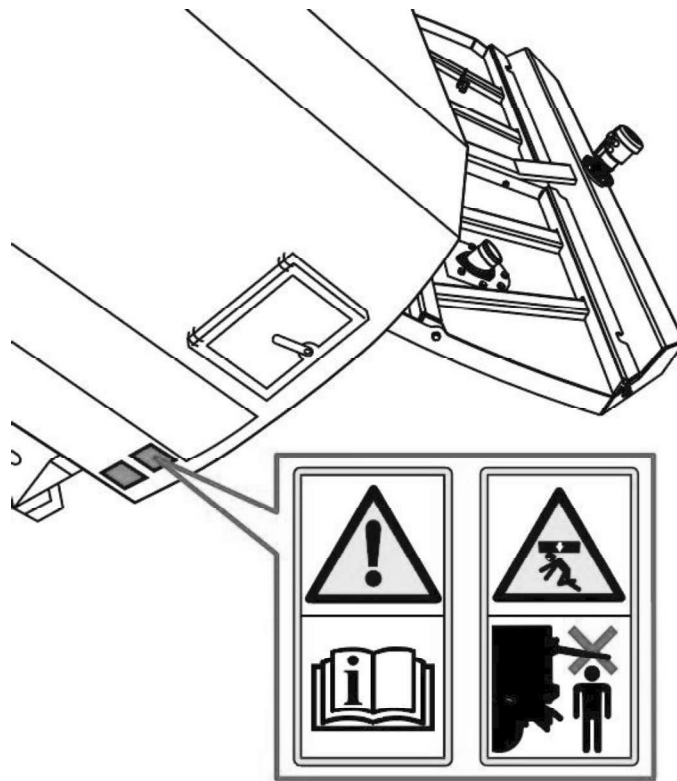
Figure 1 – Location of labels installed both sides

1. With the door in a fully closed position and the body (hopper) down, clean the surface and affix a label to each side of the body in the position shown (Figure 1).

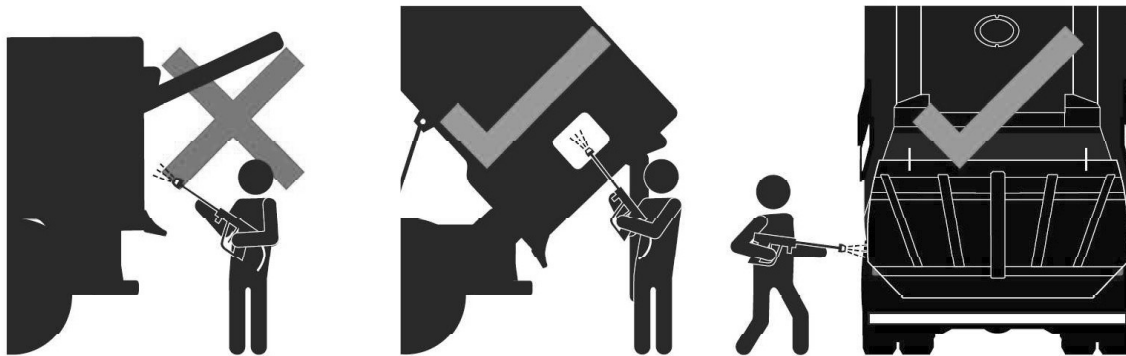
M020G-266

The body must be cleaned out with it resting on the prop and the door hanging in a vertical position. The operator should stand either side of the door to clean the body. Do not enter the zone directly underneath the door as there is a risk of debris falling out the body during the cleaning process. The side access doors can be opened to gain access to clean the rear meshes and into the body whilst providing a degree of shielding for the operator. A facemask should be used when using high pressure washing equipment
