VINFAST

TECHNICAL SERVICES BULLETIN

Document ID: 824NA00001
 Bulletin Title: VF8 Airbag Replacement
 Released by: VF - GRSC
 Date of issue: 28 May 2024
 Applies to: VF Aftersales, Dealers and Showrooms

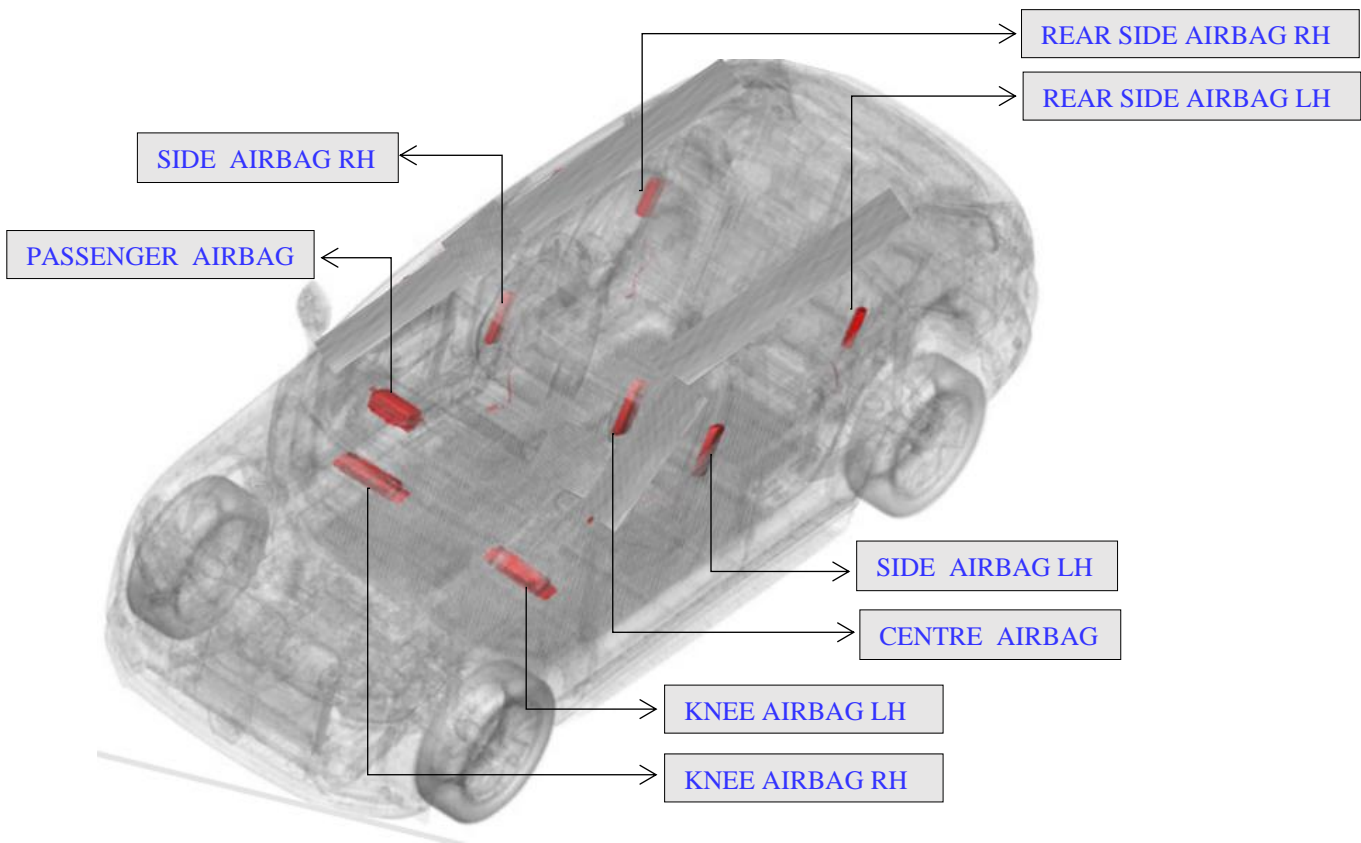
Inert Airbag/s installed in the vehicle.

1. Replace with an active airbag/s on the affected vehicles.
2. Strictly follow the shared VIN list at section (2.0) to check and verify the CRITERION of airbag/s which has impact to the individual VIN before proceeding for any replacement.

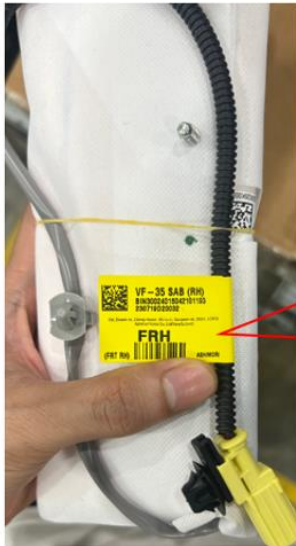
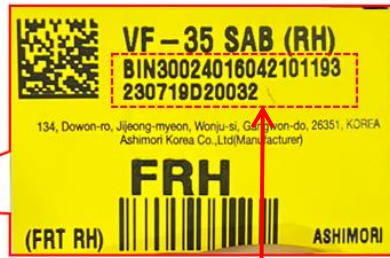
- i. If replaced any Airbag on the vehicle, the serial number of the Airbag should be recorded for both the old and the new Airbag.
- ii. The Airbag serial number [32 digit] is printed on the supplier label which is affixed on the part.
- iii. Take a picture of the complete part and the part label [with serial number] of both the old and the new part as shown below [**save the image as AIRBAG_Old and AIRBAG_New**], then add these pictures as an attachment in the repair order created against this field action in SF system.
- iv. **If failed to do so, the warranty claim will be rejected.**

Serial Number
 BIN30024016042101193230719D20032
