Storyteller Overland, LLC
Customer Service Department
428 Industrial Lane
Birmingham, AL 35211

TO: Storyteller Overland Dealers
Subject: NHTSA Recall: 23V-695

NHTSA RECALL # 24V-551 GXV NEXT OCCC Label Correction

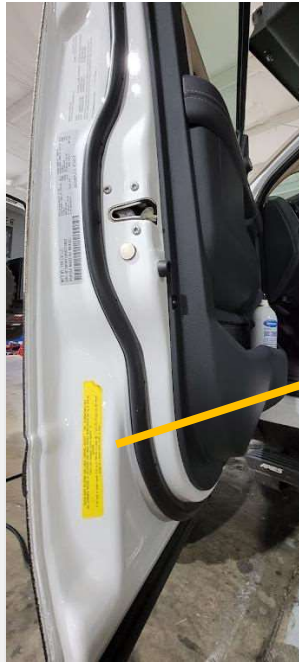
Figure 1a

1. Park the vehicle in a safe area with adequate room to access the driver's door.
2. Locate the existing yellow "Motor Home Occupant and Cargo Carrying Capacity" label on the end of the driver door. Peel off and dispose of this label. See figure 1a and 1b.

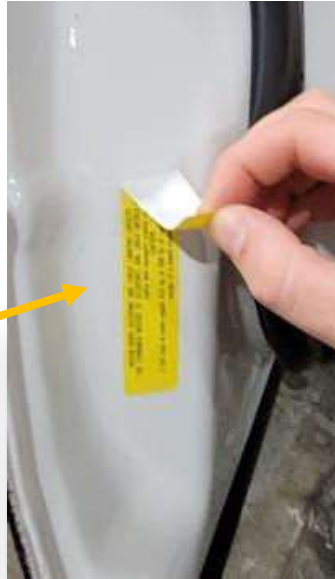
Figure 1b

Remove label

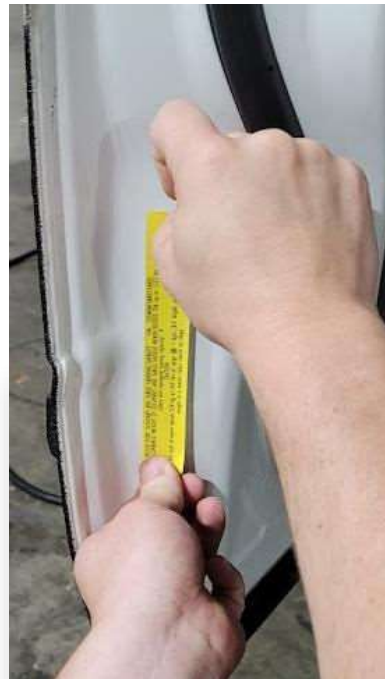
Figure 2

3. Clean the area the label was peeled off from using a clean paper towel/rag and Isopropyl alcohol. Allow the alcohol to evaporate for about 1 minute after cleaning.
4. Ensure the surface is dry, then apply the new label as shown in figure 2.
5. Once the new label has been applied to the vehicle, provide a picture of the new label on the vehicle to Storyteller at warranty@storytelleroverland.com
